SONDERGAARD GEOSCIENCE, PLLC

February 12, 2020
Revised November 6, 2020
Project No. J-0045

Subject: Geotechnical Engineering Study
Building G
Gayte Business Park
20015 67th Avenue NE
Arlington, Washington

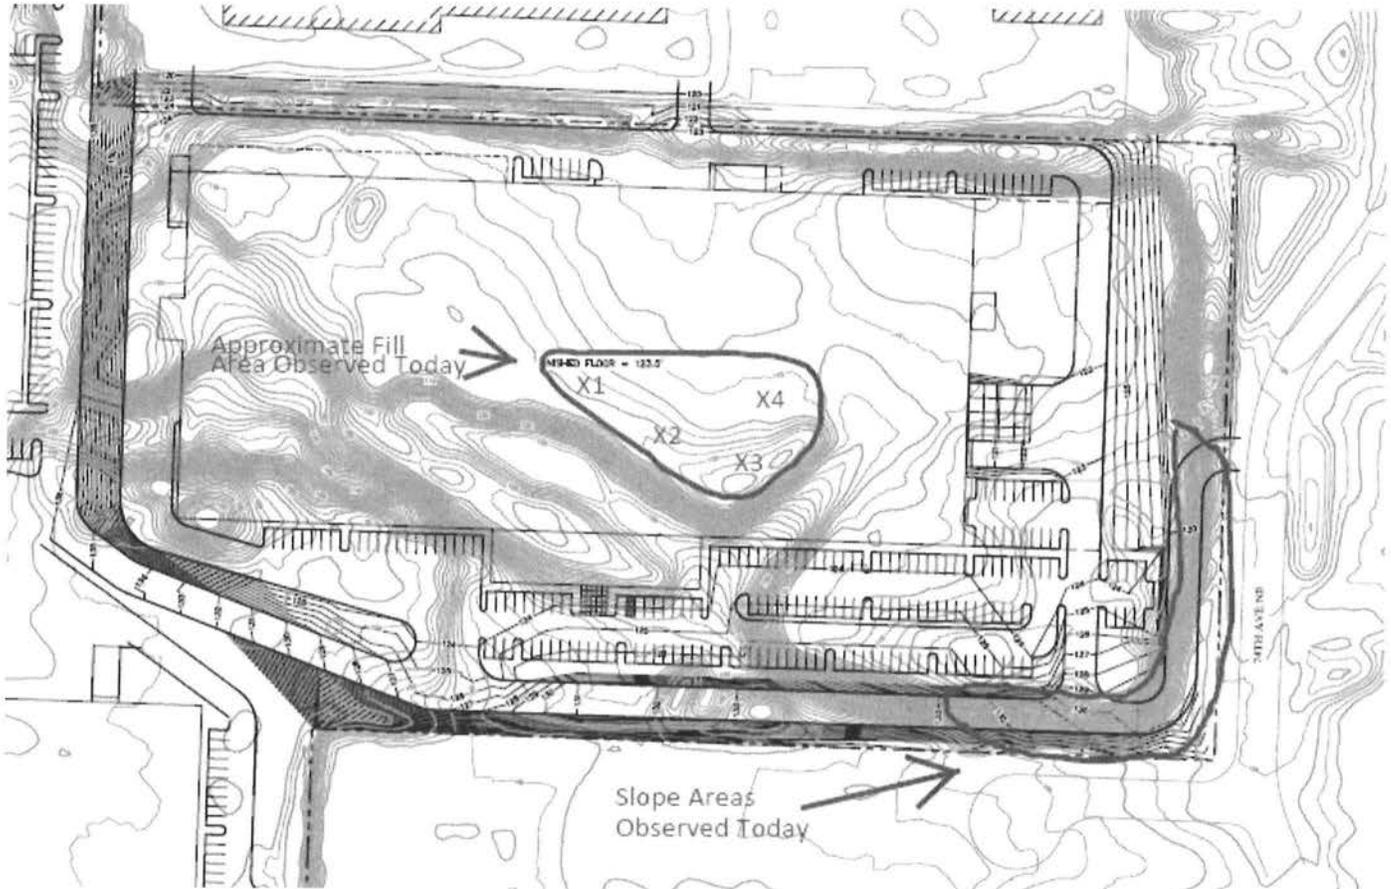
The earthwork contractor informed us they had placed about 3 to 4 feet of fill along the south side of the proposed building. We observed the subgrade soils along the edge of the fill area consisted of a gravelly sand to sandy gravel that could be penetrated from 1 to 4 inches with a 1/2 inch diameter probe rod. The fill material consisted of a dark brown, silty sand, which the contractor informed us was compacted in about 8 to 12 inch lifts with a roller. We did not observe the compaction process. A sample of the fill material was obtained for a Proctor analysis. Based on the survey stakes, we estimated the fill had been placed to an elevation between 113 to 115 feet.

The contractor inquired about placing fill against the slopes along the west and south sides of the site. We observed the slopes in general were about 45° (1H:1V) with a 4 to 5 feet vertical face at the top. We recommended the contractor bench the slope in phases at the maximum about 4 feet vertically and raise the fill to the top of the vertical cut before benching another 4 feet vertical cut.

We informed the contractor the area observed today met the 95% compaction criteria.

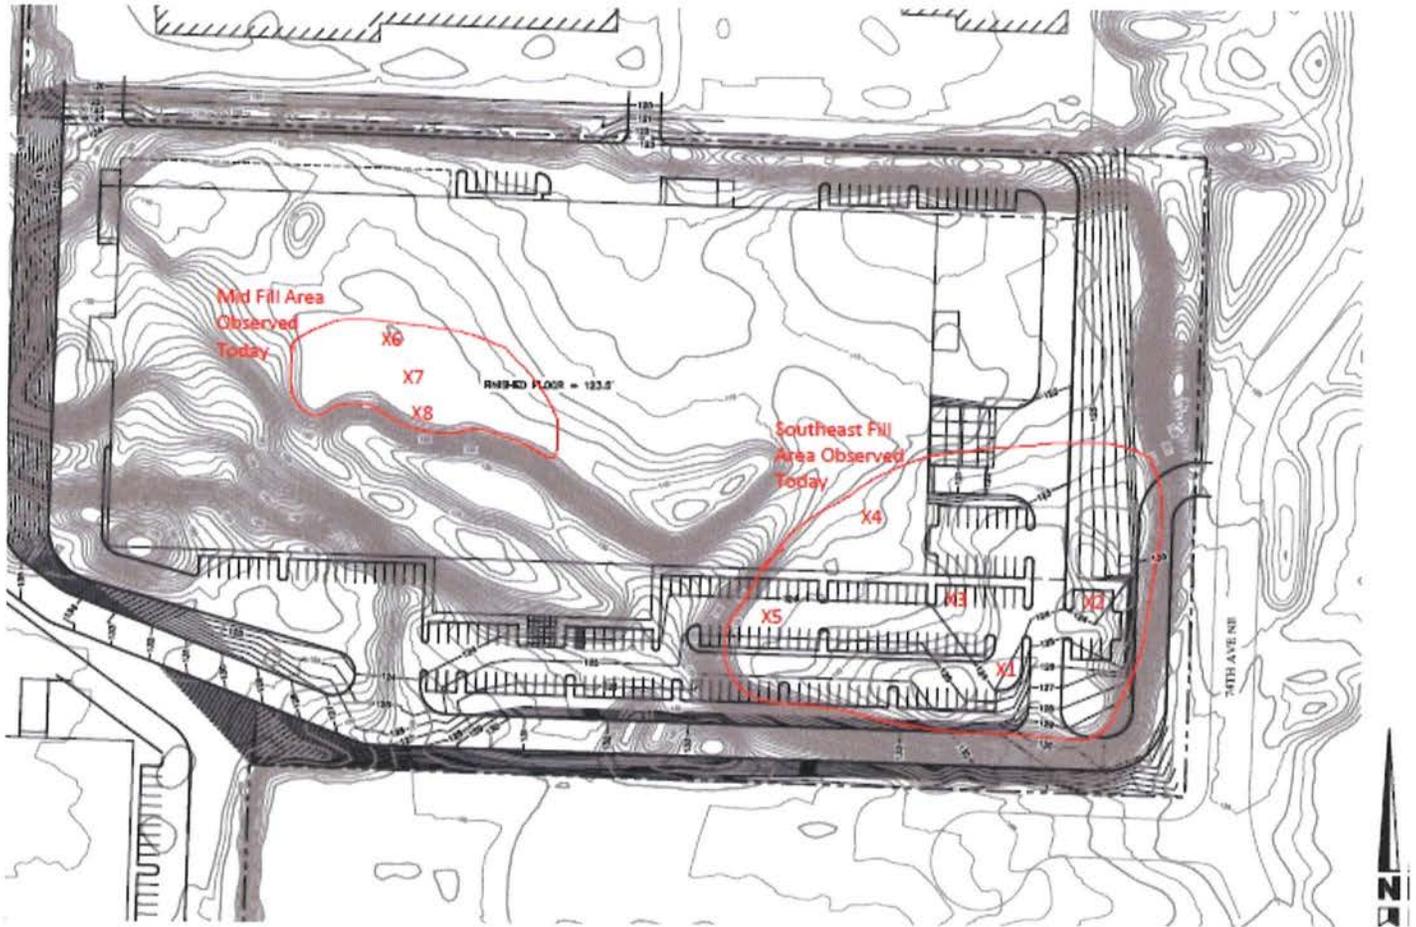
The earthwork contractor informed us they had placed about 4 to 6 feet of fill along the middle and southeast areas of the site. The middle area was within the proposed building footprint and the southeast area was mainly within the proposed parking area. We observed the subgrade soils along the edges of the fill area consisted of a gravelly sand to sandy gravel that could be penetrated from 1 to 4 inches with a 1/2 inch diameter probe rod. Fill material consisted of a sand and gravel for the southeast portion, and sand for the middle portion; which the contractor informed us was compacted in about 8 to 12 inch lifts with a sheeps foot roller. We did not observe the compaction process. A sample of the sand was obtained for a Proctor analysis. Based on the survey stakes, we estimated the fill had been placed to an elevation between 111 and 113 feet at the southeast, and between 114 and 119 feet at the middle.

We observed signs the slope areas along the south and east sides of the site were benched in phases as fill placement occurred. The contractor informed us they had been benching the 1H:1V slope with 4 feet vertical cuts and remaining vegetation along the slope areas would be removed as benching progresses up the slope.

We informed the contractor the area observed today met the 95% compaction criteria.

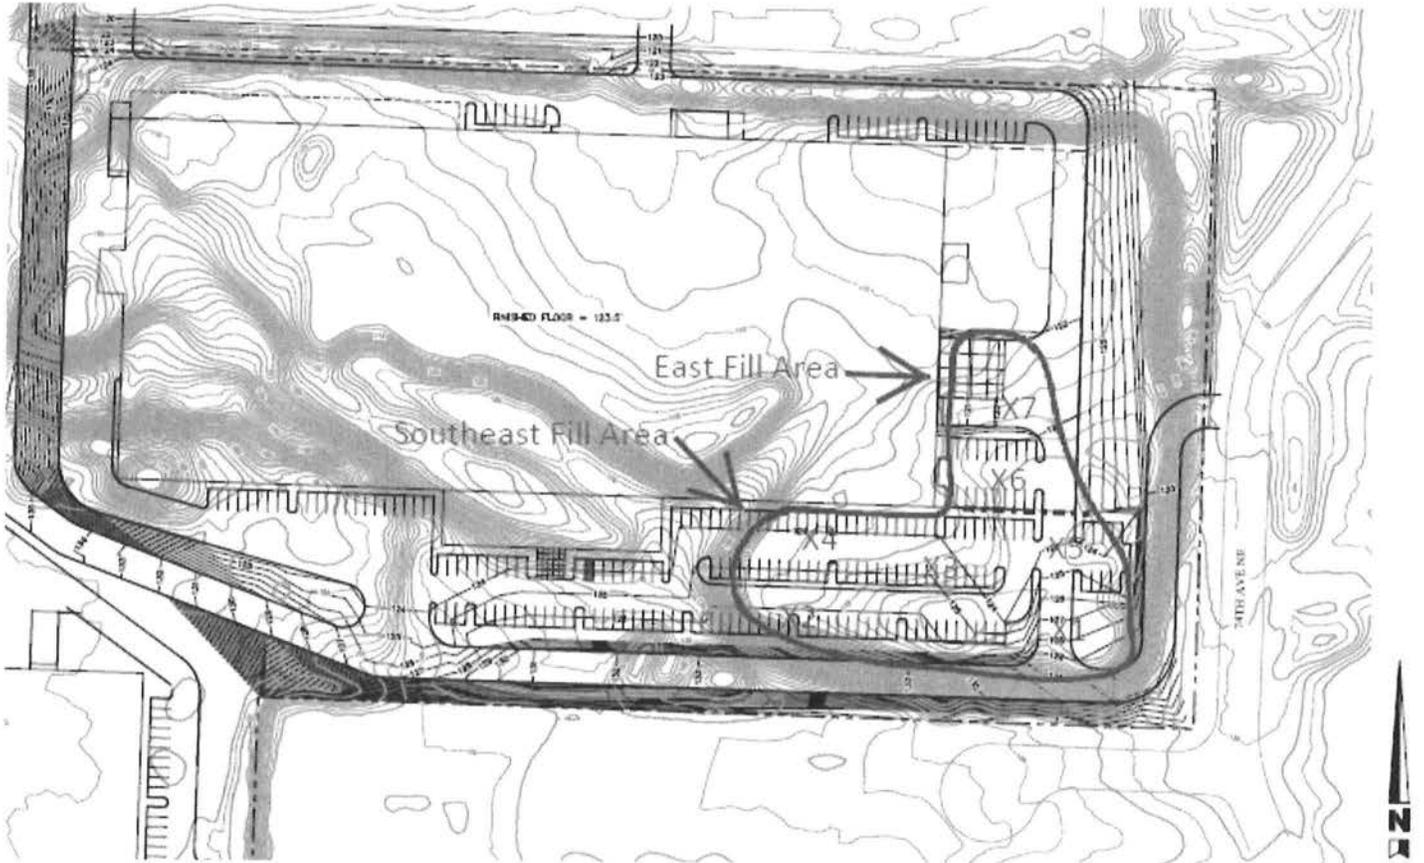
The earthwork contractor informed us they had placed about 1 to 3 feet of fill along the southeast and east areas of the site. Both the southeast and east areas were mainly within the proposed parking areas. We observed the subgrade soils along the edges of the fill area consisted of a gravelly sand to sandy gravel that could be penetrated from 1 to 4 inches with a 1/2 inch diameter probe rod. Fill material consisted of a sand and gravel from the south side of the site. The contractor informed us the fill was compacted in about 8 to 12 inch lifts with a sheeps foot roller. We did not observe the compaction process. Based on the survey stakes, we estimated the fill had been placed to an elevation between 112 and 117 feet at the southeast, and between 111 and 113 feet at the east.

We informed the contractor the area observed today met the 95% compaction criteria.

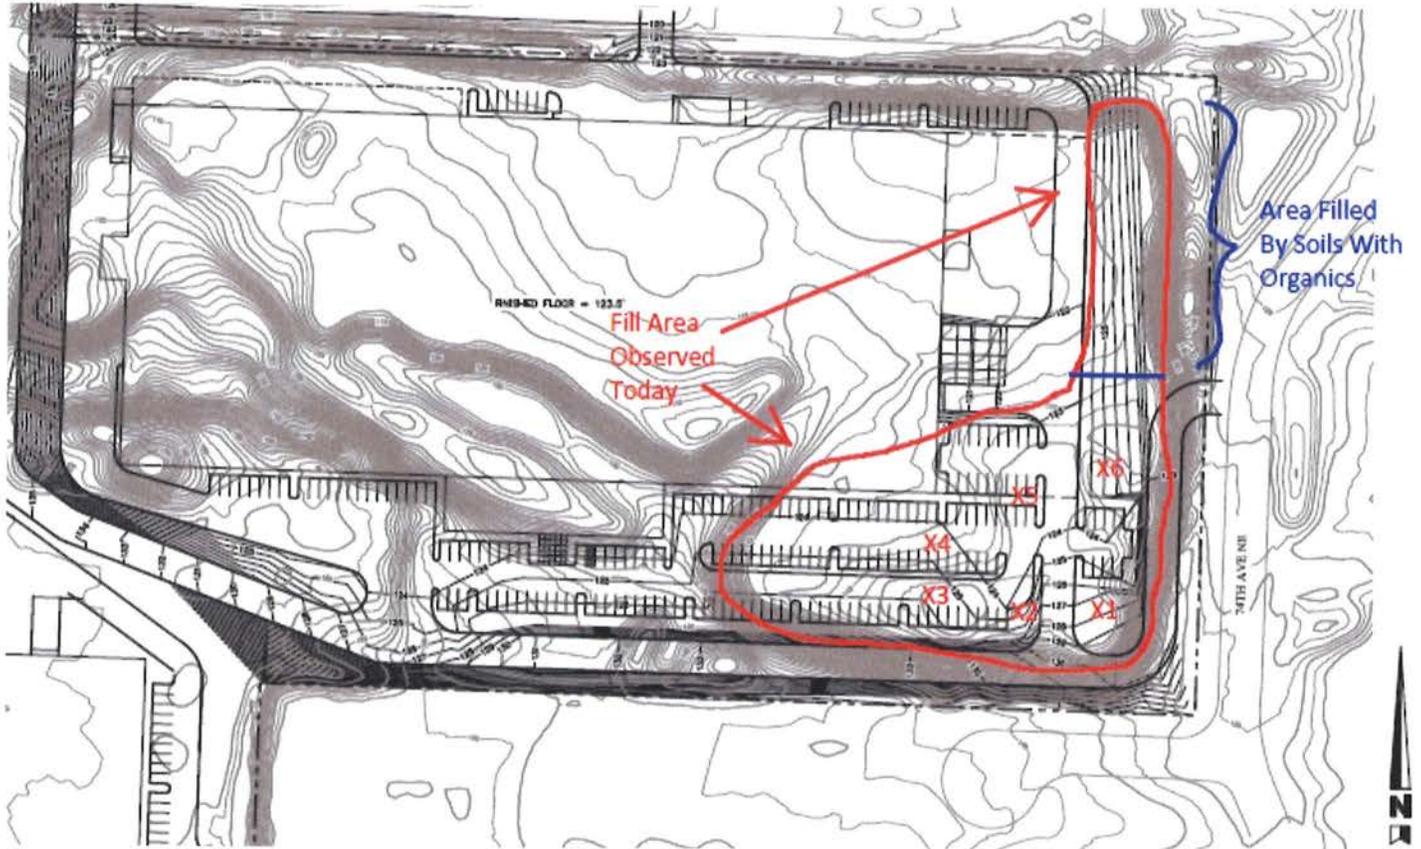
The earthwork contractor informed us they had placed about 1 to 4 feet of fill along the southeast and east areas of the site. The southeast fill area was under proposed parking and road areas, and the east fill area was within the proposed slope area. We observed the subgrade soils along the edges of the fill area consisted of a gravelly sand to sandy gravel that could be penetrated from 1 to 4 inches with a 1/2 inch diameter probe rod. Fill material for the southeast area consisted of a sand and gravel from the south side of the site, while fill material for the east fill area consisted of a silty sand, with some organics from the north side of the site. The contractor informed us the fill was compacted in about 8 to 12 inch lifts with a sheeps foot roller. We did not observe the compaction process. Based on the survey stakes, we estimated the fill had been placed to an elevation between 111 and 118 feet at the southeast, and between 111 and 117 feet at the east. We recommended to the contractor that the use of soils with some organics was acceptable under the areas that are not slopes, provided the soils with organics are spread throughout the site; however, soils with organics should not be used exclusively on slope areas.

We informed the contractor the area southeast area observed today met the 95% compaction criteria. We also recommended the contractor not place soils with organics exclusively on proposed slope areas.

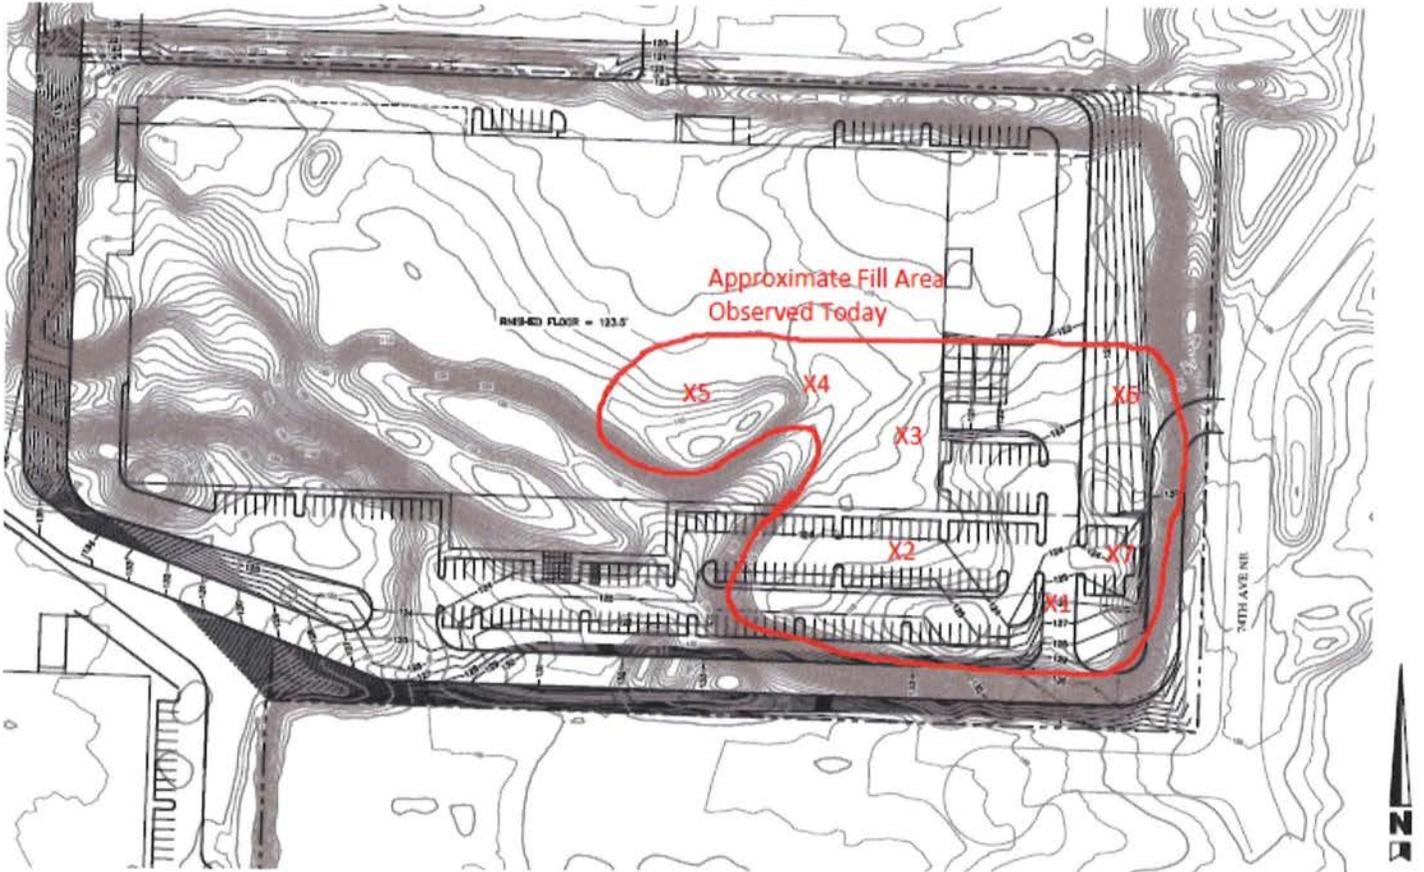
The earthwork contractor informed us they had placed about 1 to 4 feet of fill along the middle, southeast and east areas of the site. The middle fill area was within the building footprint, the southeast fill area was under proposed parking and road areas, and the east fill area was within the proposed slope area. We observed the subgrade soils along the edges of the fill area consisted of a gravelly sand to sandy gravel that could be penetrated from 1 to 4 inches with a 1/2 inch diameter probe rod. Fill material for the areas observed today consisted of a sand and gravel from the south side of the site. The contractor informed us the fill was compacted in about 4 to 8 inch lifts with a smooth drum roller. We did not observe the compaction process. Based on the survey stakes, we estimated the fill areas observed today had been placed to an elevation between 114 and 120 feet.

We informed the contractor the fill areas observed today met the 95% compaction criteria.

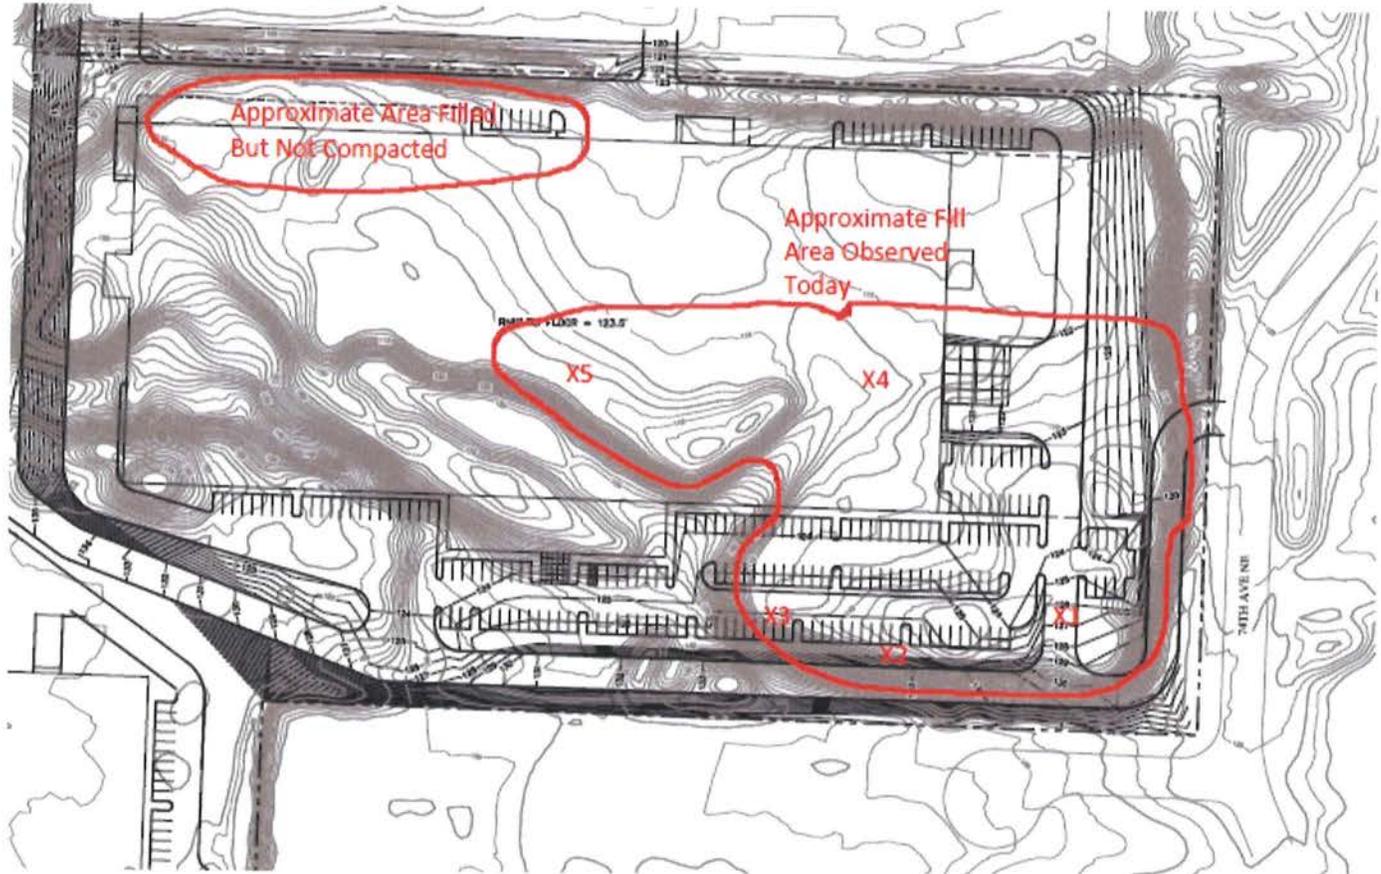
The earthwork contractor informed us they had placed fill along the middle, southeast and east areas of the site. The middle fill area was within the building footprint, the southeast fill area was under proposed parking and road areas, and the east fill area was within the proposed slope area. We observed the contractor was in the process of placing fill along the northwest portions of the site but were informed that they did not intend to compact the area until Monday. Fill material for the areas observed today consisted of a sand and gravel from the south and southwest areas of the site. The contractor informed us the fill was compacted in about 4 to 8 inch lifts with a smooth drum roller. We did not observe the compaction process. Based on the survey stakes, we estimated the fill areas observed today had been placed to an elevation between 115 and 126 feet.

We informed the contractor the fill areas observed today met the 95% compaction criteria.
