Soundview Consultants LLC

Arborist Report

Re: Arborist Report and Tree Retention Plan
SR 530 Mixed Use Development

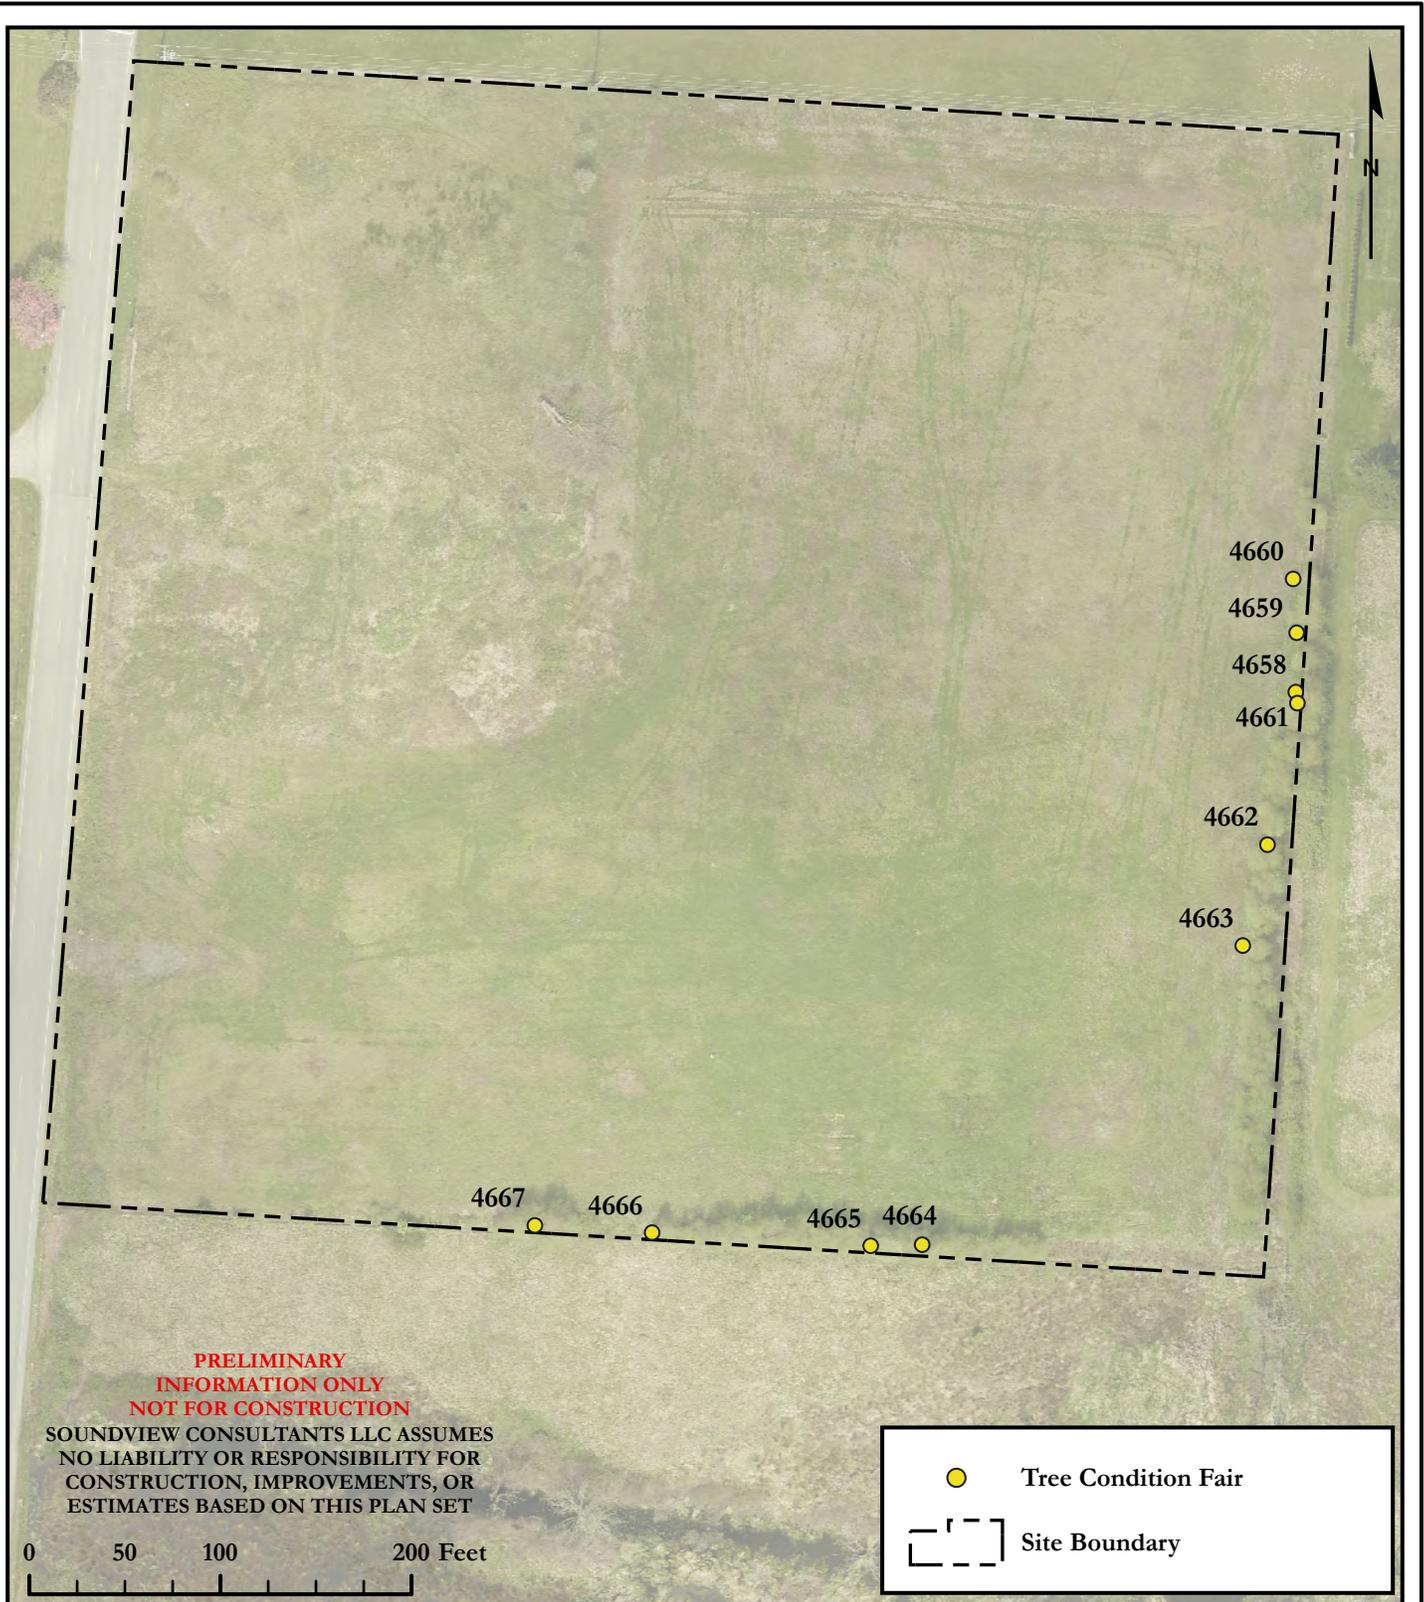
TREE ASSESSMENT

The 8.80-acre subject property is located in mixed residential/agricultural interface in the City of Arlington. The vast majority of the site consists of open fields. Trees are limited to a few scattered individuals along the eastern and southern perimeters of the site. Observed species included nine (9) white bark birch (*Betula papyrifera*) with a DBH of 8 inches or greater, and one Hooker's willow (*Salix hookeriana*) with a DBH of 12 inches. A Tree Assessment Spreadsheet summarizing the observed trees is provided in Attachment B.

All ten trees are in fair condition. Two birch trees contained individual stems and the other eight were multi-stemmed trees, where the sum of the square root of the combined stems resulted in a final diameter calculation equal to or greater than 8 inches. The multi-stemmed birch and willow tree's trunks originate at ground level, yet contain connective tissue at the base, identified as trees with "basally joined" stems. This growth pattern is common for birch and willow tree species, naturally or intentionally curated for the multi-stem effect. Both species are fast-growing tree species with relatively short life spans and prone to have stems split-out or fail at the point of origin as they age or in high winds or if covered in ice. However, the unions of the assessed significant trees were sufficiently rooted and would not be considered "hazardous"

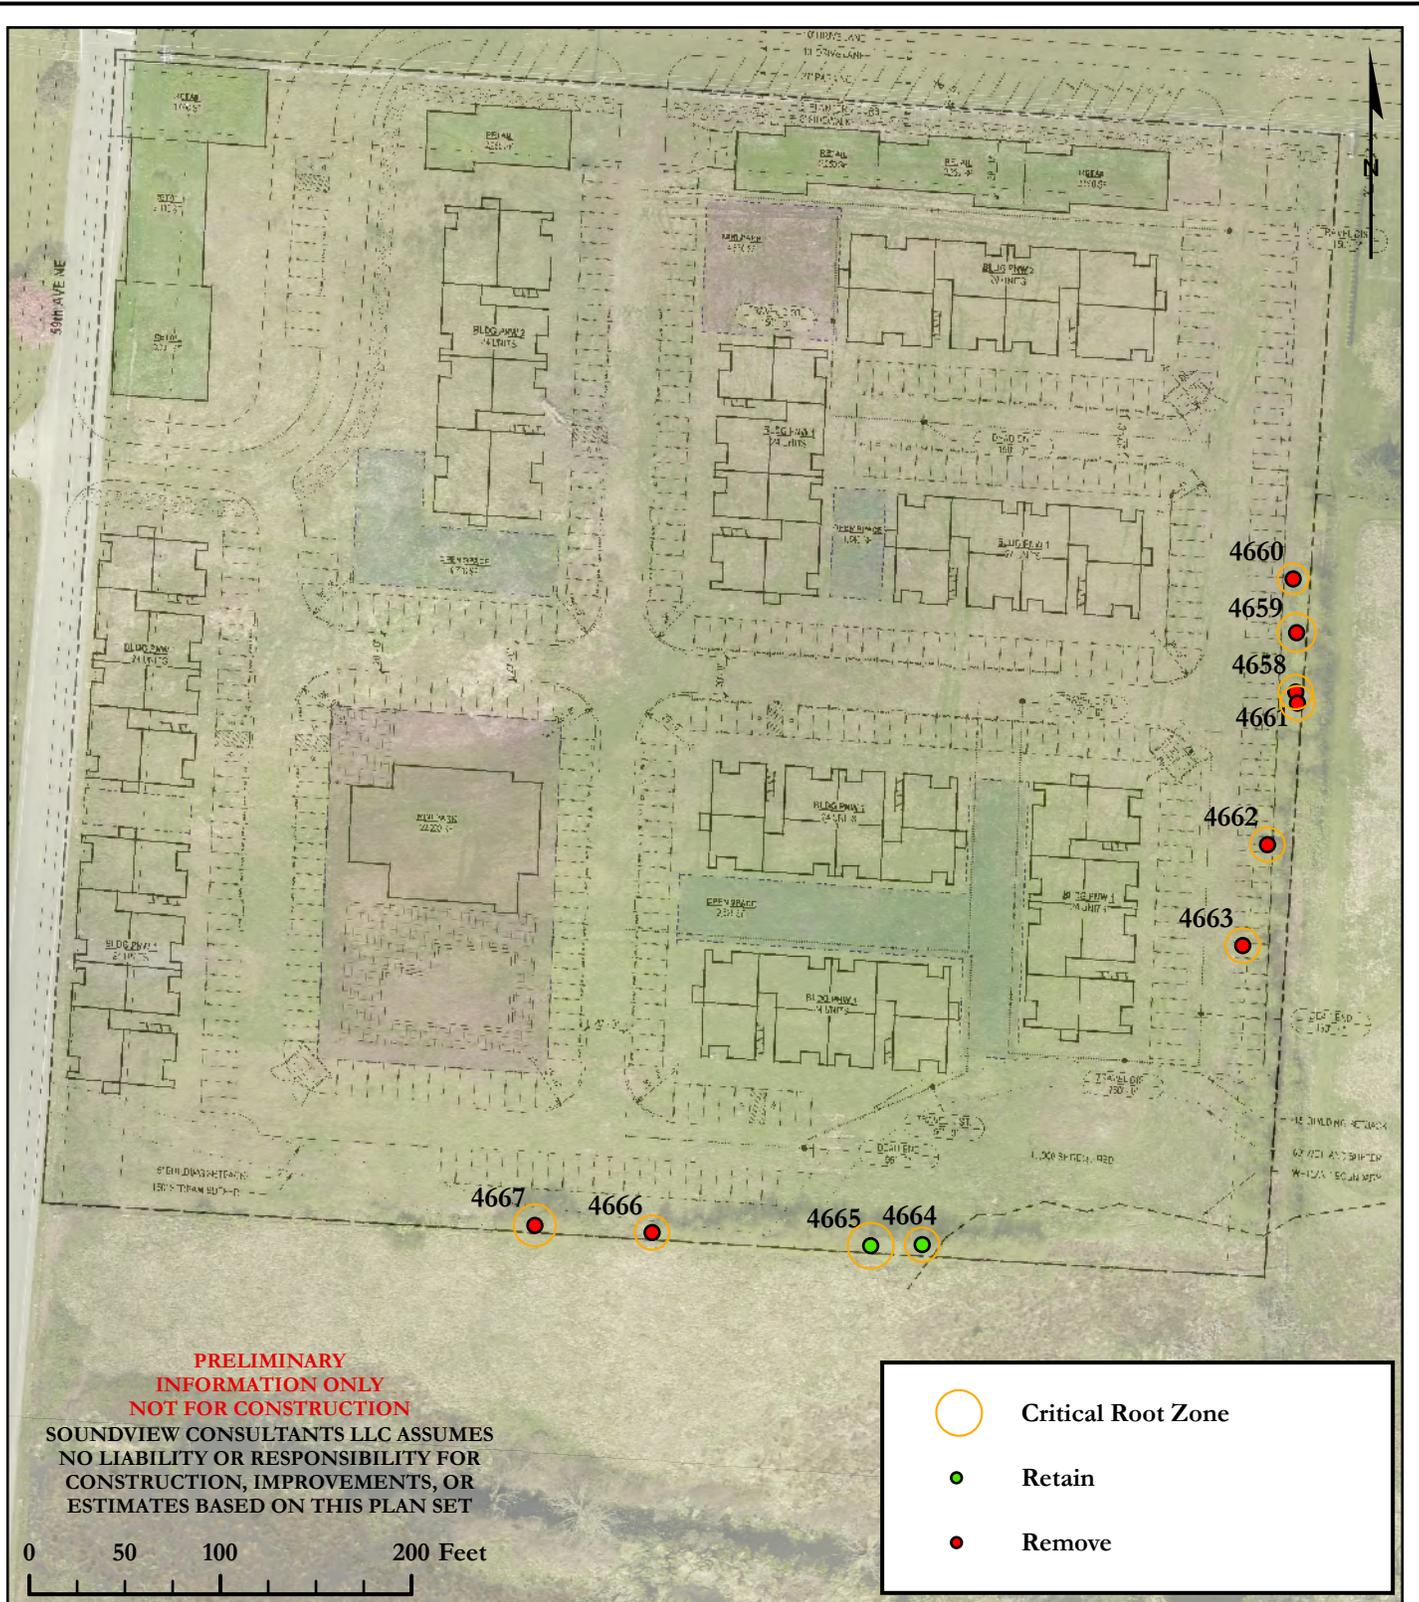
TREE RETENTION EXHIBIT

The proposed project requires the removal of eight (8) significant trees (T-4658, T-4659, T-4660, T-4661, T-4662, T-4663, T-4666, and T-4667). T-4662 and T-4663 are located within the footprint of proposed parking and site access. T-4658, T-4659, T-4660, T-4661, T-4666, and T-4667 are situated adjacent to the proposed parking and site access such that associated grading would substantially impact the CRZ and be detrimental to the trees. The proposed parking and site access are the minimum necessary to provide adequate and safe access and parking for the proposed mixed-use development. The six (6) remaining trees and CRZs are located entirely outside of the footprint of the proposed development. A Tree Retention Plan is provided in Attachment C.

Per AMC 20.76.120(d), any significant trees removed shall be replaced with five-gallon sized native species at a ratio of 3:1. If the replacement trees are to be planted on building lots, the developer shall provide adequate protection from damage during construction, or planting shall occur after construction, in which case a planting plan and security shall be provided to ensure their planting.

Given the ratio of 3:1 replacement trees for the removal of every significant tree, the proposed project requires planting 24 five-gallon native trees onsite. These may be planted in critical area buffers, open space tracts, or park spaces to be retained/provided onsite. These trees should be specified in future landscaping plans. Per AMC 20.97.120(e), if it is physically impossible to replant all replacement trees onsite, then the Applicant may mitigate the loss of significant trees by either planting trees on public property within the City as approved by the community development director, and/or paying a mitigation fee to the City's tree mitigation in-lieu fee (ILF) fund.

In addition to requirements for significant tree retention and replacement, per AMC 20.76.120(d), CRZs shall be fenced prior to construction with orange plastic mesh fencing or an approved equivalent to prevent encroachment.

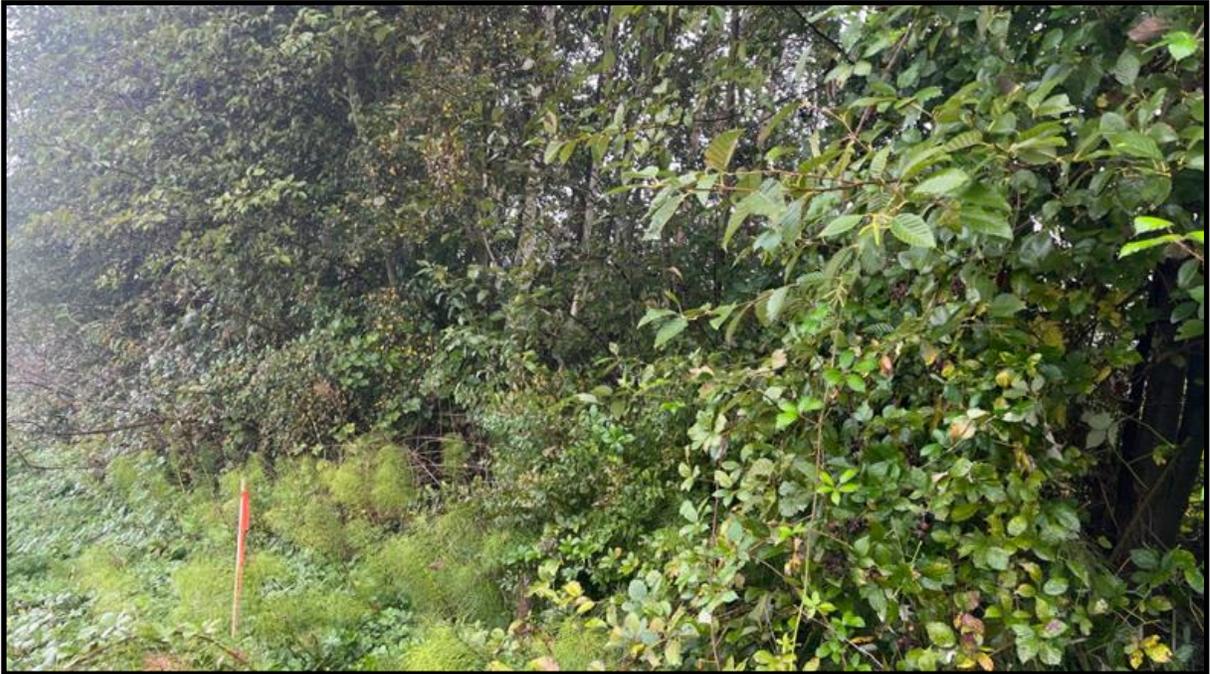
All of the assessed trees are located in dense thickets or stands. If all non-significant trees are removed from the two perimeter stands leaving only the significant trees, the remaining significant trees may need to be reassessed by an arborist or landscape professional to determine if they are windfirm. Environmental forces, such as strong winds may affect newly isolated individual trees. If some insignificant trees can be thinned but retained within the proximity of significant trees to be retained, the failure potential will likely decrease.

Density of Alder and Birch Perimeter Stand, Facing Northeast

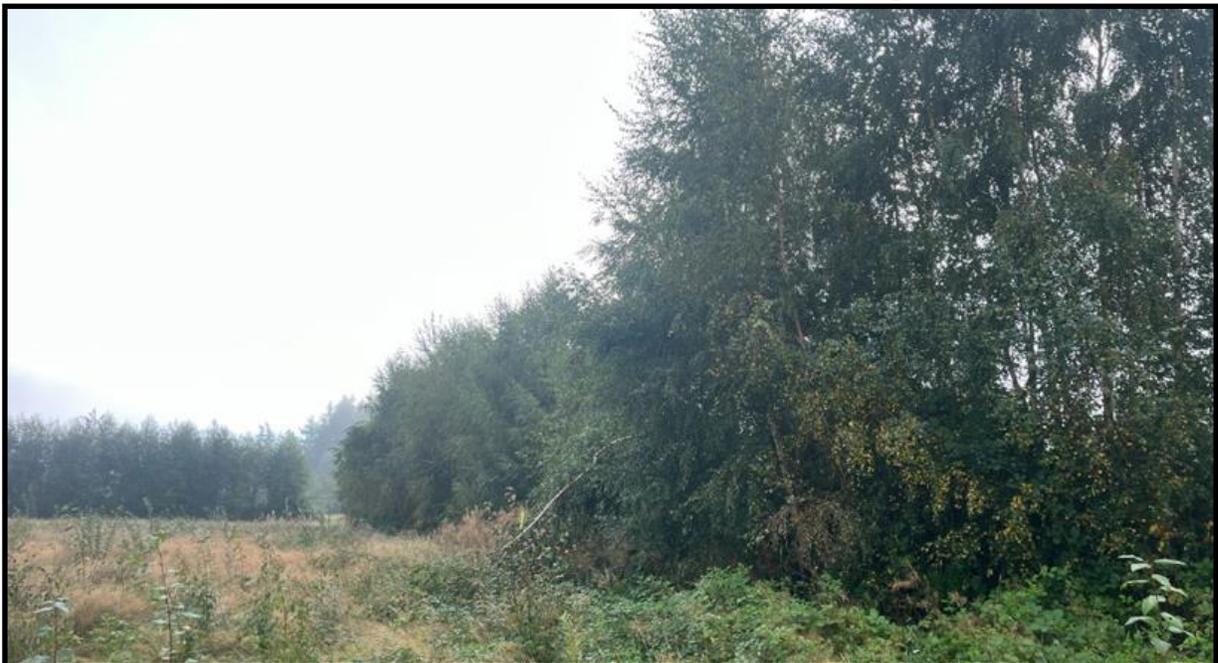
Eastern and Southern Perimeter Tree Stands, Facing East
