PRELIMINARY INFILTRATION EVALUATION  
ARLINGTON APARTMENTS  
21117 59<sup>th</sup> Avenue Northeast  
Arlington, Washington

PROJECT NO. 24-207

October 2024

Subject: **Preliminary Infiltration Evaluation  
Proposed Arlington Apartments  
21117 59th Avenue Northeast, Arlington, Washington**

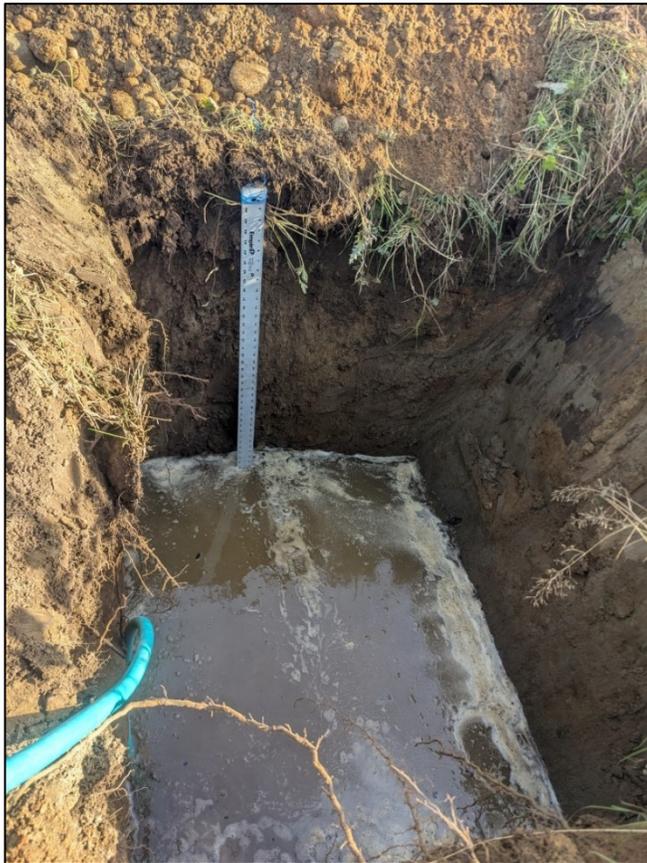
*Plate 1: View of infiltration testing in progress at Test Pit PIT-101.*

The field infiltration tests were conducted in general accordance with the procedure for the small PIT as outlined in the WDOE Manual. Plate 1 on the next page shows a test underway at the location of Test Pit TP-6. In general, the test consisted of the following procedure:

- A test pit was excavated with a minimum bottom area of 12 square feet.
- The test pit was pre-soaked using potable water from a municipal water source for six hours by maintaining a water level of at least 12 inches above the bottom of the pit. A flow meter was used to monitor the amount of water used during the pre-soak.
- At the end of pre-soak period, a flow meter was used to monitor the amount of water needed to maintain a constant head of 12 inches for at least one hour and until at least a point at which a constant volume of water per time unit was achieved.
- At the end of the constant head test, we measured the falling head infiltration rate by shutting off the water flow and recording the decrease in water level over regular time intervals until the water was infiltrated.

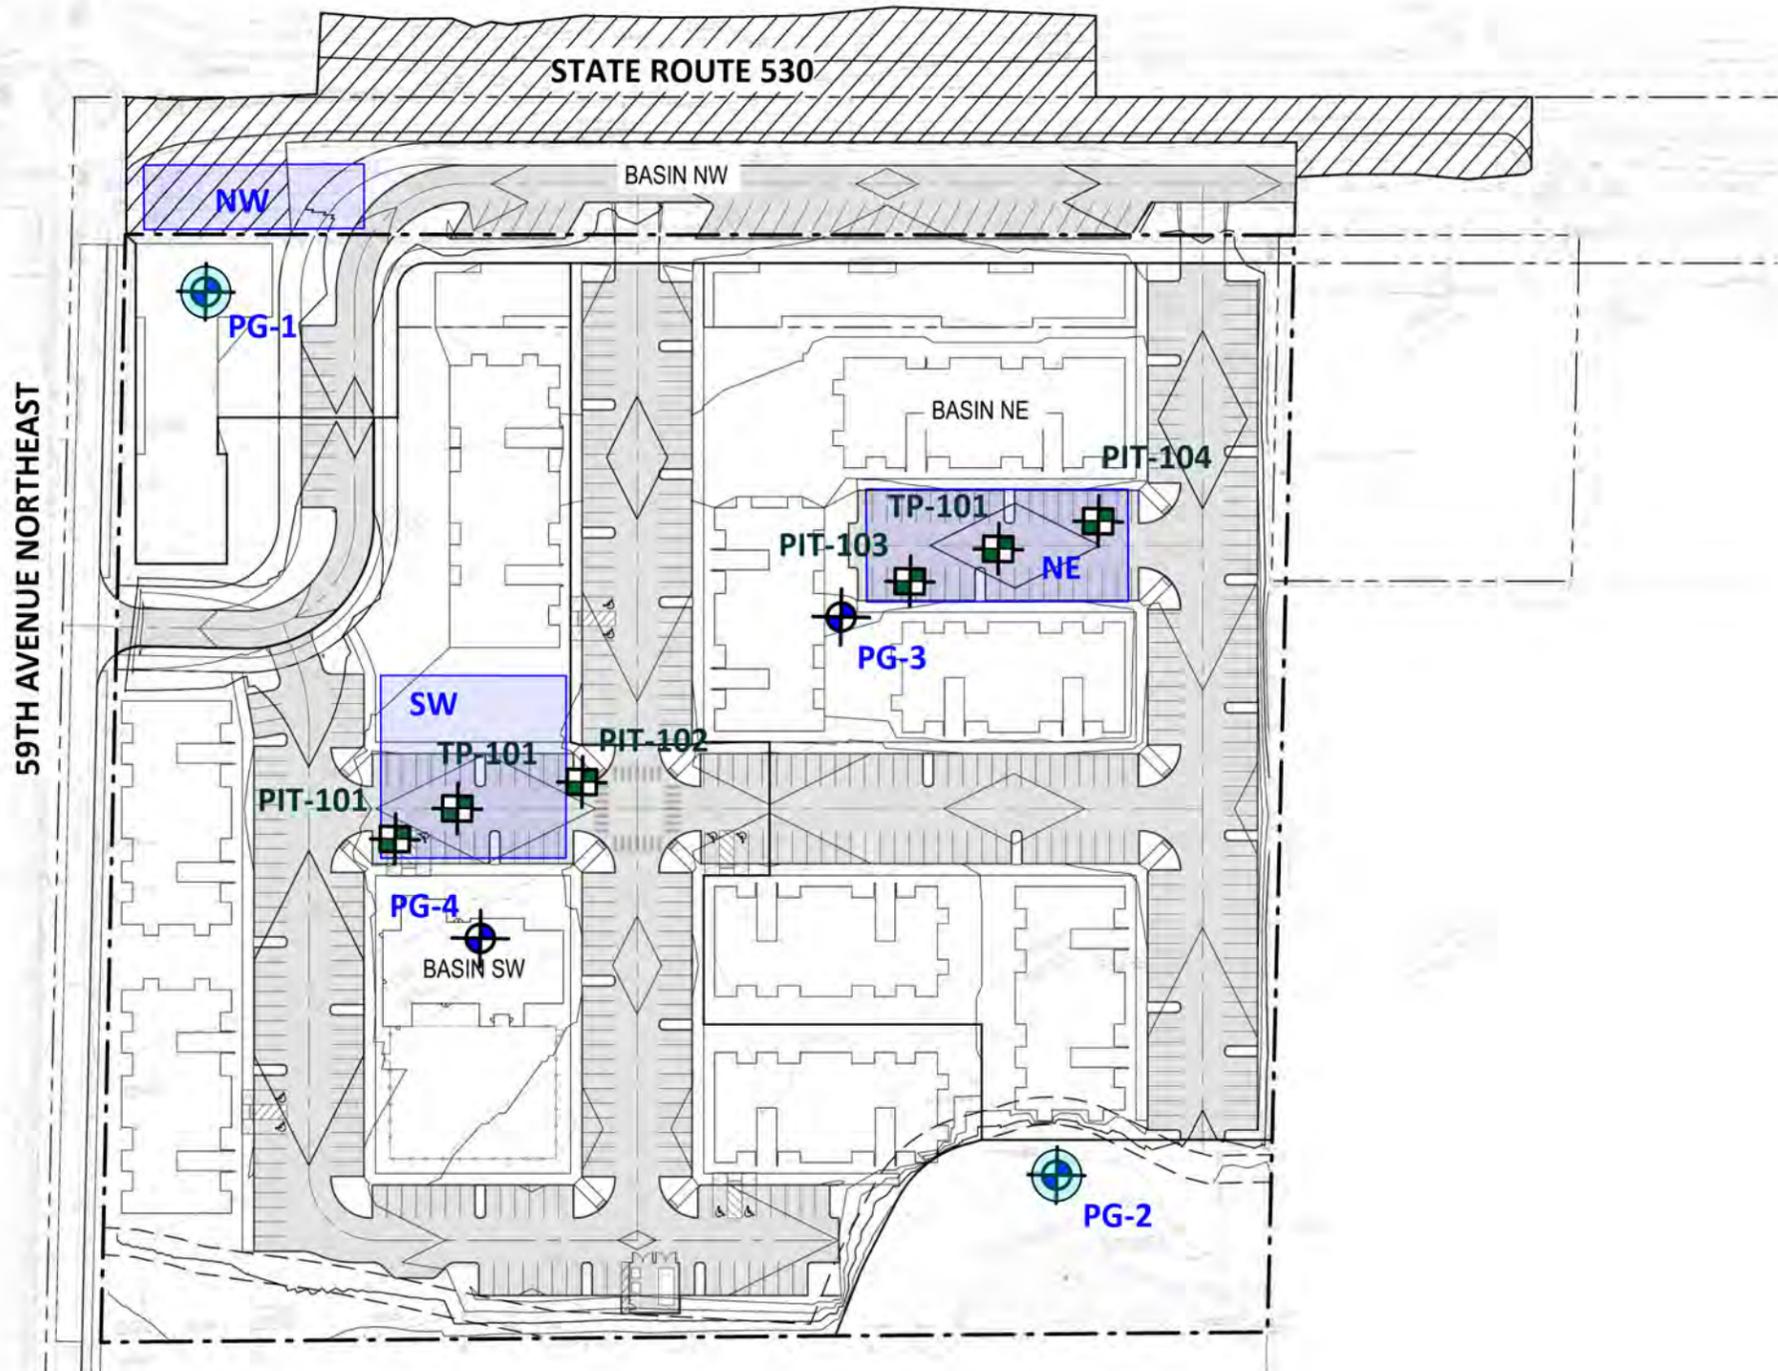
Surface water from the planned improvements will be collected and disposed of by infiltration into the site soils. Three infiltration basins have been established and are identified as the Southwest Basin, Northeast Basin, and Northwest Basin. The locations of the basins and proposed infiltration systems are shown in Figure 2.

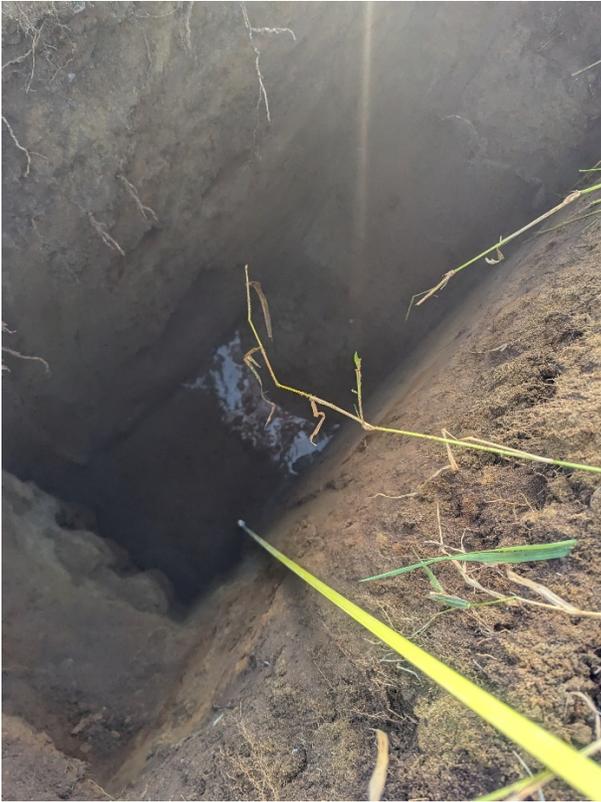
Image of test pit soils at approximately 7 feet below grade. Groundwater was encountered at approximately 6 feet below grade during excavation. Soil caving was observed from 6 to 8 feet.	
<b>Logged by:</b> E. Eckles

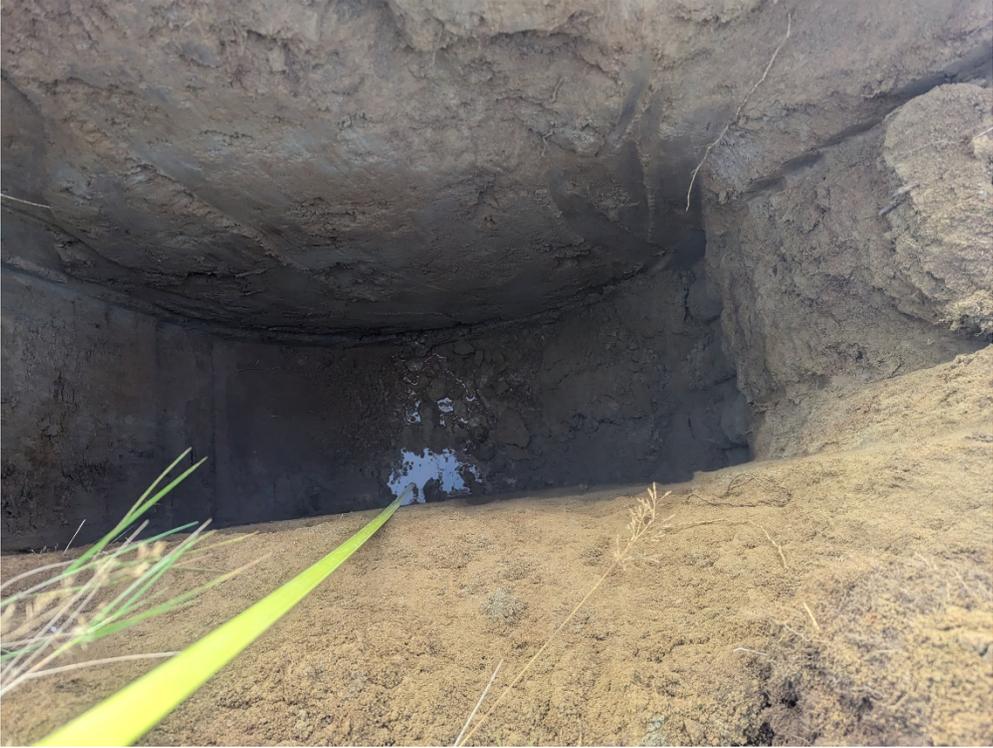
Image of test pit soils encountered approximately 8 feet below grade. Groundwater was encountered at about 7 feet below grade. Sidewall caving was observed from 7 to 8 feet.	
<b>Logged by:</b> E. Eckles

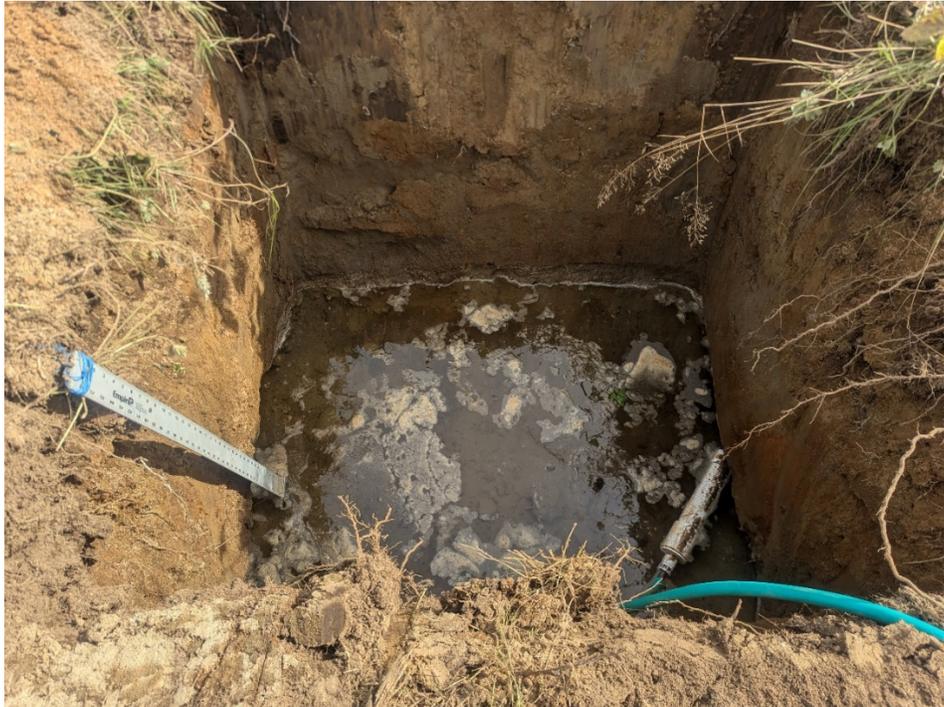
Image of small PIT test pit setup approximately 4-ft below grade. Soil caving was observed from 4 to 8 feet.

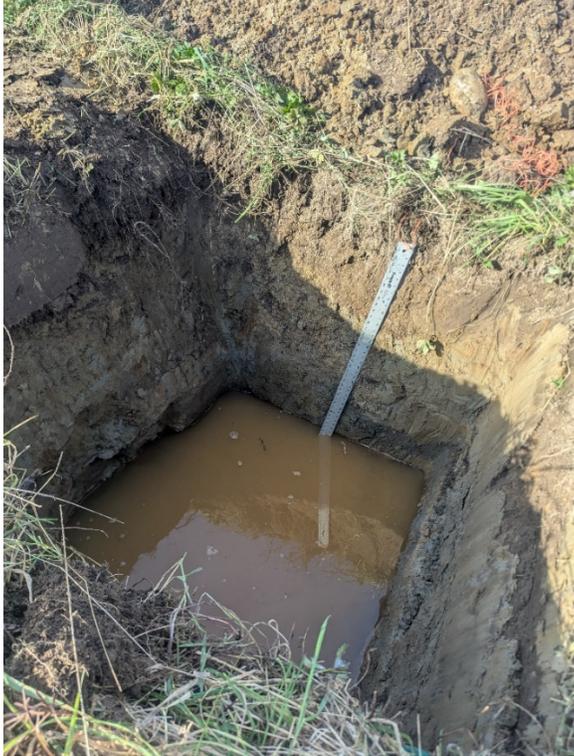
Image of small PIT test pit setup approximately 4-ft below grade. Soil caving was observed from 4½ feet to 7½ feet.	
<b>Logged by:</b> E. Eckles

We encountered a layer of silty sand and sandy silt at the test elevation at PIT-102 which resulted in a reduced infiltration rate of  $1/10^{\text{th}}$  of an inch per hour. If lenses of silty sand or sandy silt are encountered in the base of the infiltration system elevation, we recommend they be overexcavated and replaced with a permeable soil such as pea gravel or washed

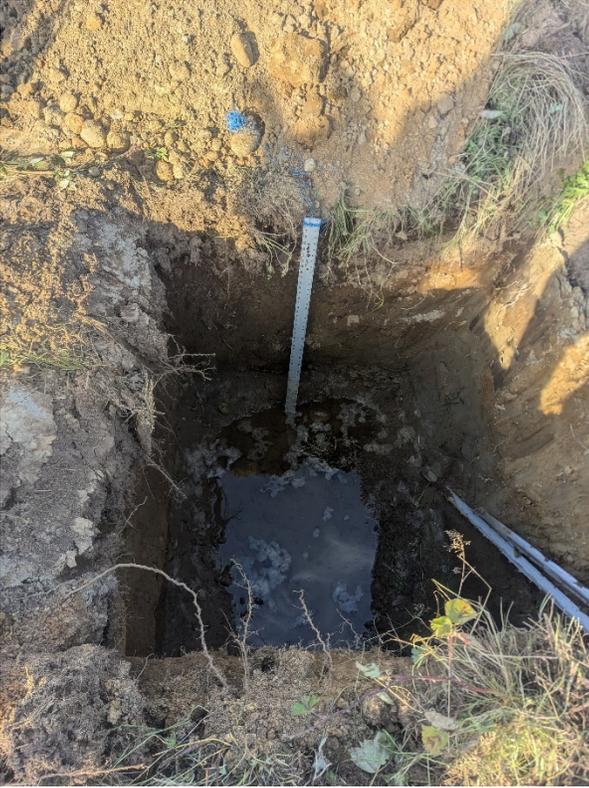
Image of test pit soils at approximately 4 feet below grade. Soil caving was observed was observed from 4 feet to 8 feet.	
<b>Logged by:</b> E. Eckles

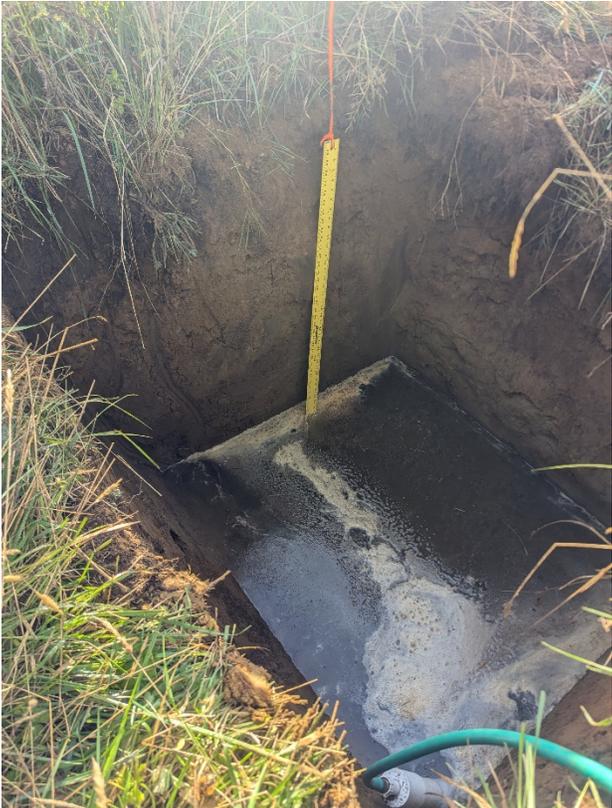
Image of PIT setup at approximately 4 feet below grade. Soil caving was observed from 3½ to 8 feet.	
<b>Logged by:</b> E. Eckles

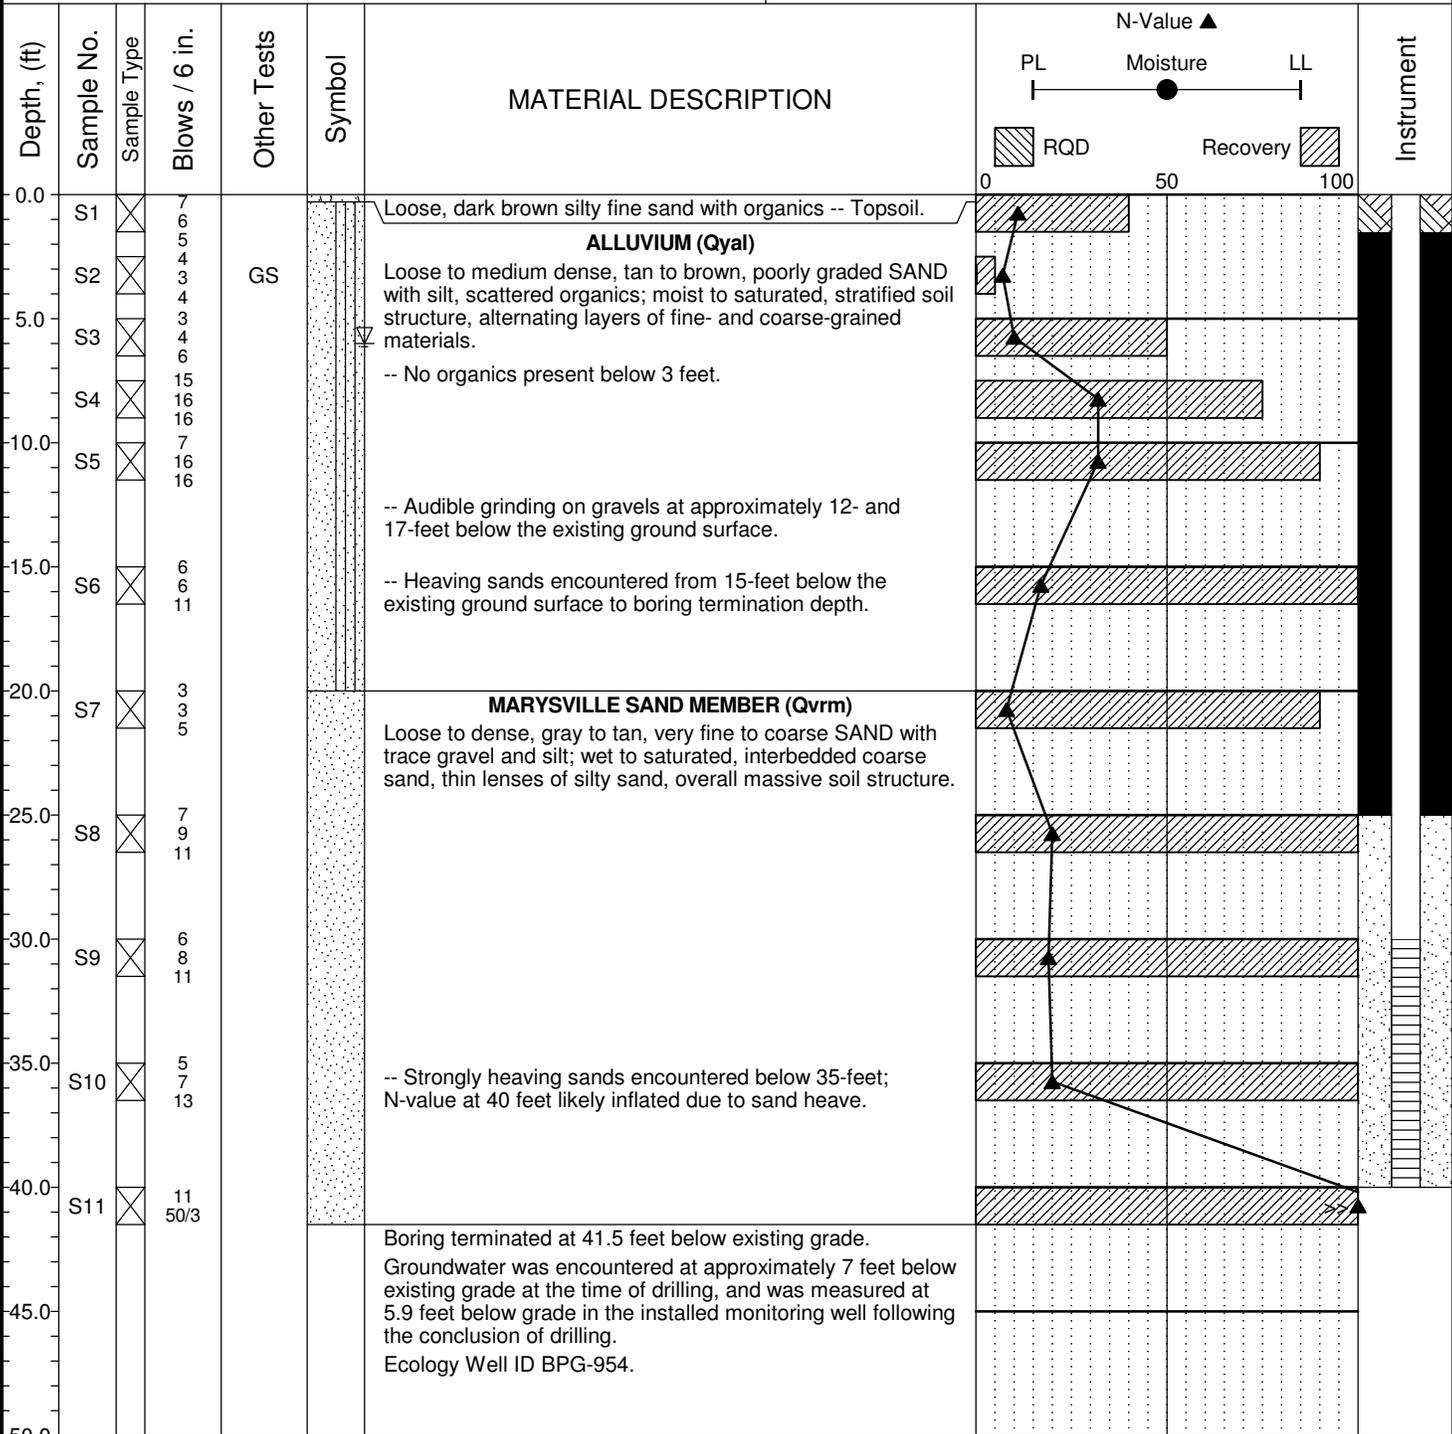
Project:	21117 59th Avenue Northeast	Surface Elevation:	64.0ft
Job Number:	24-207	Top of Casing Elev.:	64.0ft
Location:	21117 59th Ave NE, Arlington, WA	Drilling Method:	EC55 Track Drill Rig, Hollow Stem Auger
Coordinates:	Northing: 48.1879372, Easting: -122.1504602	Sampling Method:	SPT w/rope & cathead

Completion Depth:	41.5ft	Remarks: Standard penetration test (SPT) sampler driven with a 140 lb. safety hammer. Hammer operated with a rope and cathead mechanism. Approximate state plane coordinates and elevation are based on Google Earth. This information is provided for relative information only and is not a substitution for field survey. <b>Datum: Washington North / NAVD88</b>
Date Borehole Started:	6/27/24	
Date Borehole Completed:	6/27/24	
Logged By:	E. Eckles	
Drilling Company:	Boretect1 Inc.

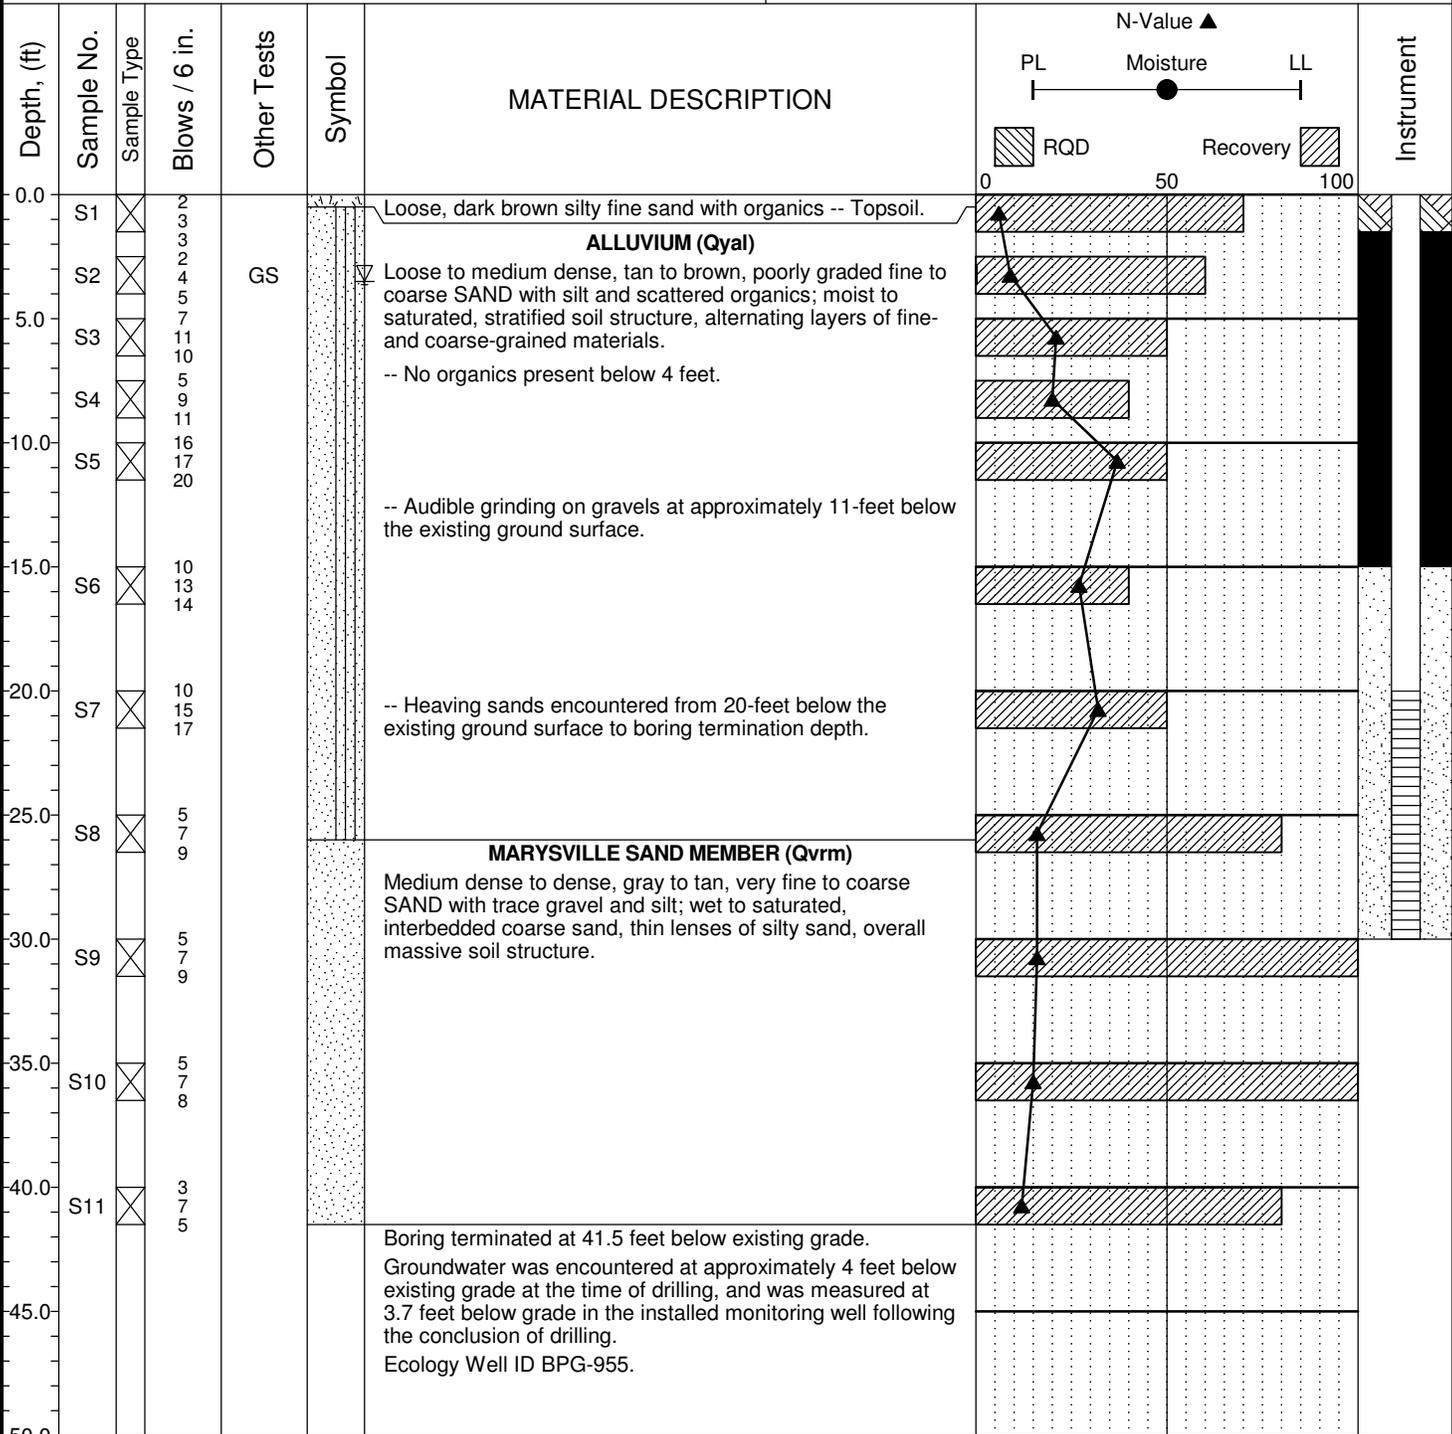
Project:	21117 59th Avenue Northeast	Surface Elevation:	62.0ft
Job Number:	24-207	Top of Casing Elev.:	62.0ft
Location:	21117 59th Ave NE, Arlington, WA	Drilling Method:	EC55 Track Drill Rig, Hollow Stem Auger
Coordinates:	Northing: 48.18686, Easting: -122.1487876	Sampling Method:	SPT w/rope & cathead

Completion Depth:	41.5ft	Remarks: Standard penetration test (SPT) sampler driven with a 140 lb. safety hammer. Hammer operated with a rope and cathead mechanism. Approximate state plane coordinates and elevation are based on Google Earth. This information is provided for relative information only and is not a substitution for field survey. <b>Datum: Washington North / NAVD88</b>
Date Borehole Started:	6/27/24	
Date Borehole Completed:	6/27/24	
Logged By:	E. Eckles	
Drilling Company:	Boretect1 Inc.

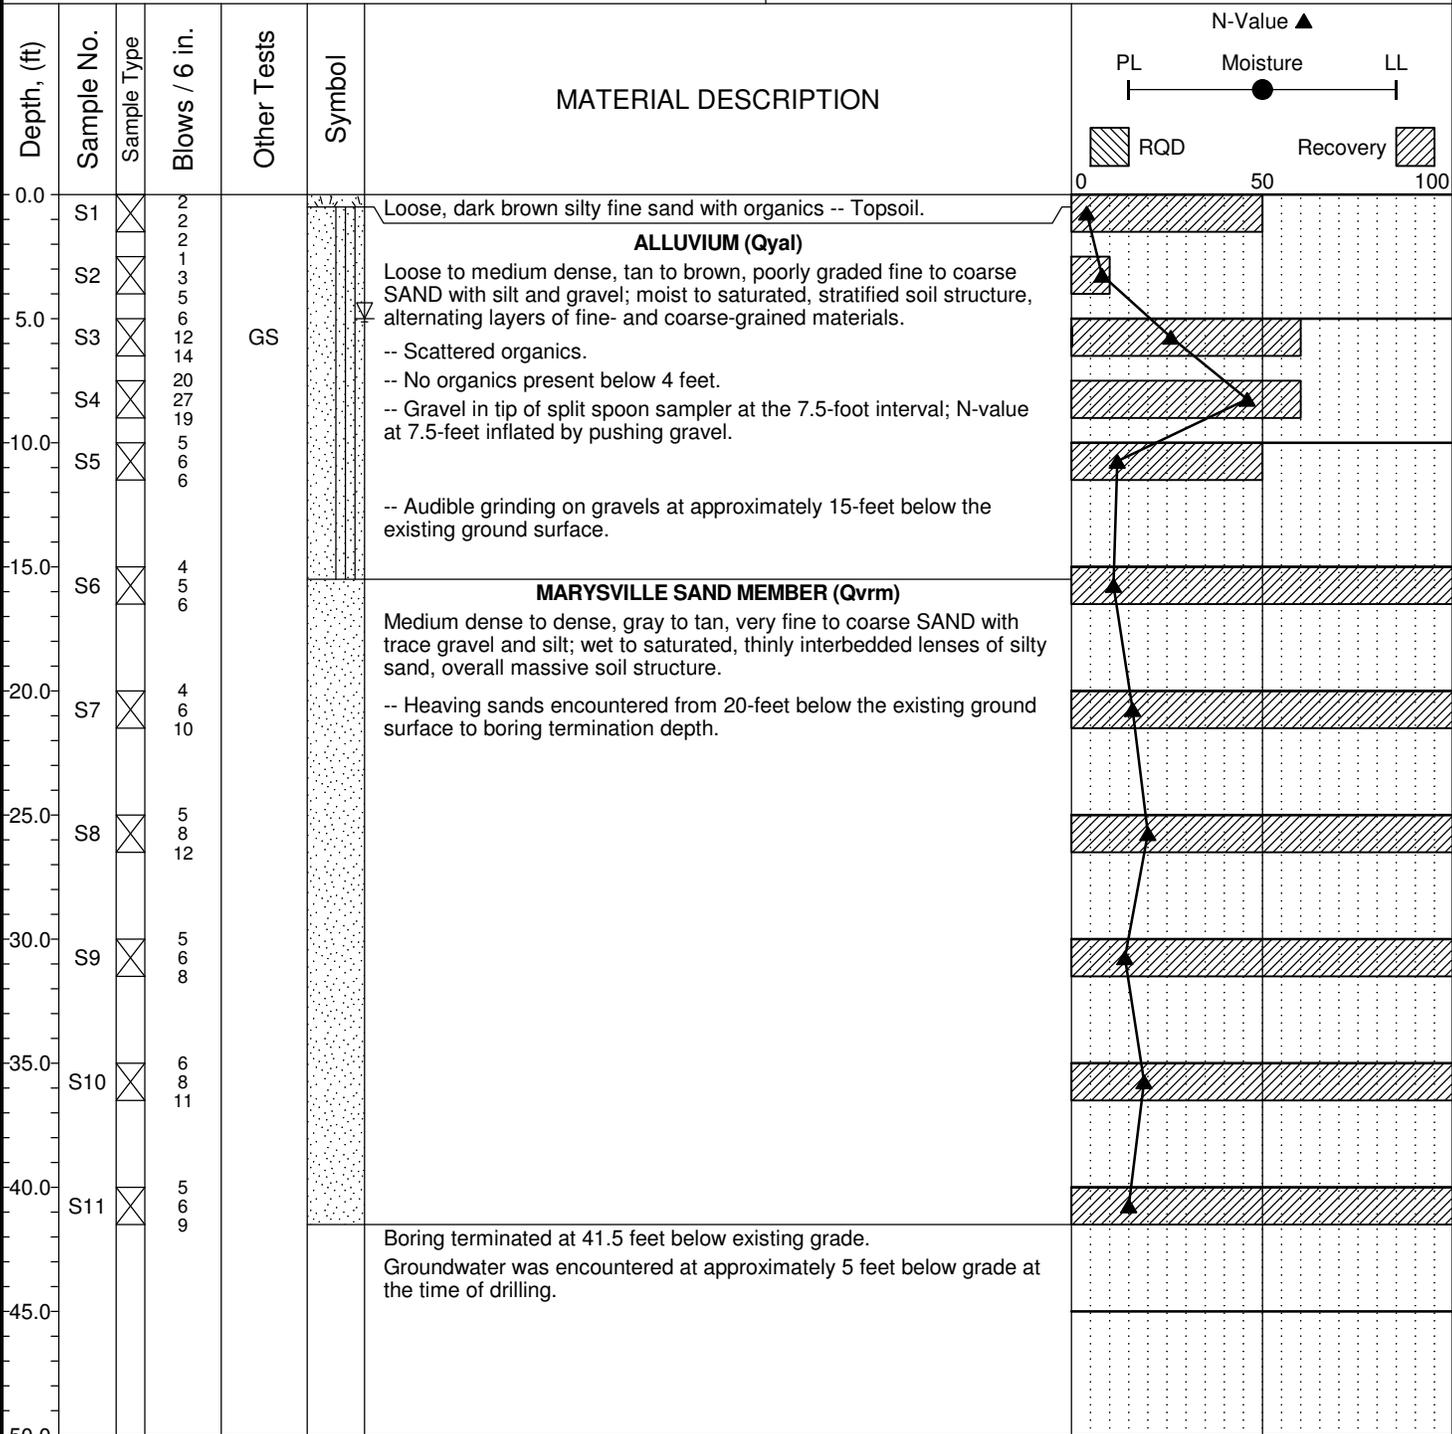
Project:	21117 59th Avenue Northeast	Surface Elevation:	65.0ft
Job Number:	24-207	Top of Casing Elev.:	
Location:	21117 59th Ave NE, Arlington, WA	Drilling Method:	EC55 Track Drill Rig, Hollow Stem Auger
Coordinates:	Northing: 48.1874709, Easting: -122.1491178	Sampling Method:	SPT w/rope & cathead

Completion Depth:	41.5ft	Remarks: Standard penetration test (SPT) sampler driven with a 140 lb. safety hammer. Hammer operated with a rope and cathead mechanism. Approximate state plane coordinates and elevation are based on Google Earth. This information is provided for relative information only and is not a substitution for field survey. <b>Datum: Washington North / NAVD88</b>
Date Borehole Started:	6/28/24	
Date Borehole Completed:	6/28/24	
Logged By:	E. Eckles	
Drilling Company:	Boretect1 Inc.

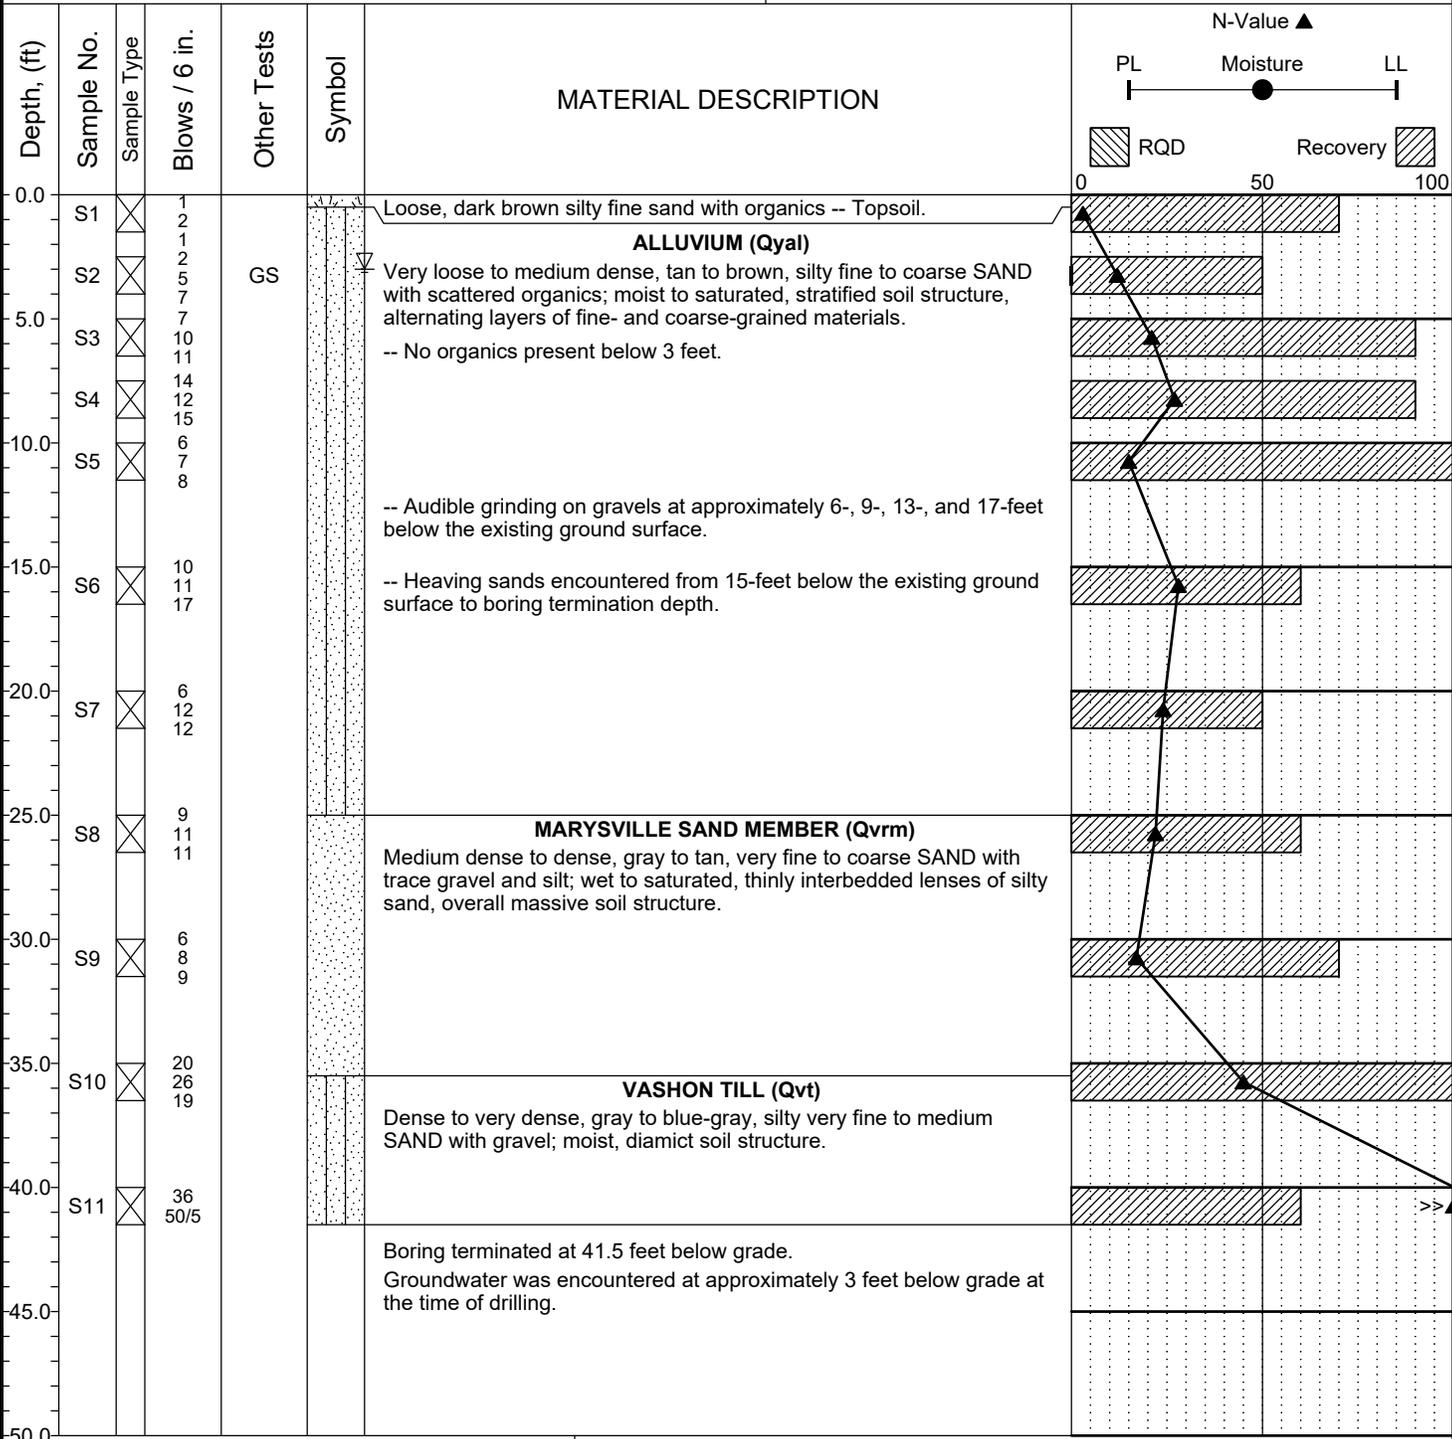
Project:	21117 59th Avenue Northeast	Surface Elevation:	63.0ft
Job Number:	24-207	Top of Casing Elev.:	
Location:	21117 59th Ave NE, Arlington, WA	Drilling Method:	EC55 Track Drill Rig, Hollow Stem Auger
Coordinates:	Northing: 48.1871629, Easting: -122.1499584	Sampling Method:	SPT w/rope & cathead

Completion Depth:	41.5ft	Remarks: Standard penetration test (SPT) sampler driven with a 140 lb. safety hammer. Hammer operated with a rope and cathead mechanism. Approximate state plane coordinates and elevation are based on Google Earth. This information is provided for relative information only and is not a substitution for field survey. <b>Datum: Washington North / NAVD88</b>
Date Borehole Started:	6/28/24	
Date Borehole Completed:	6/28/24	
Logged By:	E. Eckles	
Drilling Company:	Boretac1 Inc.

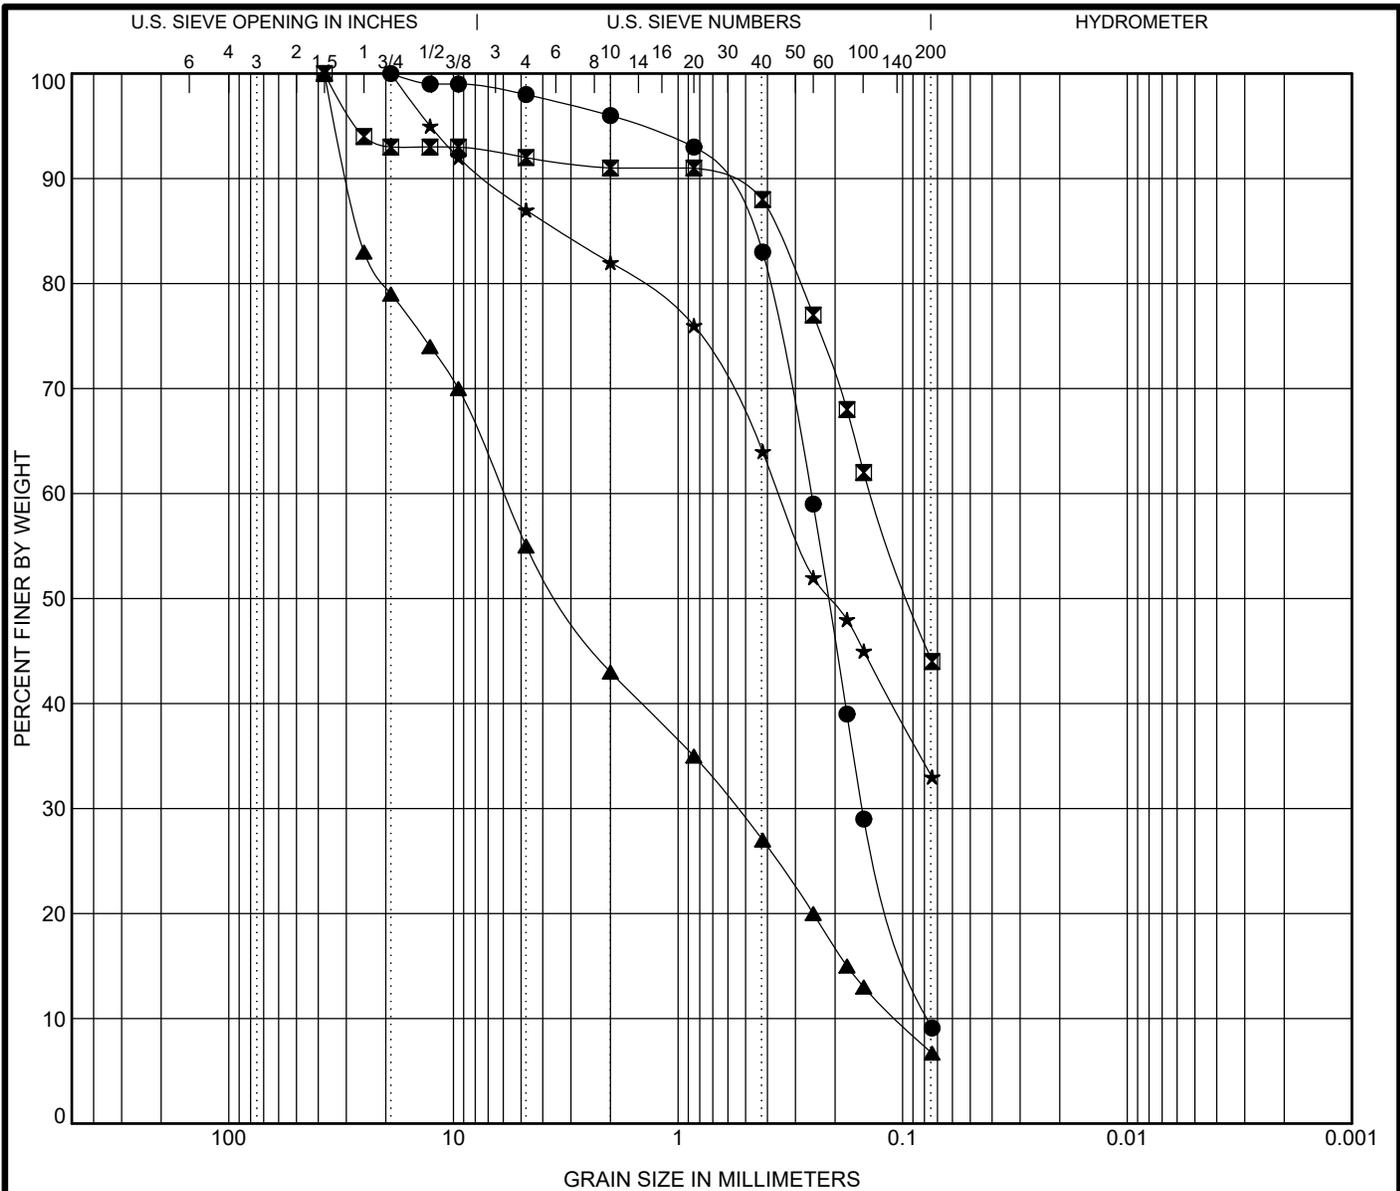
Specimen Identification	Classification	LL	PL	PI	Cc	Cu
● PG-1 @ 2.5 ft.	POORLY GRADED SAND with SILT(SP-SM)				1.18	3.34
☒ PG-2 @ 2.5 ft.	SILTY SAND(SM)					
▲ PG-3 @ 5.0 ft.	POORLY GRADED SAND with SILT and GRAVEL(SP-SM)				0.47	56.05
★ PG-4 @ 2.5 ft.	SILTY SAND(SM)

The recommended infiltration rate for the northwest basin are based on a sieve analysis conducted in Boring PG-1. We recommend field infiltration testing be performed at this location.
