*Subsurface Exploration, Geologic Hazards,
Preliminary Geotechnical Engineering, and Infiltration Feasibility Report*

ARLINGTON OPERATIONS CENTER REDEVELOPMENT

Arlington, Washington

Project No. 20240001E001

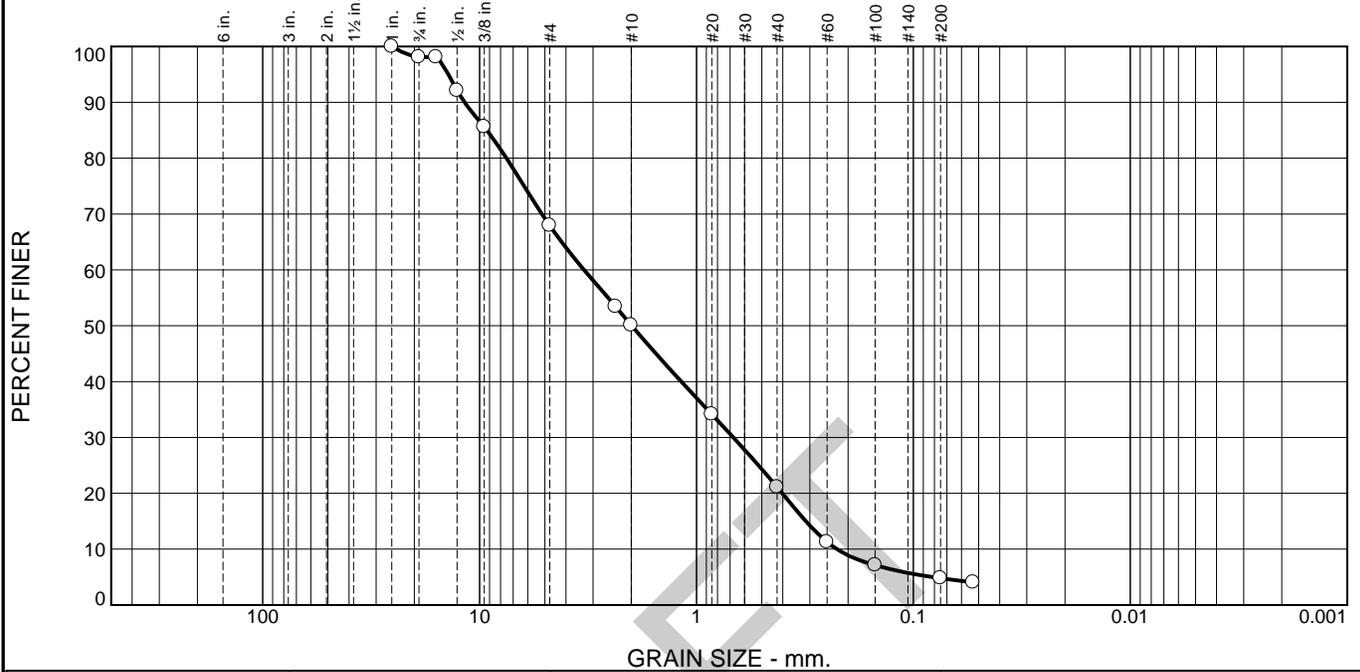
Particle Size Distribution Report

% +3"	% Gravel		% Sand			% Fines	
	Coarse	Fine	Coarse	Medium	Fine	Silt	Clay
0.0	1.9	30.2	17.8	29.0	16.3	4.8

Sediments encountered directly below the existing fill at a depth of 19 feet in EB-1 and EB-2 and at 5.5 feet in EB-3 generally consisted of medium dense to dense, partially stratified, brownish gray, sand, some gravel with trace to some silt and ranged to gravelly sand with some silt. Occasional layers of very stiff silt, sandy silt, and/or medium dense to dense gravel were observed within the unit with cobbles encountered during drilling. We interpret these sediments to be representative of Vashon recessional outwash (Marysville Sand Member). The Vashon recessional outwash was deposited by meltwater streams flowing off of the retreating glacial ice during the latter portion of the Vashon Stade of the Fraser Glaciation approximately 12,500 to 15,000 years ago. Where encountered in our explorations the recessional outwash extended beyond the depths explored. Laboratory sieve analyses were conducted on three samples of the recessional outwash to assess the suitability of the outwash for infiltration. Copies of the sieve analyses results are included in Appendix C.
