Critical Areas Report Stormwater Treatment Wetland Snohomish County, Washington

May 13, 2010

**City of Arlington
Arlington, Washington**

**LANDAU
ASSOCIATES**

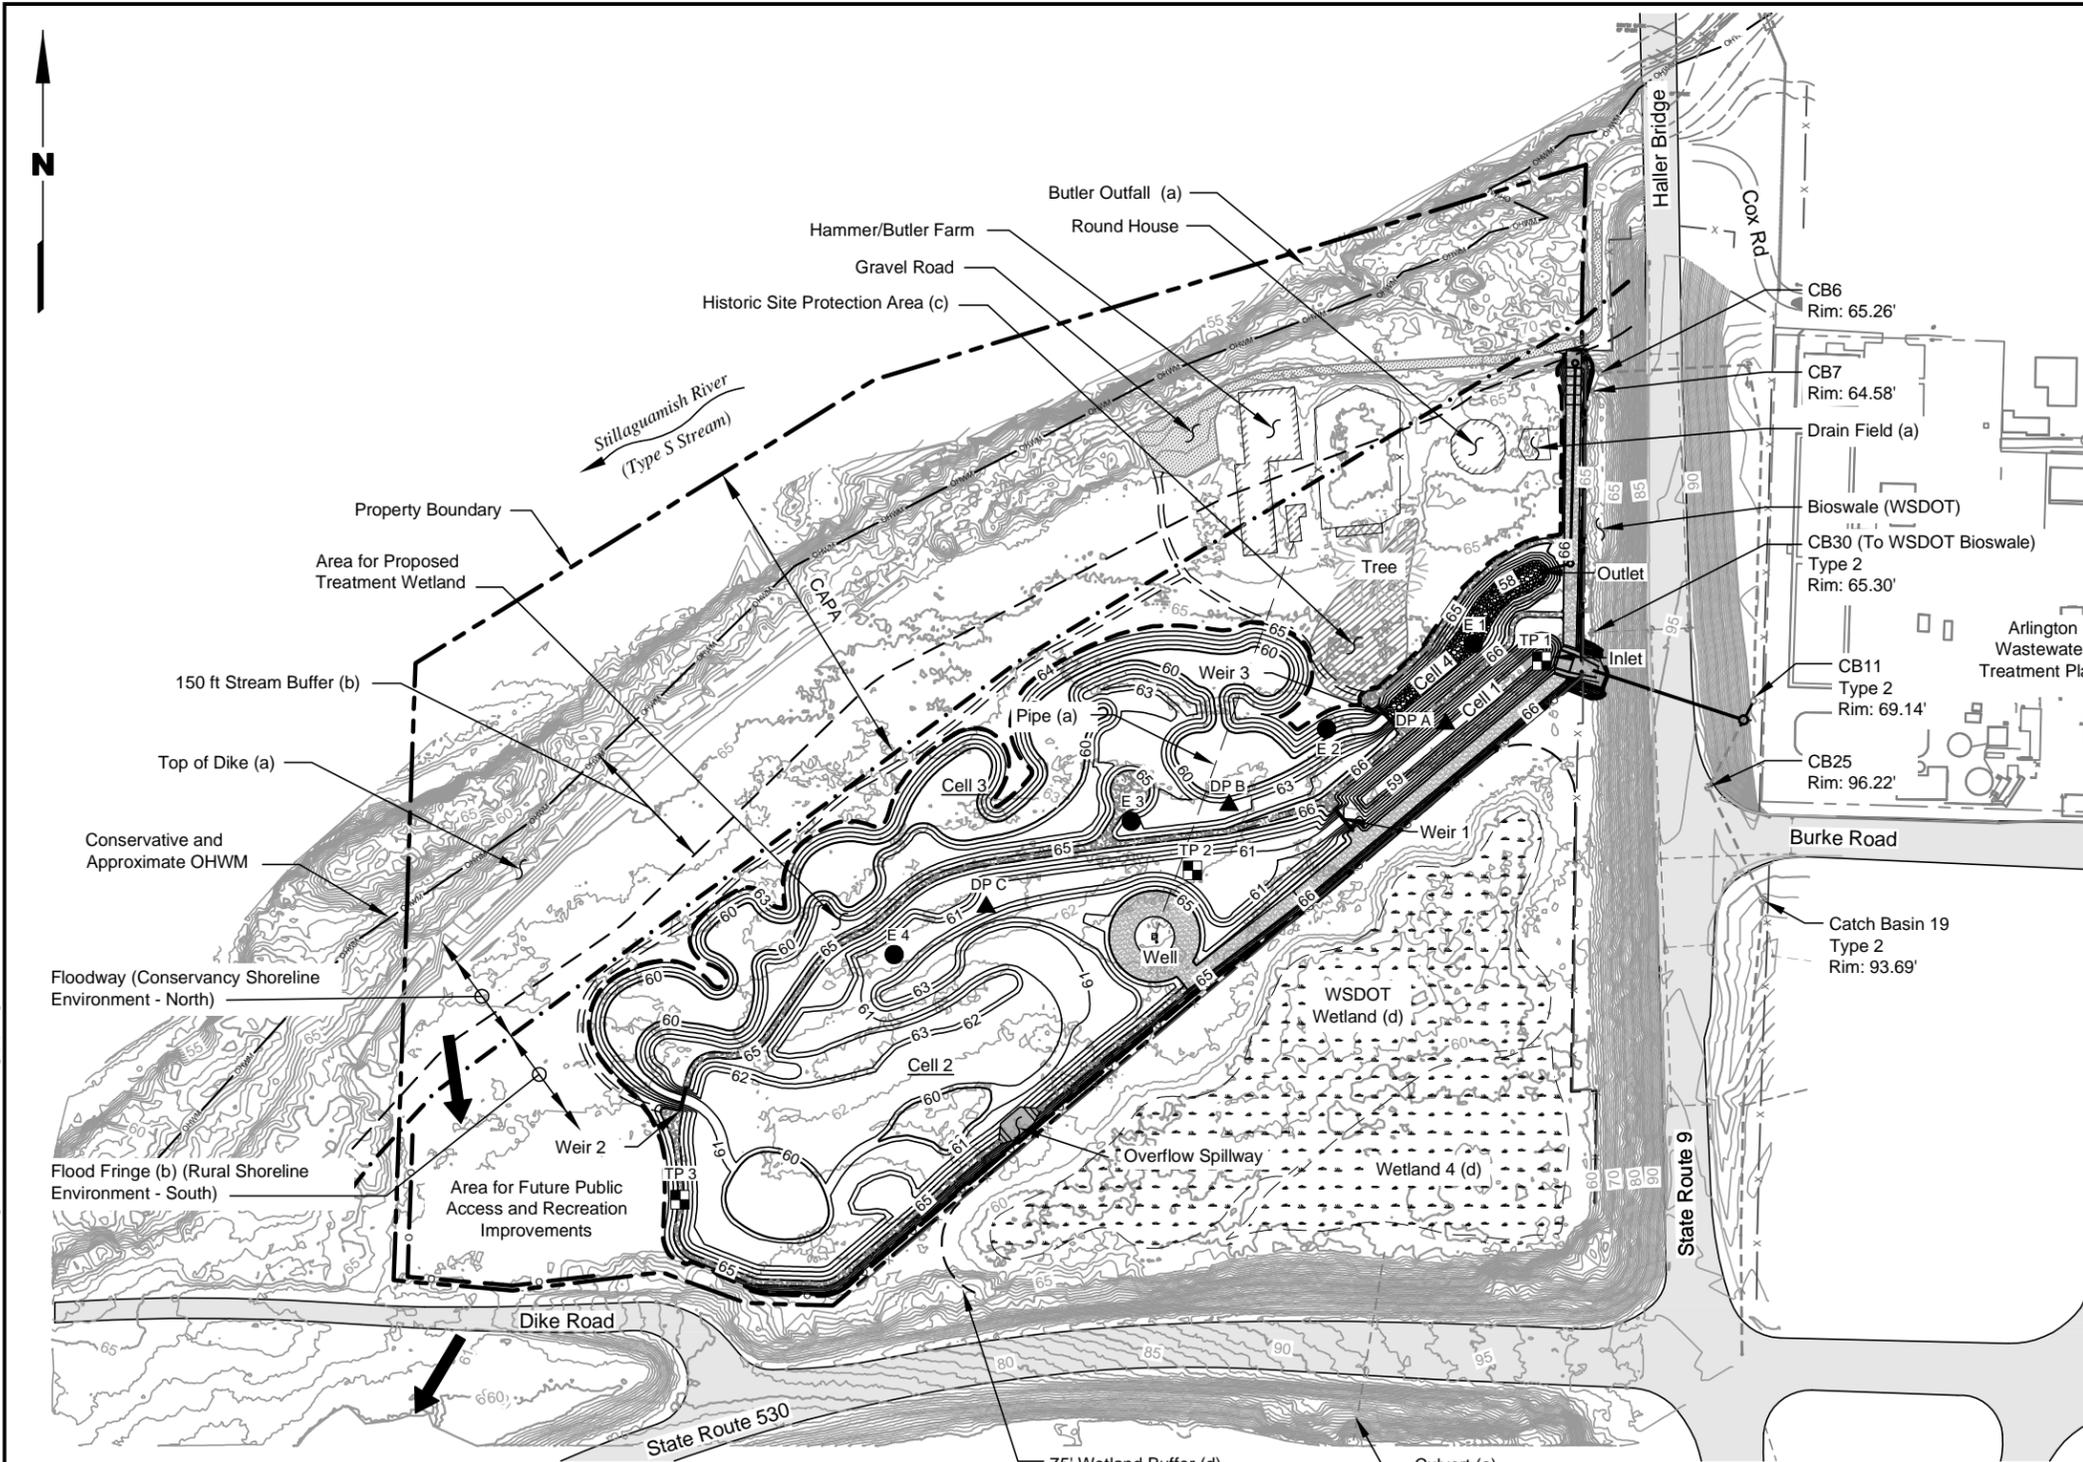
City of Arlington Stormwater Wetland Project Snohomish County, Washington	Site, Shoreline/Flood Hazard, and TESC Plan	Figure 2
---	---	--------------------

Legend	
TP 1	Test Pit Location and Designation
E 3	Excavation Test Location and Designation
DP B	Excavated Soil Pit Location and Designation (a)
---	Property Boundary
---	Clearing And Grading Limits
---	Proposed Contours
---	Existing Contours
---	Silt Fence
---	Existing Wire Fence
---	Proposed Pipe
---	Existing Pipe
---	CAPA - Floodway Boundary (Snohomish County Permit and Zoning Map 2009)
---	Ordinary High Water Mark
---	Wetland / Stream Buffer
---	River Rock (Rounded Cobbles)
---	Proposed Mowed Grass Path
---	Proposed Gravel Path
---	Proposed Improved Roadway
---	Existing Trail
---	Existing Gravel Road
---	Existing Paved Road
---	Wetland
---	Existing Building
---	Historic Protection Area
---	Dominant Flood Path (e)

An archaeological and cultural resources assessment conducted for the project site located a privy (designated as site AWTP-06-01) (Northwest Archaeological Associates 2008). During the investigation, approximately 133 artifacts were recovered dating from 1890 to 1930. This site is recommended as eligible for listing in the National Register of Historic Places because it has yielded, and may be likely to yield, information important in prehistory or history. The Washington State Department of Archaeology and Historic Preservation (DAHP) concurred with the finding of "no cultural resource impact" associated with the project and the project is now in compliance with Executive Order 05-05 (DAHP 2008). No excavation will occur within the protection area (see Figure 2), and minimal fill may be placed along its southern boundary.

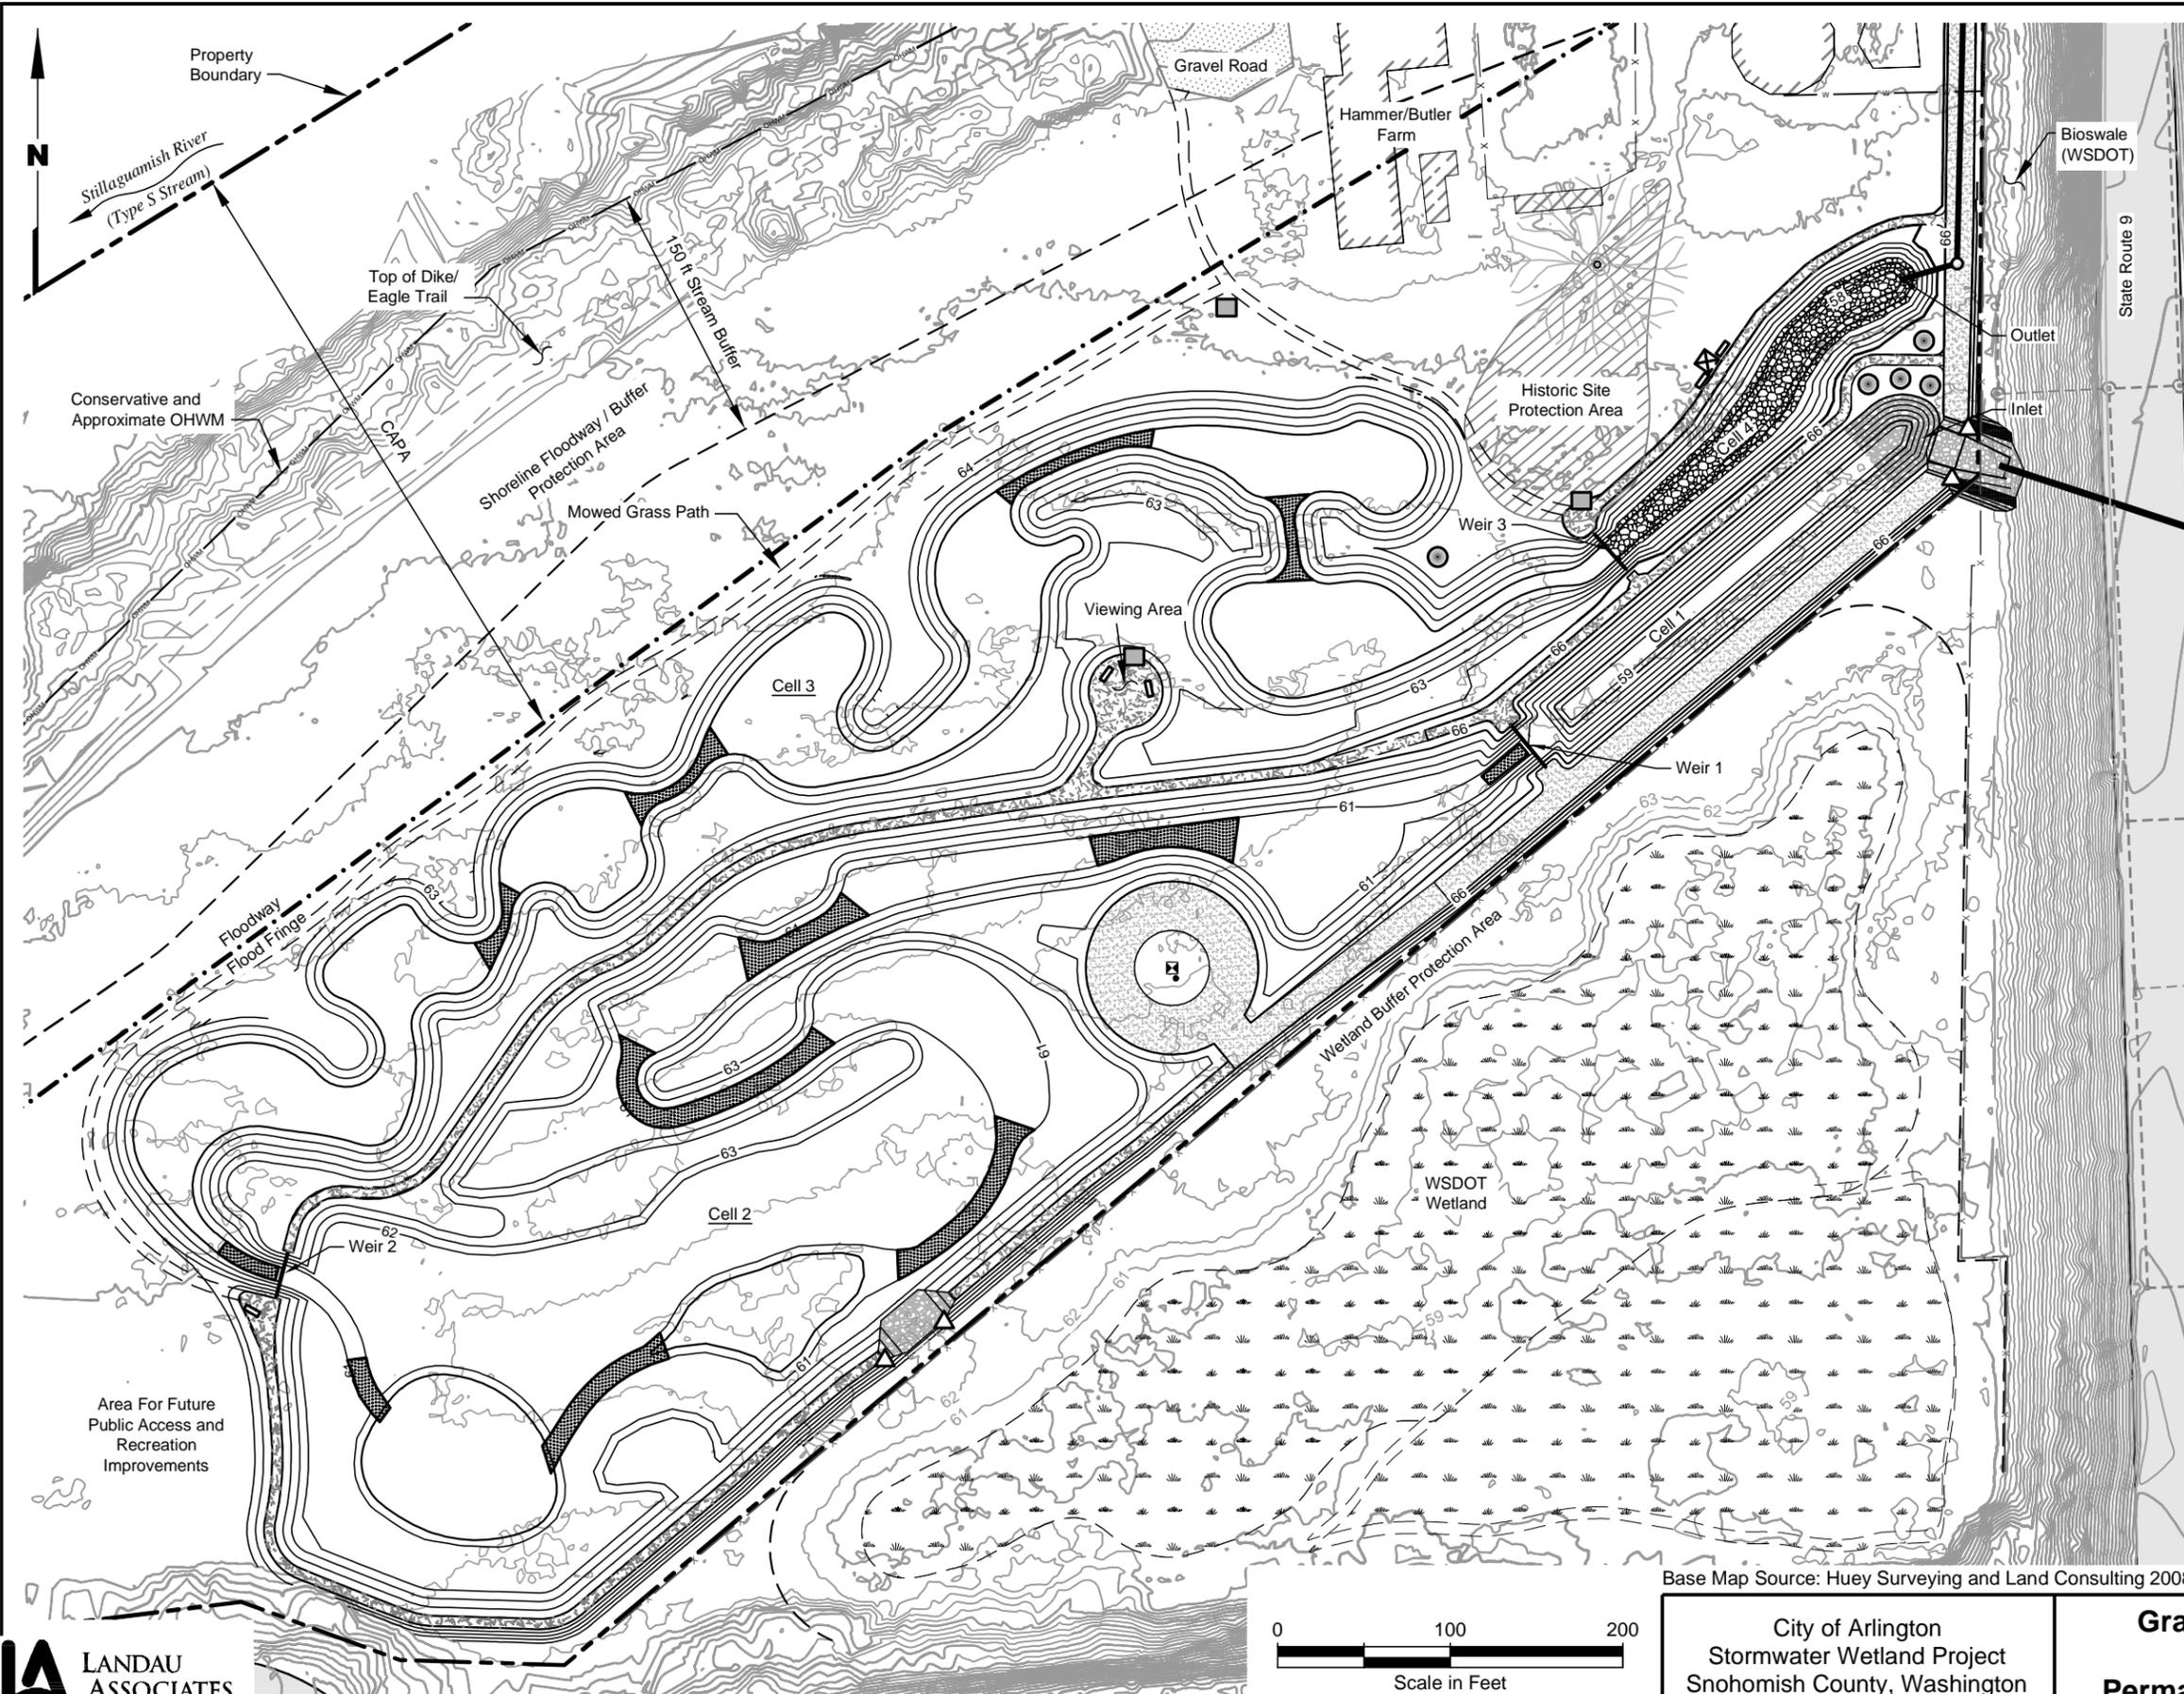
Figure
4

- ### Legend
- * Interpretive Sign
 - Watch Your Step Sign
 - * Future Sculpture / Art Location
 - * Bench, Picnic Table or Kiosk
 - * Shelter
 - Proposed Contours
 - Existing Contours
 - CAPA - Floodway Boundary (Snohomish County Permit and Zoning Map 2009)
 - Ordinary High Water Mark
 - Stream Buffer
 - Coir Fiber Fabric
 - River Rock (Rounded Cobbles)
 - Proposed Mowed Grass Path
 - Proposed Gravel Path
 - Proposed Improved Roadway
 - Existing Trail
 - Existing Gravel Road
 - Existing Paved Road
 - Wetland
 - Existing Building
 - Historic Protection Area

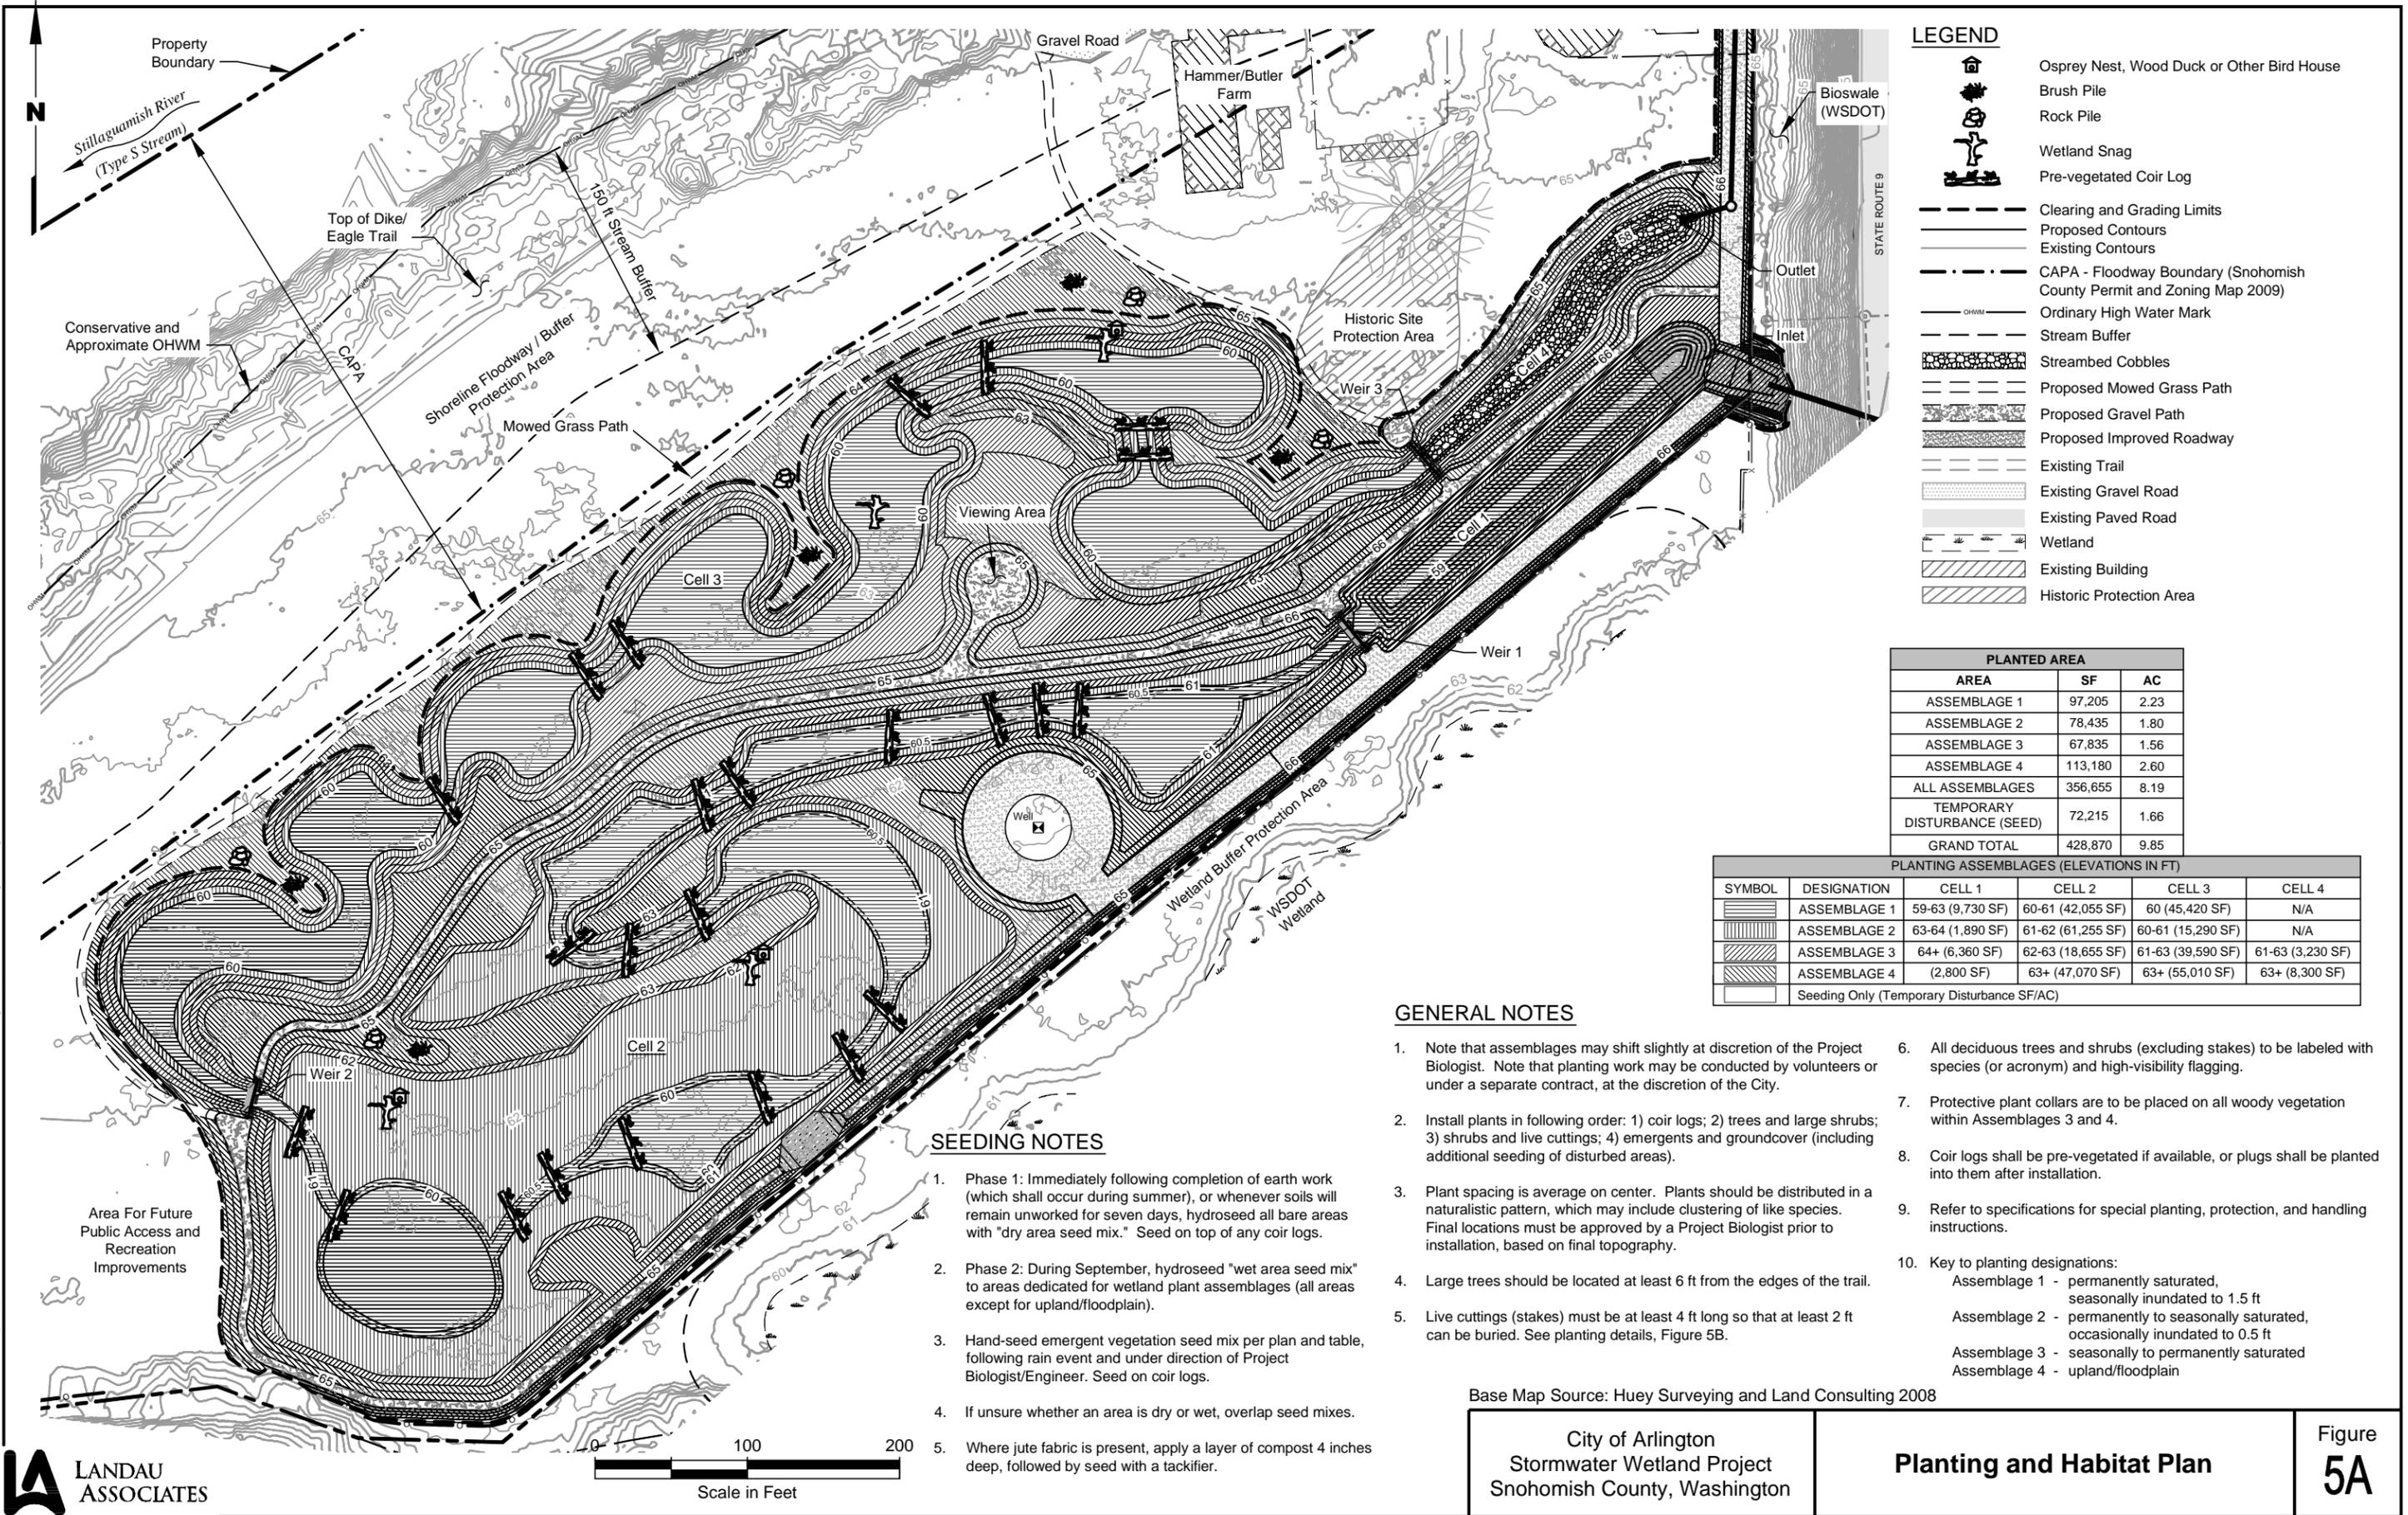
Critical Areas Report | V:\1097001\1010015\DCons R3 Revised\CAR Fig 2_4_5A_5B_R3.dwg (A) *Figure 5A 5/13/2010

- Osprey Nest, Wood Duck or Other Bird House
- Brush Pile
- Rock Pile
- Wetland Snag
- Pre-vegetated Coir Log
- Clearing and Grading Limits
- Proposed Contours
- Existing Contours
- CAPA - Floodway Boundary (Snohomish County Permit and Zoning Map 2009)
- Ordinary High Water Mark
- Stream Buffer
- Streambedded Cobbles
- Proposed Mowed Grass Path
- Proposed Gravel Path
- Proposed Improved Roadway
- Existing Trail
- Existing Gravel Road
- Existing Paved Road
- Wetland
- Existing Building
- Historic Protection Area

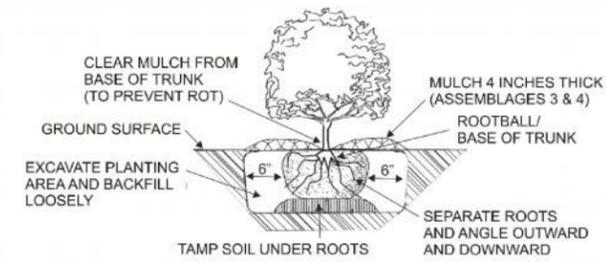
1 CONTAINER/BAREROOT PLANTING
SCALE: NONE

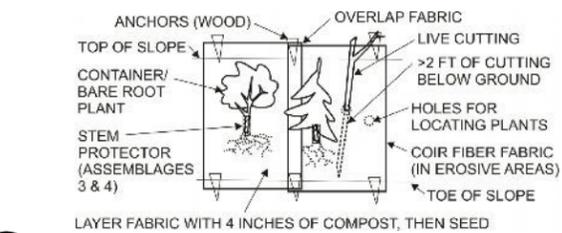
3 PLANTS IN COIR FIBER NETTING
SCALE: NONE

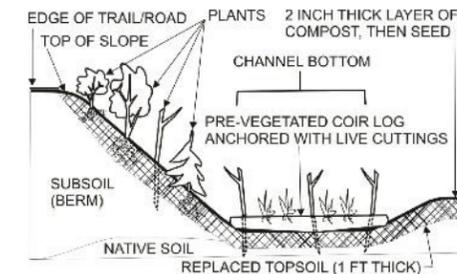
2 SOIL AMENDMENT, COIR LOG INSTALLATION AND PLANTING
SCALE: NONE

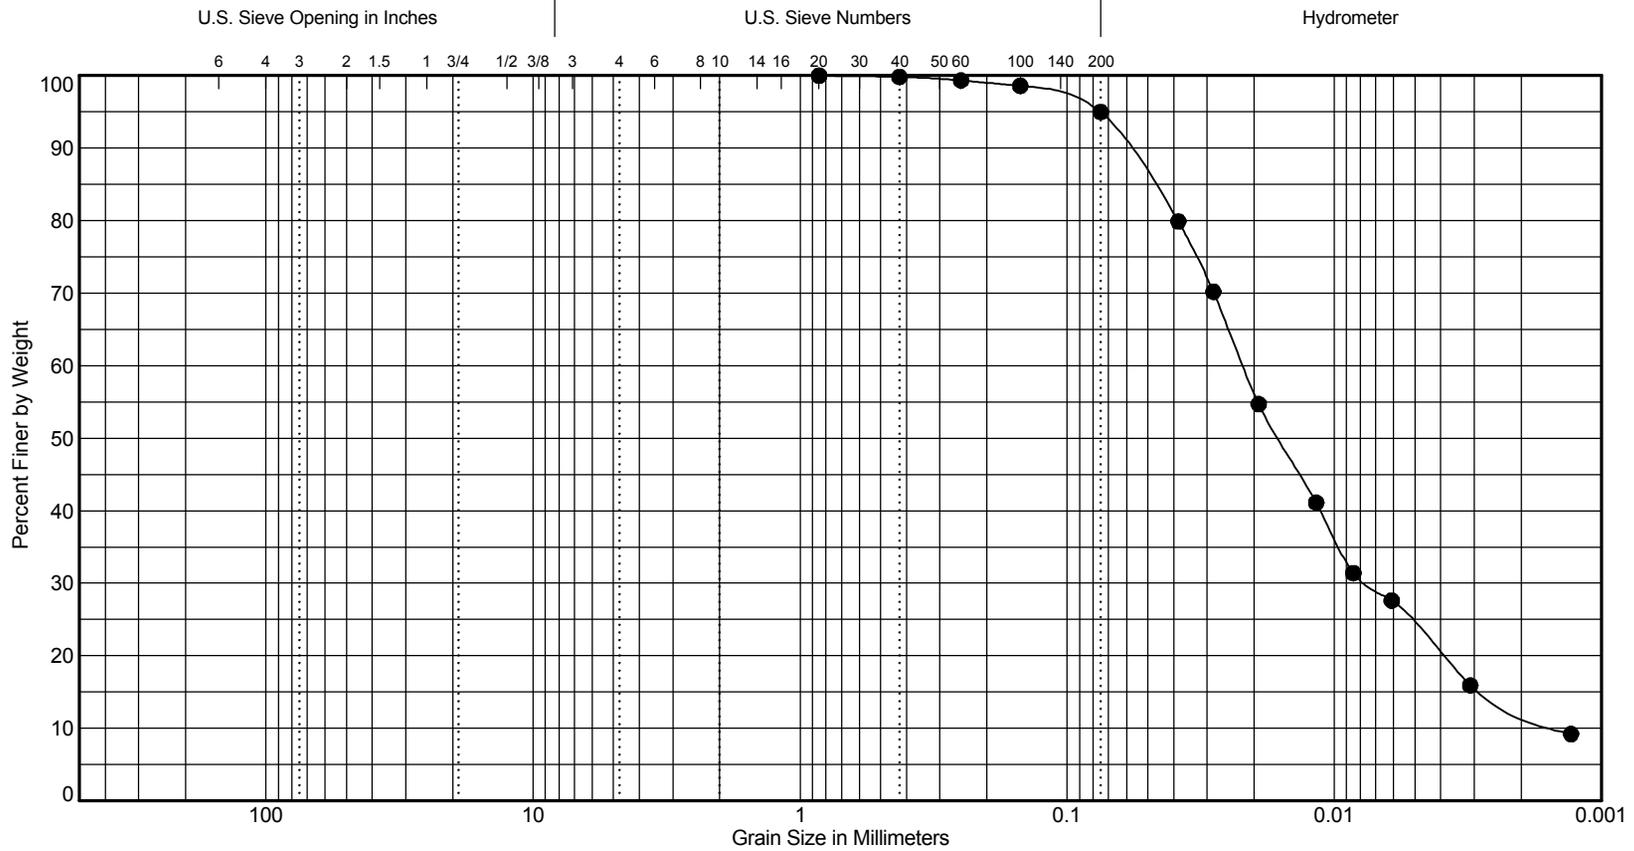
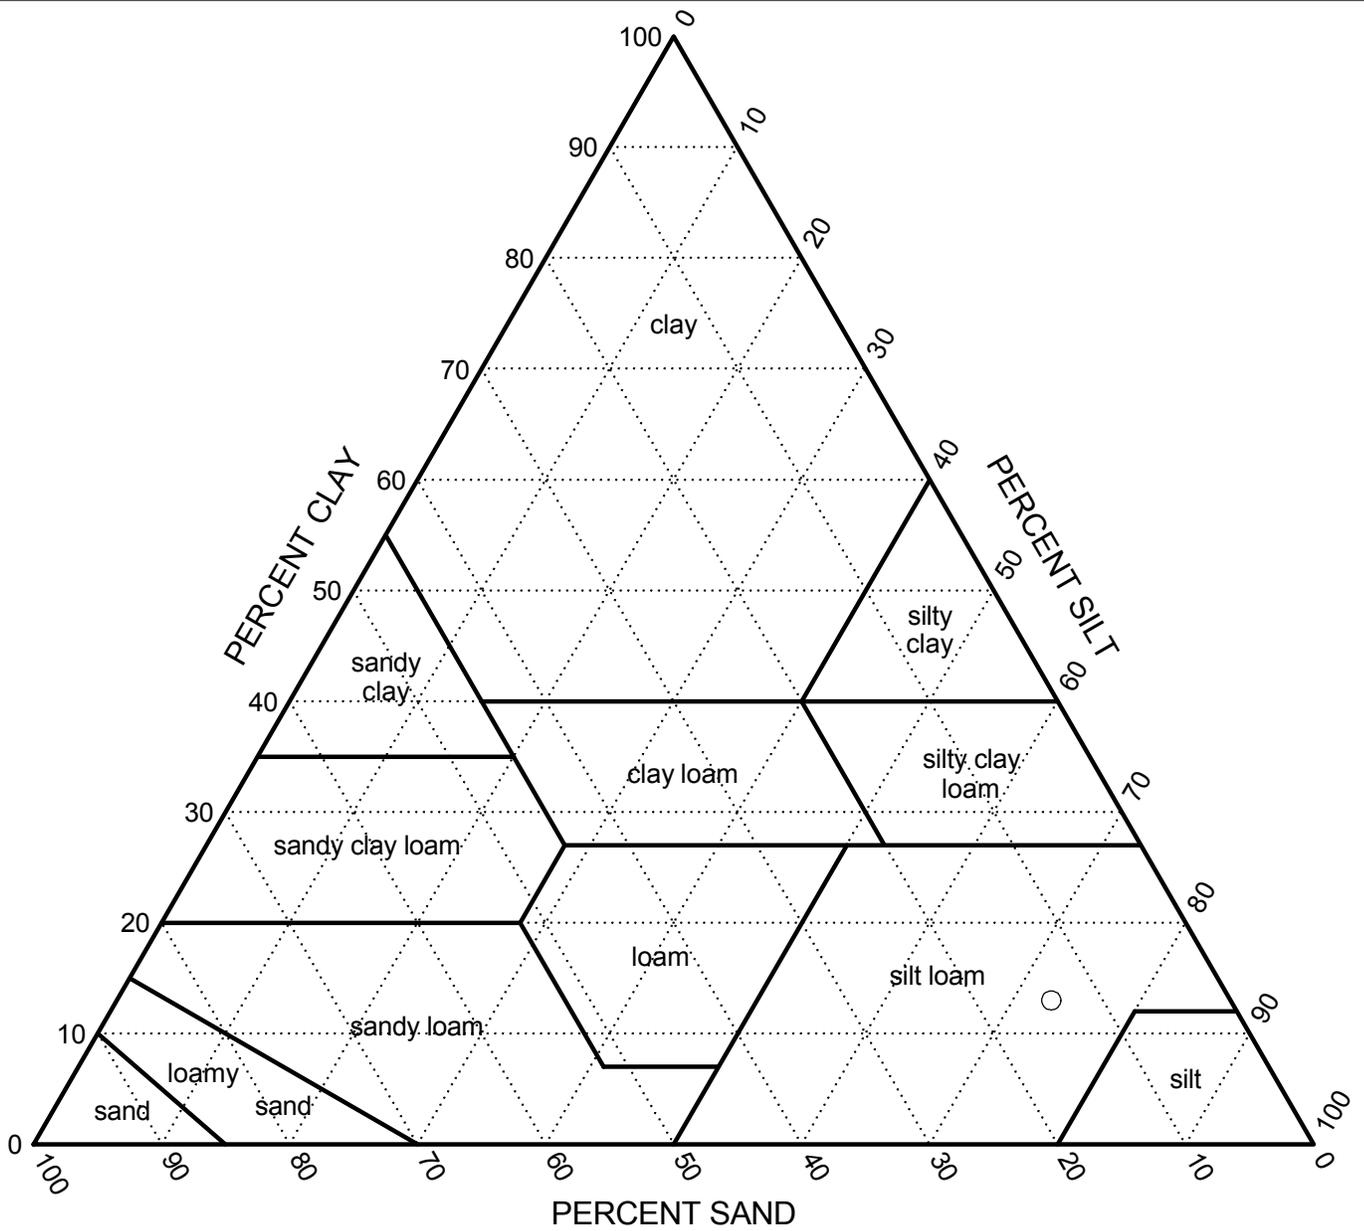
Symbol	Exploration Number	Sample Number	Depth (ft)	Natural Moisture (%)	Soil Description	Unified Soil Classification
●	TP-2		3.5	31

Exploration Number	Sample Number	Depth (ft)	Natural Moisture (%)	USDA Textural Classification	USCS Classification
○	TP-2		3.5	31	SILT LOAM

was collected from TP 2 at 3.5 ft below ground surface (BGS) and analyzed for grain size distribution and to determine the U.S. Department of Agriculture (USDA) textural classification (see Appendix A). Infiltration rates are used as stated in the USDA Natural Resources Conservation Service (NRCS) online database for the soil type present (NRCS website 2008). Information on soils was also collected as part of the cultural resources and the wetland investigations, and was reviewed. Additional soil descriptive information was acquired from the NRCS web soil survey. Pertinent soil properties, as excerpted from the NRCS database, are also provided in Appendix A.

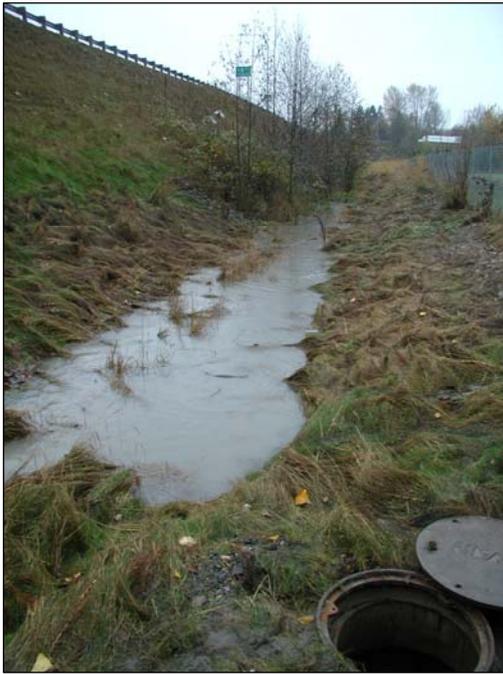
1. View of WSDOT bioswale and CB 7 facing upgradient (south) during high water.

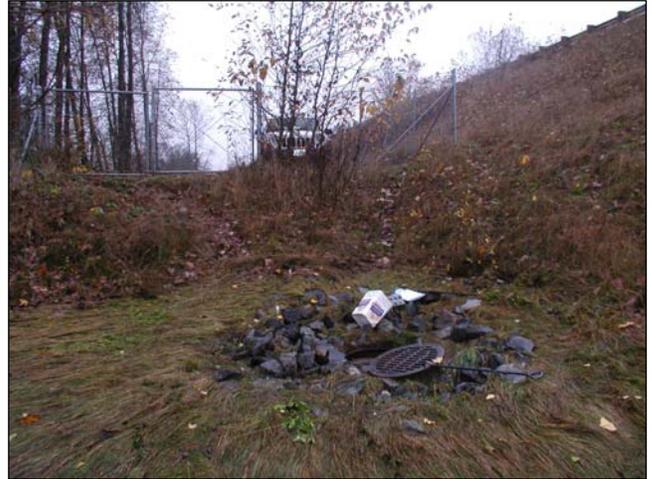
2. CB 6 at north end of WSDOT bioswales, just south of access road.

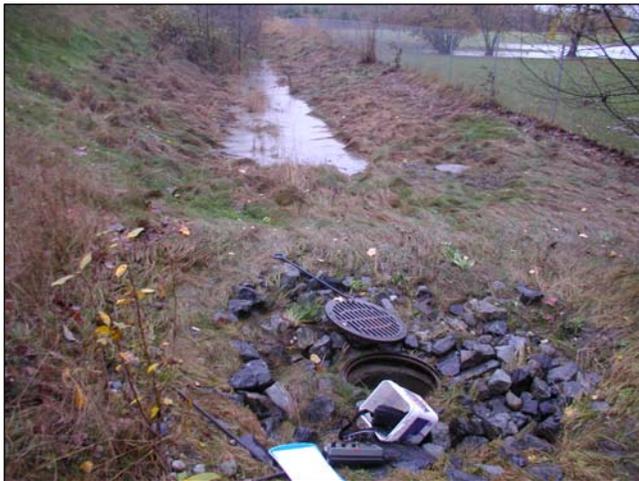
3. Another view of bioswales and stormwater sampling at CB 6.

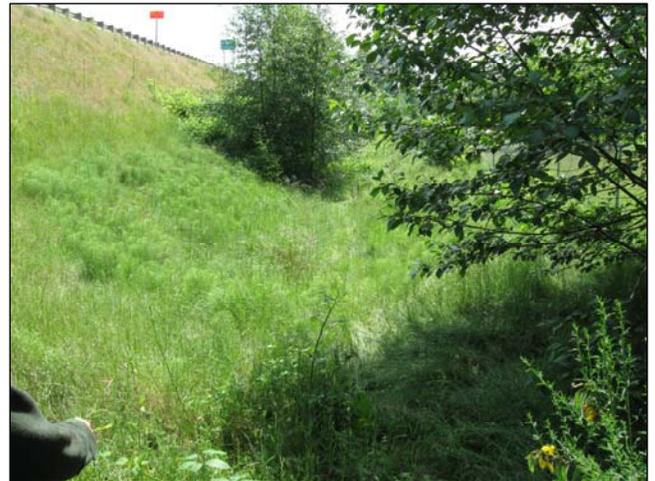
4. View of WSDOT bioswale facing upgradient (south) during dry season.

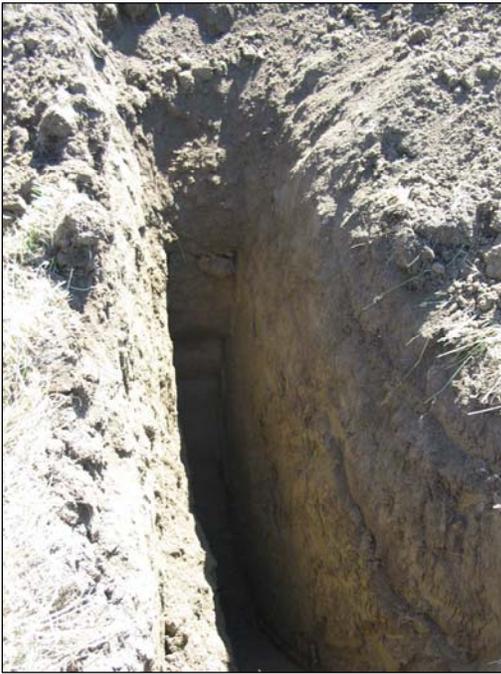
5. View of Test Pit 2.

A soils investigation was conducted by Landau Associates with assistance by City staff on May 27, 2008 to determine soil geotechnical properties and infiltration rates, which are pertinent to design and modeling tasks. Three TPs were excavated using a backhoe (as described above) from the areas shown on Figure 2. See Appendix A for a description of soils profiles from the TPs. A representative sample

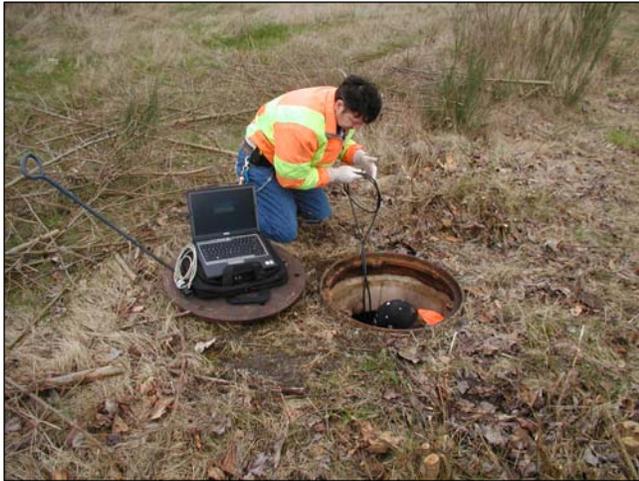
11. View of data logging in CB 7 in March 2008.

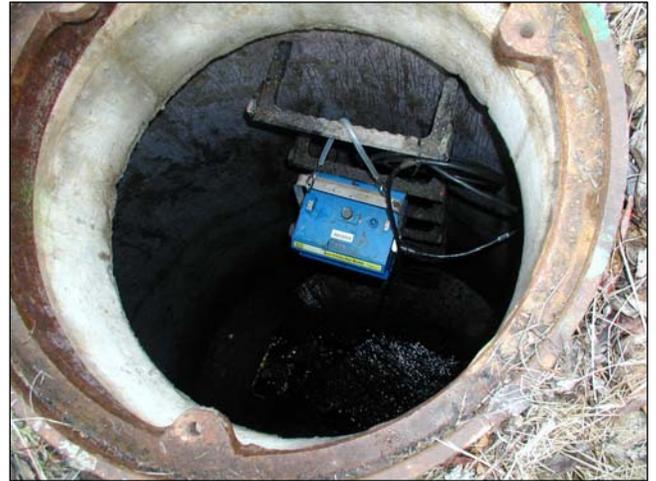
12. View of data logging in CB 7 in March 2008.

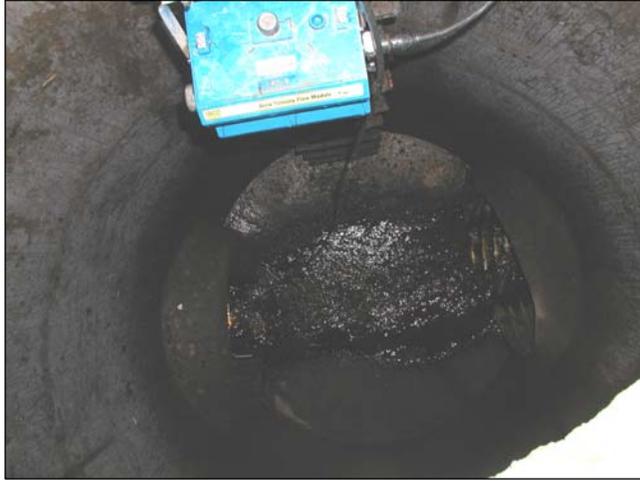
13. View of data logging in CB 6 in March 2008.

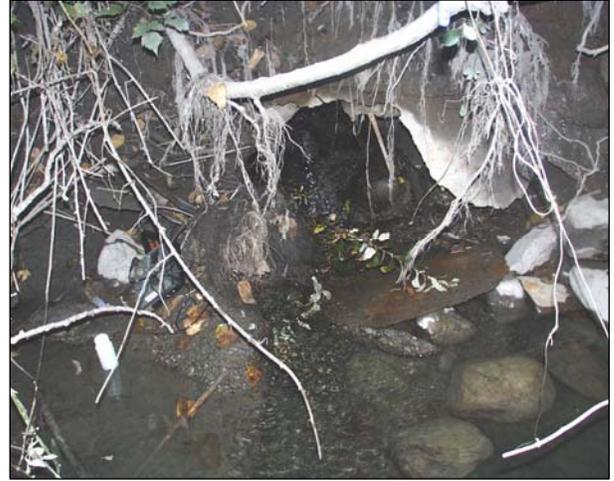
14. View of Butler outfall during low flow event.

The Butler outfall outlet (elevation 51.7 ft NAVD88/48.0 ft NGVD29) is often at or just above river level during summer low flows, and is often below river level during higher winter flows. There is currently no floodgate on the outfall to prevent river water from flowing back to the proposed wetland when the river level rises. Thus, backwater conditions currently occur on the site, with water spilling to the surface near the WSDOT bioswales. For instance, on November 17, 2009, during a 2-year storm event, when river levels was approximately 66 ft in elevation at the Butler outfall (above bankful stage of 54.2 ft, approximately 43,000 cfs flow), water was observed to be near the point of backwatering from the catch basin located immediately north of the WSDOT bioswale (water was still flowing out of the outfall into the river) (Welch, P., 2009, personal communication).

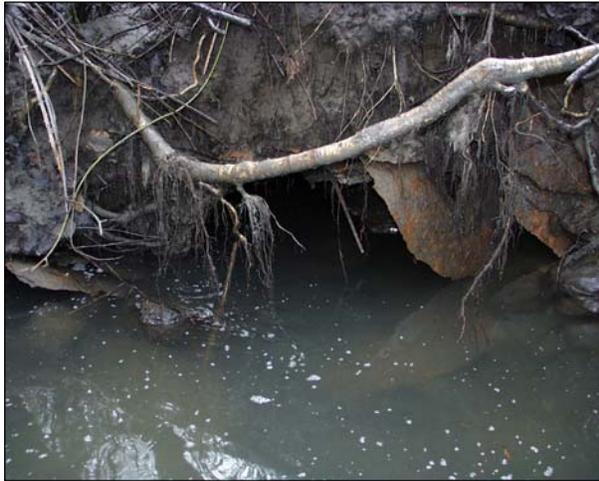
15. View of Butler outfall during high flow event.

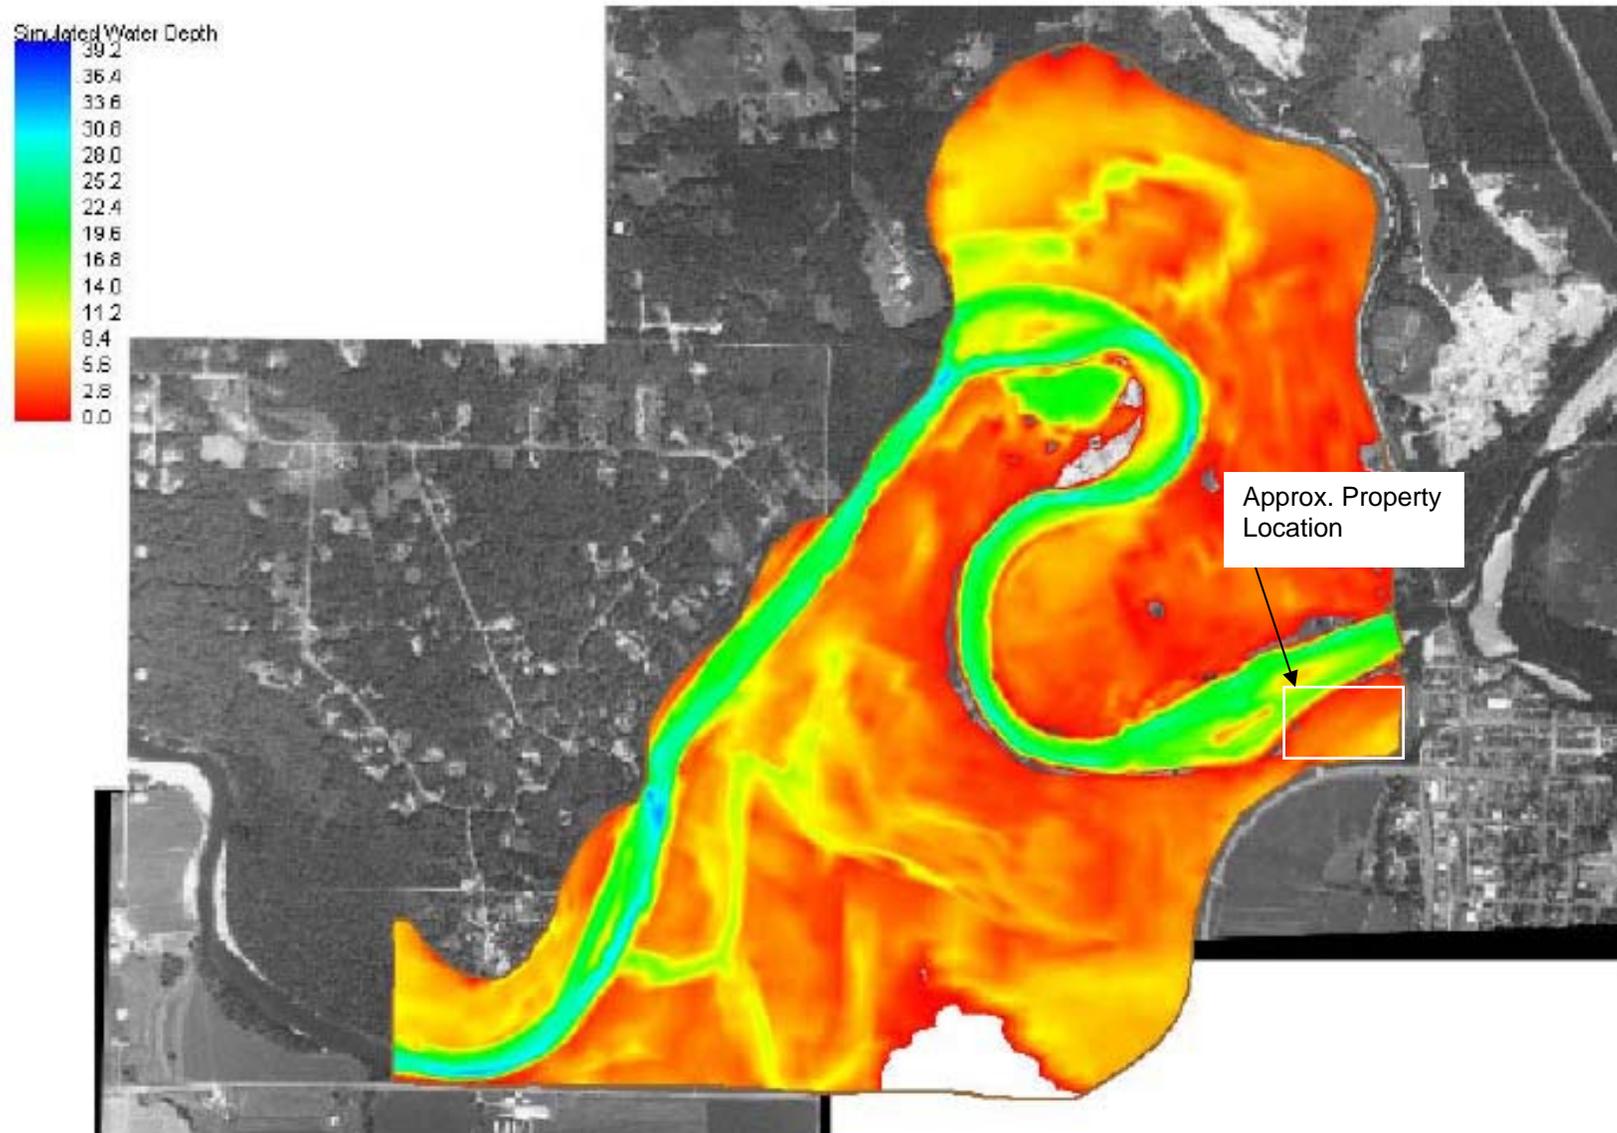
**Modeled Water Levels During Flooding
(Excerpt from R2 Resource Consultants 2005)**

Plate 5. Simulated water depth contours for the 100-year flood event.

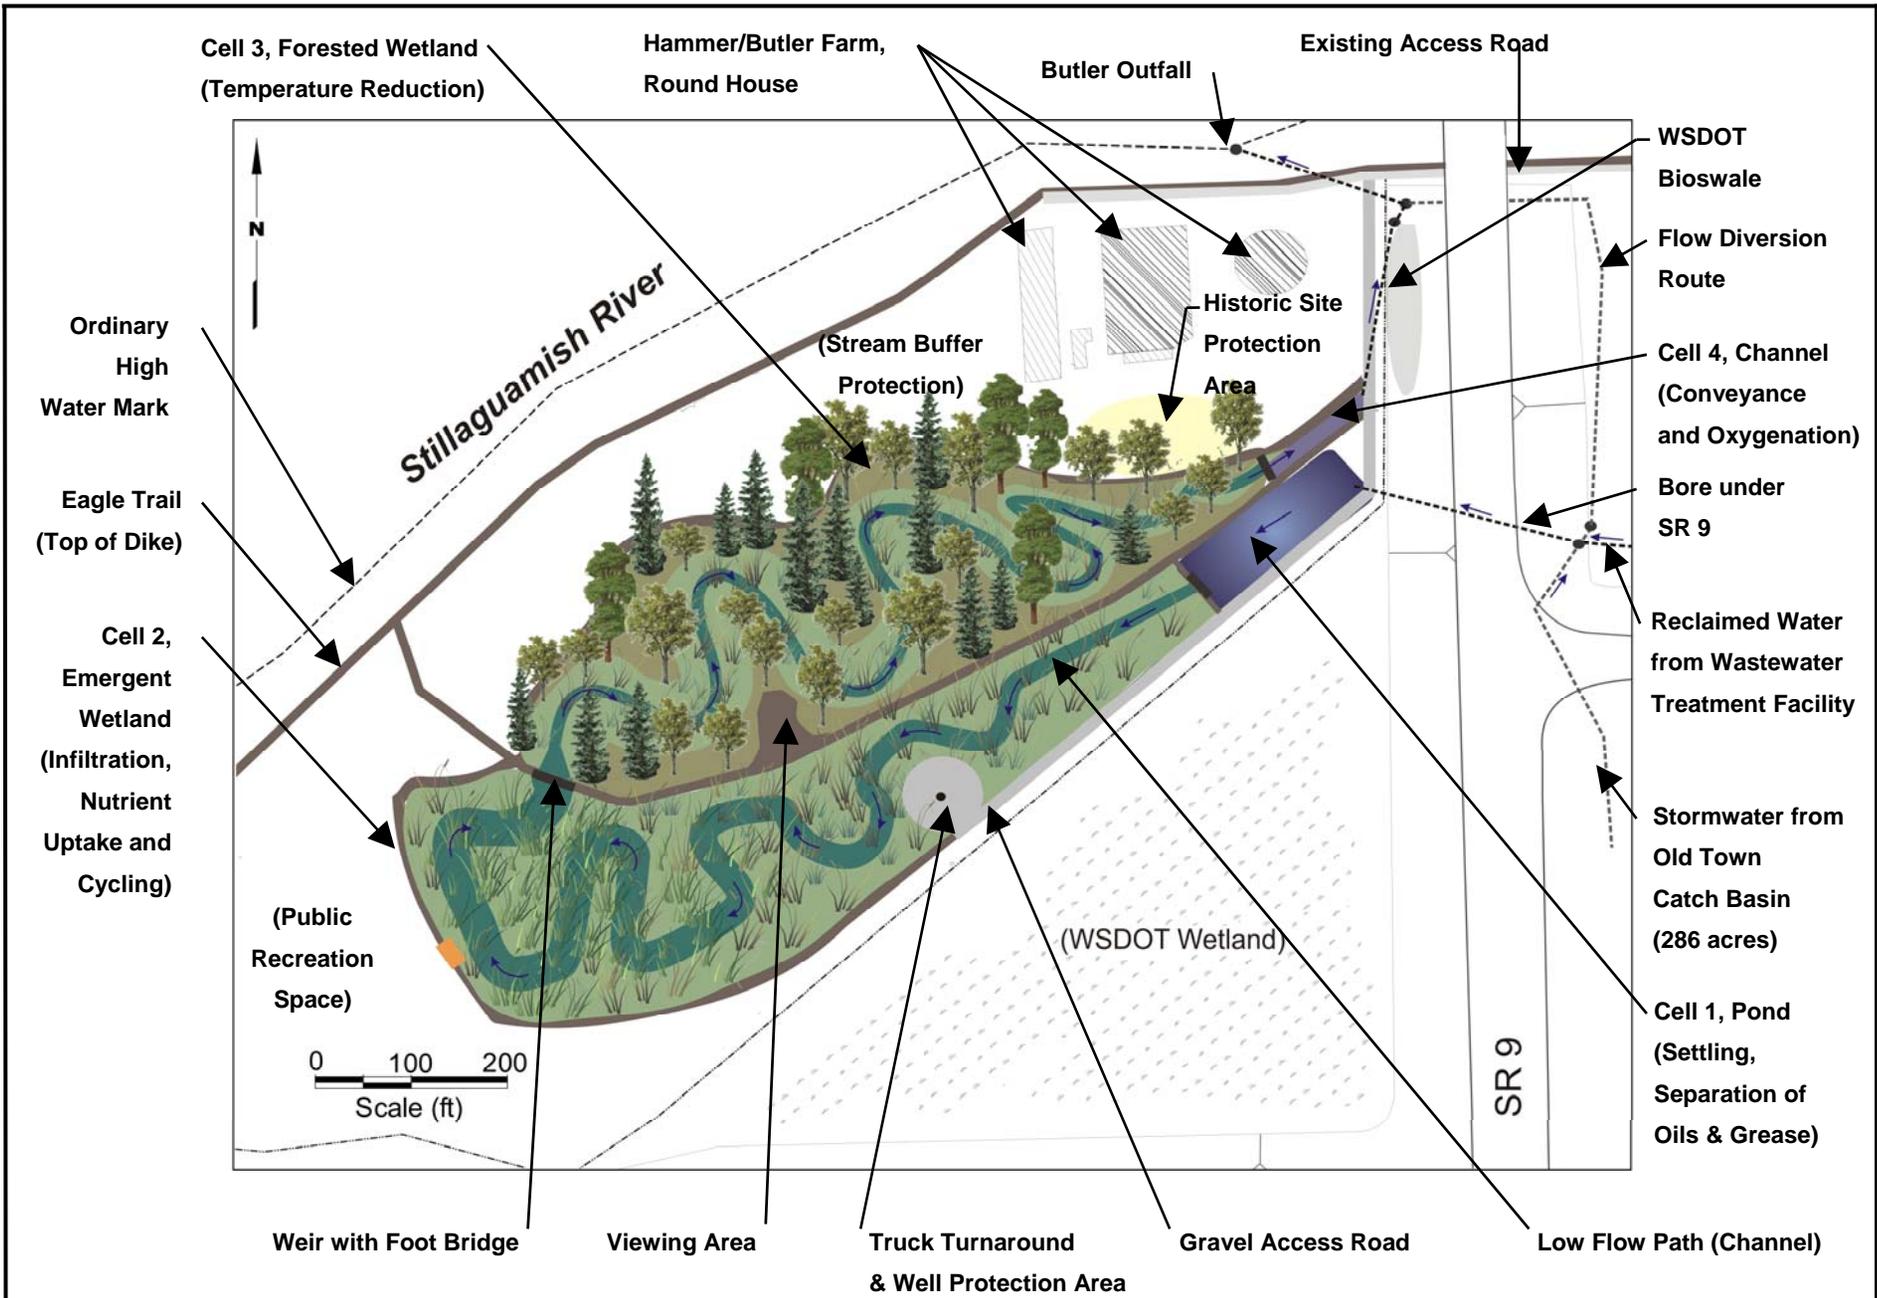
Illustration of Stormwater Wetland Features

Illustration of Design Features and Habitat
