Critical Areas Report Stormwater Treatment Wetland Snohomish County, Washington

May 13, 2010

**City of Arlington
Arlington, Washington**

**LANDAU
ASSOCIATES**

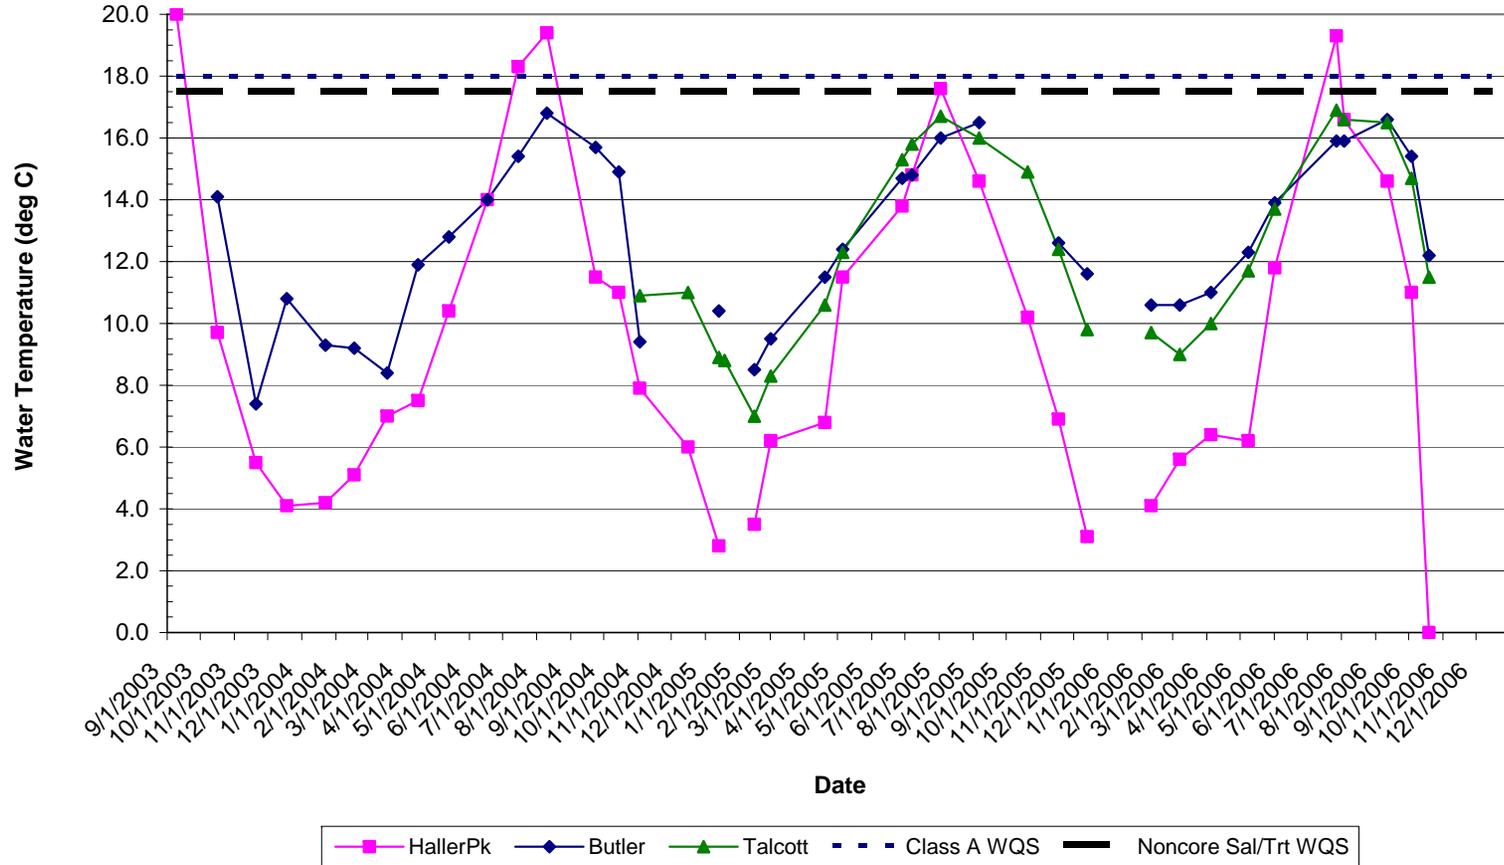
Stillaguamish TMDL Temperature Monitoring

Stillaguamish River at Haller Park, Butler Outfall, Talcott Outfall

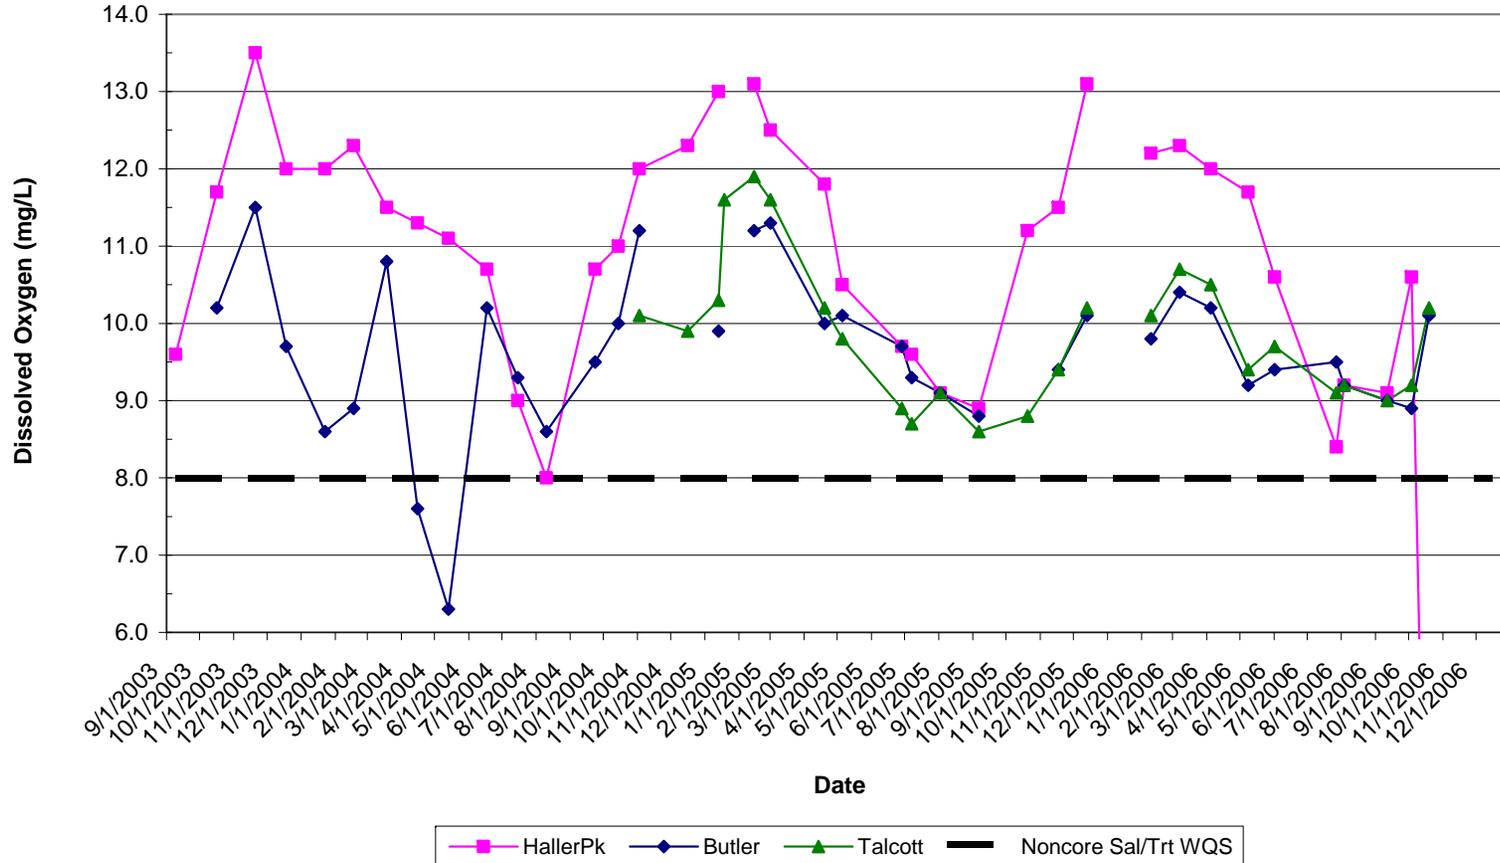
Stillaguamish TMDL Dissolved Oxygen Monitoring

Stillaguamish River at Haller Park, Butler Outfall, Talcott Outfall

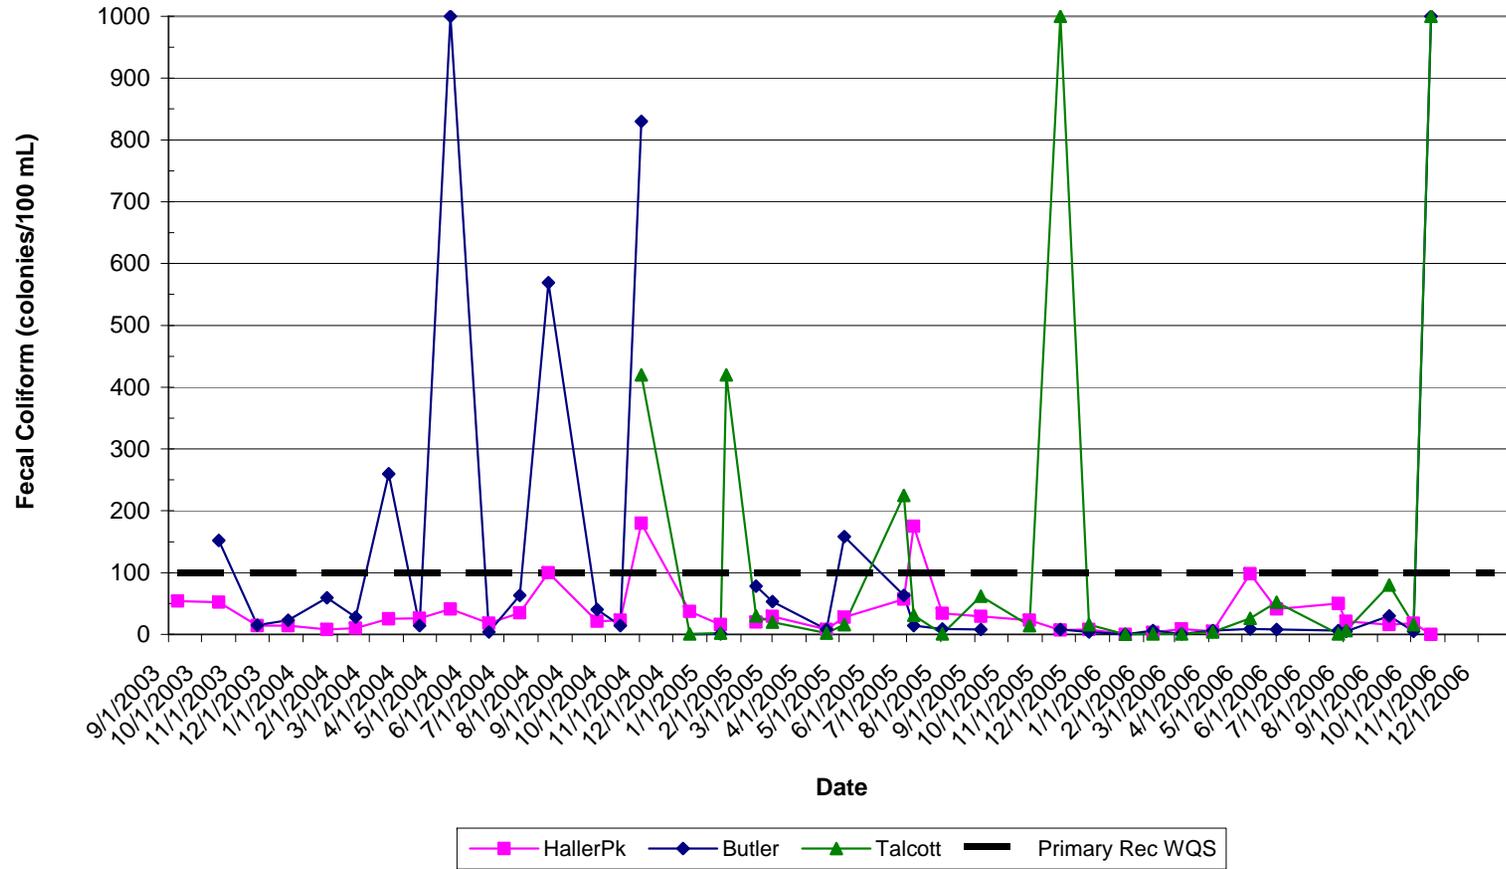
Stillaguamish TMDL Fecal Coliform Monitoring

Stillaguamish River at Haller Park, Butler Outfall, Talcott Outfall

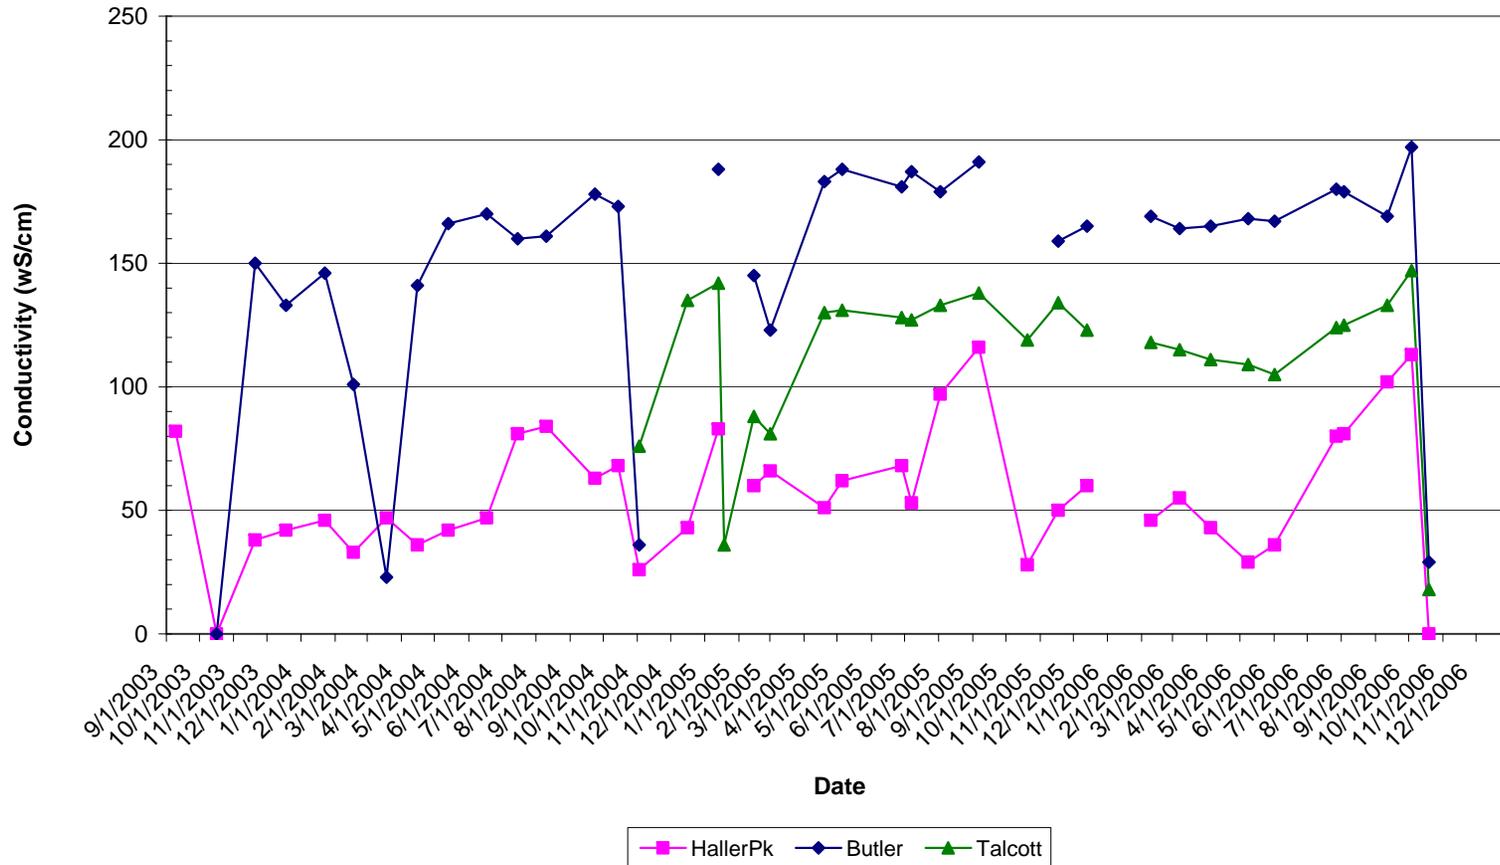
Stillaguamish TMDL Conductivity Monitoring

Stillaguamish River at Haller Park, Butler Outfall, Talcott Outfall
