SONDERGAARD GEOSCIENCE, PLLC

February 12, 2020
Revised November 6, 2020
Project No. J-0045

Subject: Geotechnical Engineering Study
Building G
Gayte Business Park
20015 67th Avenue NE
Arlington, Washington

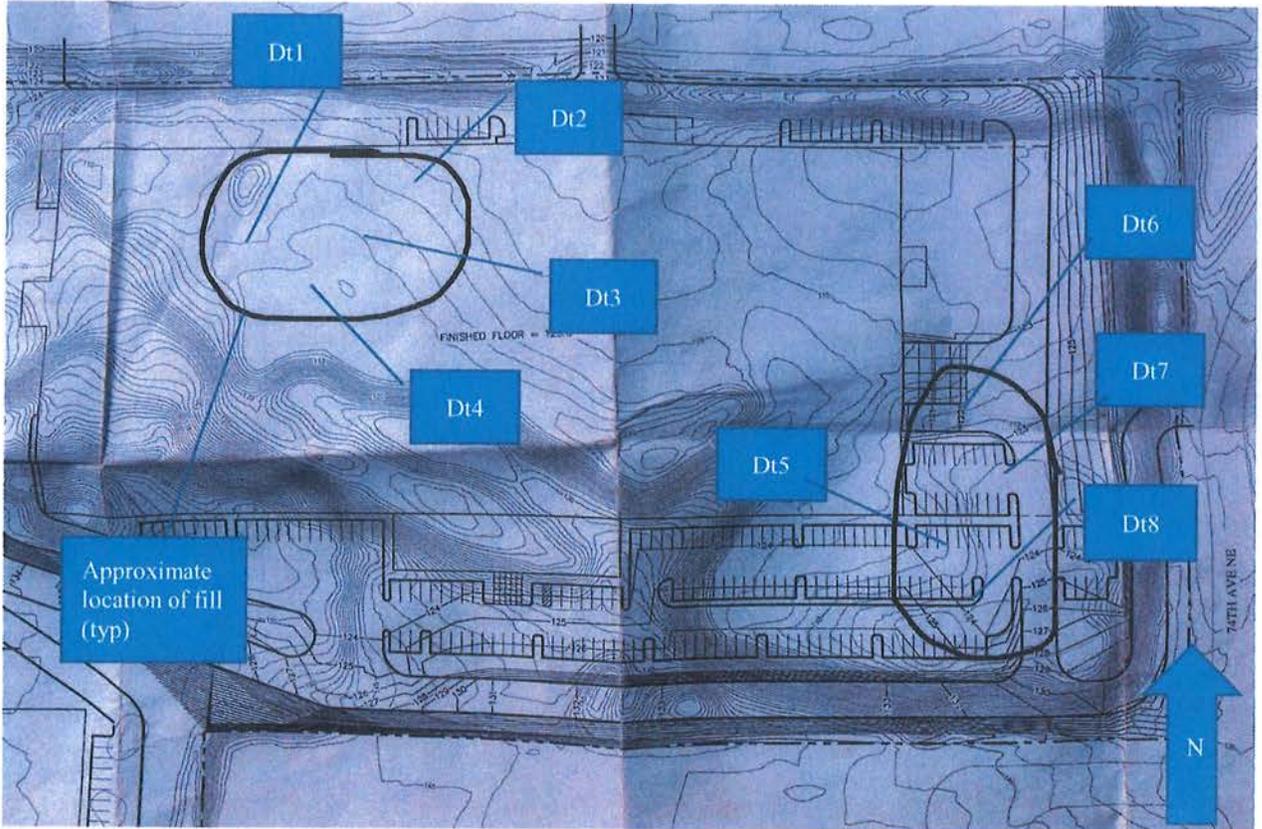
Trending generally north to south, the earthwork contractor continued mass grading processes for the proposed building pad and east parking areas. Using a large excavator, off-road dump truck, and belly load scraper assembly, the contractor placed approximately 2-3' of material (over the course of two days) near the NW and SW corners of the building area. Per prior recommendations, the material (generally brown gravelly SAND with trace silts/excavated from south margins of property) was wet to at/near optimum moisture levels (via large water truck) before being compacted/re-compacted (as recommended) in a series of 8-10" loose lifts via vibrator roller (complete process not observed). The compacted fill appeared firm/unyielding (during time of observation) with corresponding T-probe depths of 2-4" respectively. AESI conducted a series of in place density tests to confirm the specified minimum compaction for the structural area (95% ASTM 1557). The contractor was notified of all density results listed below. See Figure 1.

Test #	Location	Depth (ft below fsg)	% Moist	Density (pcf)	Proctor (pcf)	% Compaction
DT1	Grading/See Figure 1	-6	5.3	122	128.3	95.1
DT2	Grading/See Figure 1	-6	6.1	122.6	128.3	95.6
DT3	Grading/See Figure 1	-6	6.3	123.1	128.3	95.9
DT4	Grading/See Figure 1	-6	5.8	122.5	128.3	95.5
DT5	Grading/See Figure 1	-10	6.8	122.1	128.3	95.2
DT6	Grading/See Figure 1	-10	7	122.4	128.3	95.4
DT7	Grading/See Figure 1	-10	6.6	123.2	128.3	96.0
DT8	Grading/See Figure 1	-10	7.3	122.4	128.3	95.4

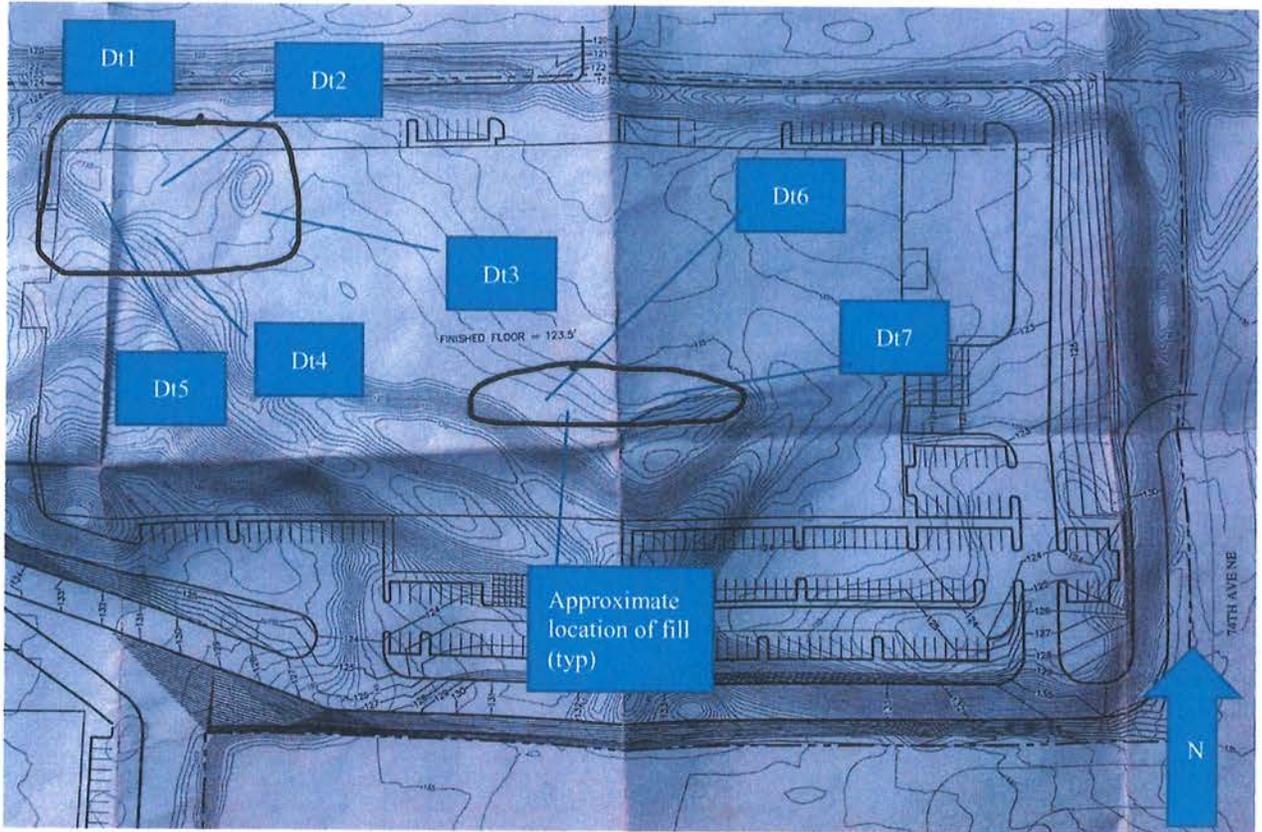
Trending generally north to south, the earthwork contractor continued mass grading processes for the proposed building pad and east parking areas. Using a large excavator, off-road dump truck, and belly load scraper assembly, the contractor placed approximately 2' of material (over the course of two days) near the NW and central portions of the building area. Per prior recommendations, the material (generally brownish gray SAND with trace silts and gravels/excavated from south margins of property) was wet to at/near optimum moisture levels (via large water truck) before being compacted/re-compacted (as recommended) in a series of 8-10" loose lifts via vibrator roller (complete process not observed). The compacted fill appeared firm/unyielding (during time of observation) with corresponding T-probe depths of 2-4" respectively. AESI conducted a series of in place density tests to confirm the specified minimum compaction for the structural area (95% ASTM 1557). The contractor was notified of all density results listed below. See Figure 1.

Test #	Location	Depth (ft below fsg)	% Moist	Density (pcf)	Proctor (pcf)	% Compaction
DT1	Grading/See Figure 1	-4	5.1	116	122.1	95.0
DT2	Grading/See Figure 1	-4	5.5	116.7	122.1	95.6
DT3	Grading/See Figure 1	-5	6.3	116.6	122.1	95.5
DT4	Grading/See Figure 1	-5	5.7	117.1	122.1	95.9
DT5	Grading/See Figure 1	-4	5.3	116.5	122.1	95.4
DT6	Grading/See Figure 1	-4	5.8	117.3	122.1	96.1
DT7	Grading/See Figure 1	-4	5.5	116.4	122.1	95.3
