Stormwater Drainage Report

**Arlington Operations Center
19620 67th Ave NE
Arlington, WA 98223**

*Subsurface Exploration, Geologic Hazards,
Preliminary Geotechnical Engineering, and Infiltration Feasibility Report*

ARLINGTON OPERATIONS CENTER REDEVELOPMENT

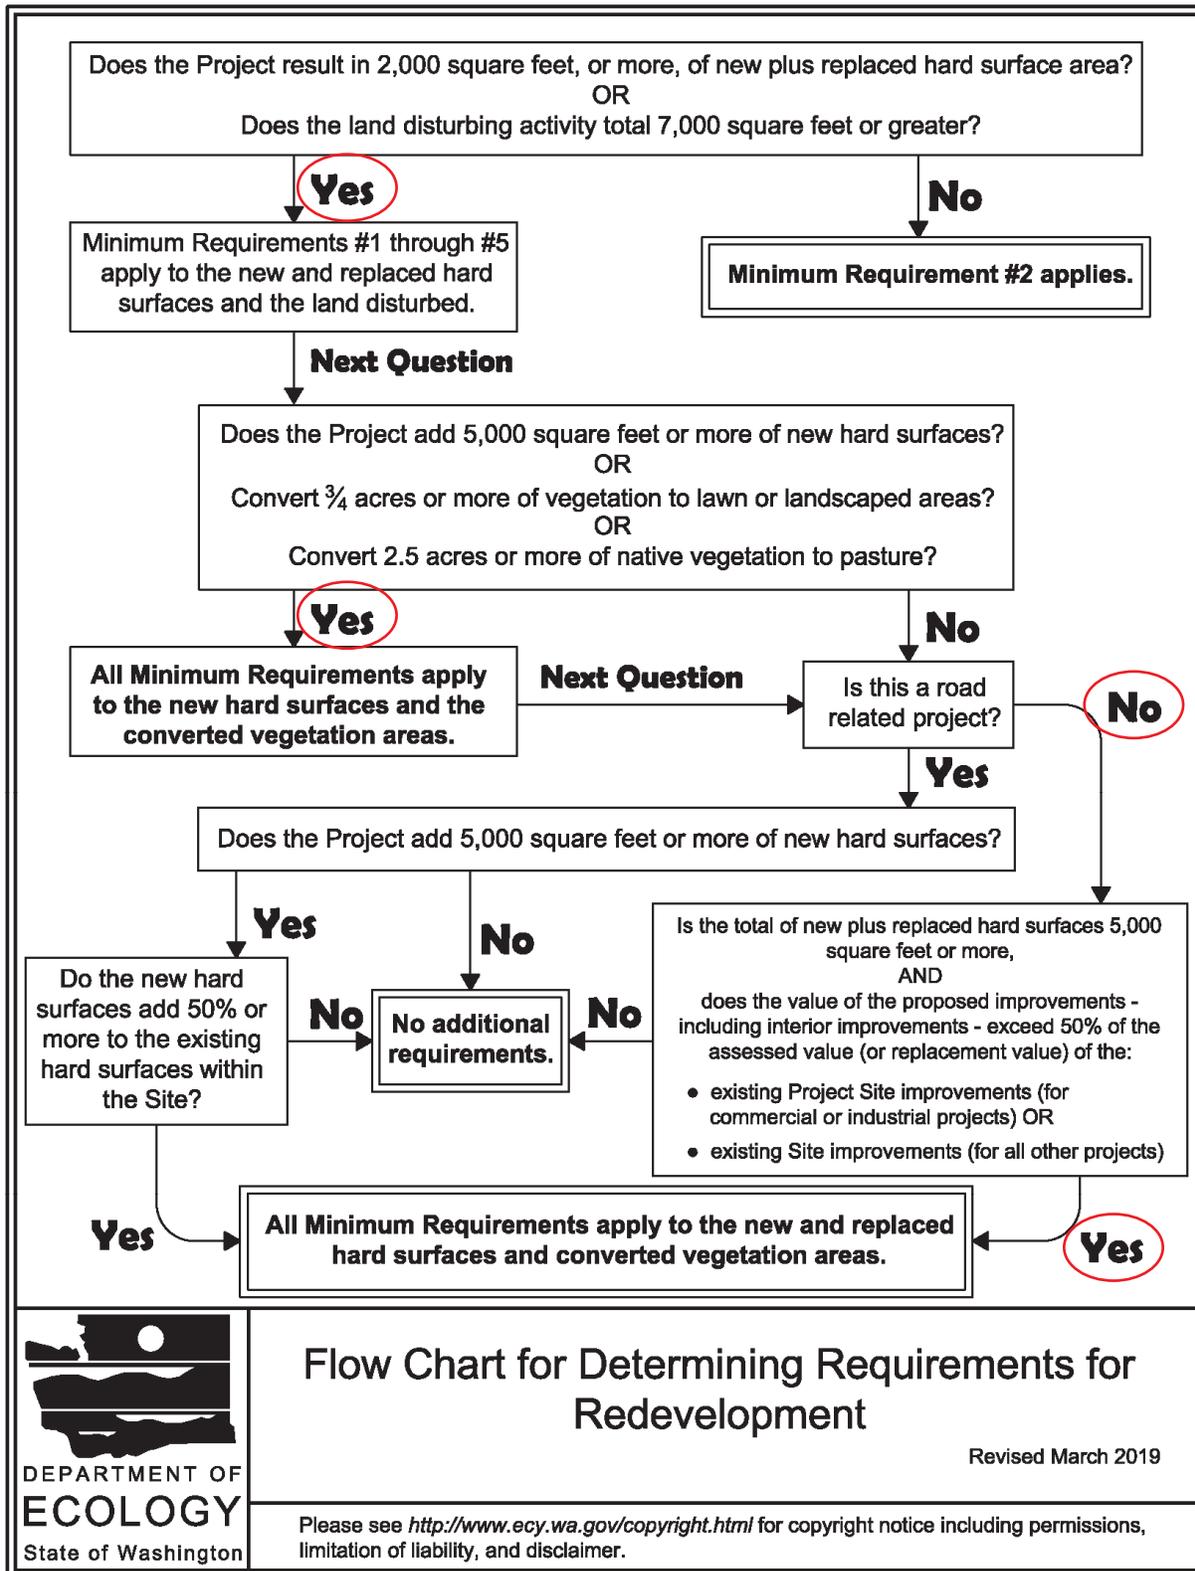
Figure I-3.2: Flow Chart for Determining Requirements for Redevelopment

Flow Chart for Determining Requirements for Redevelopment

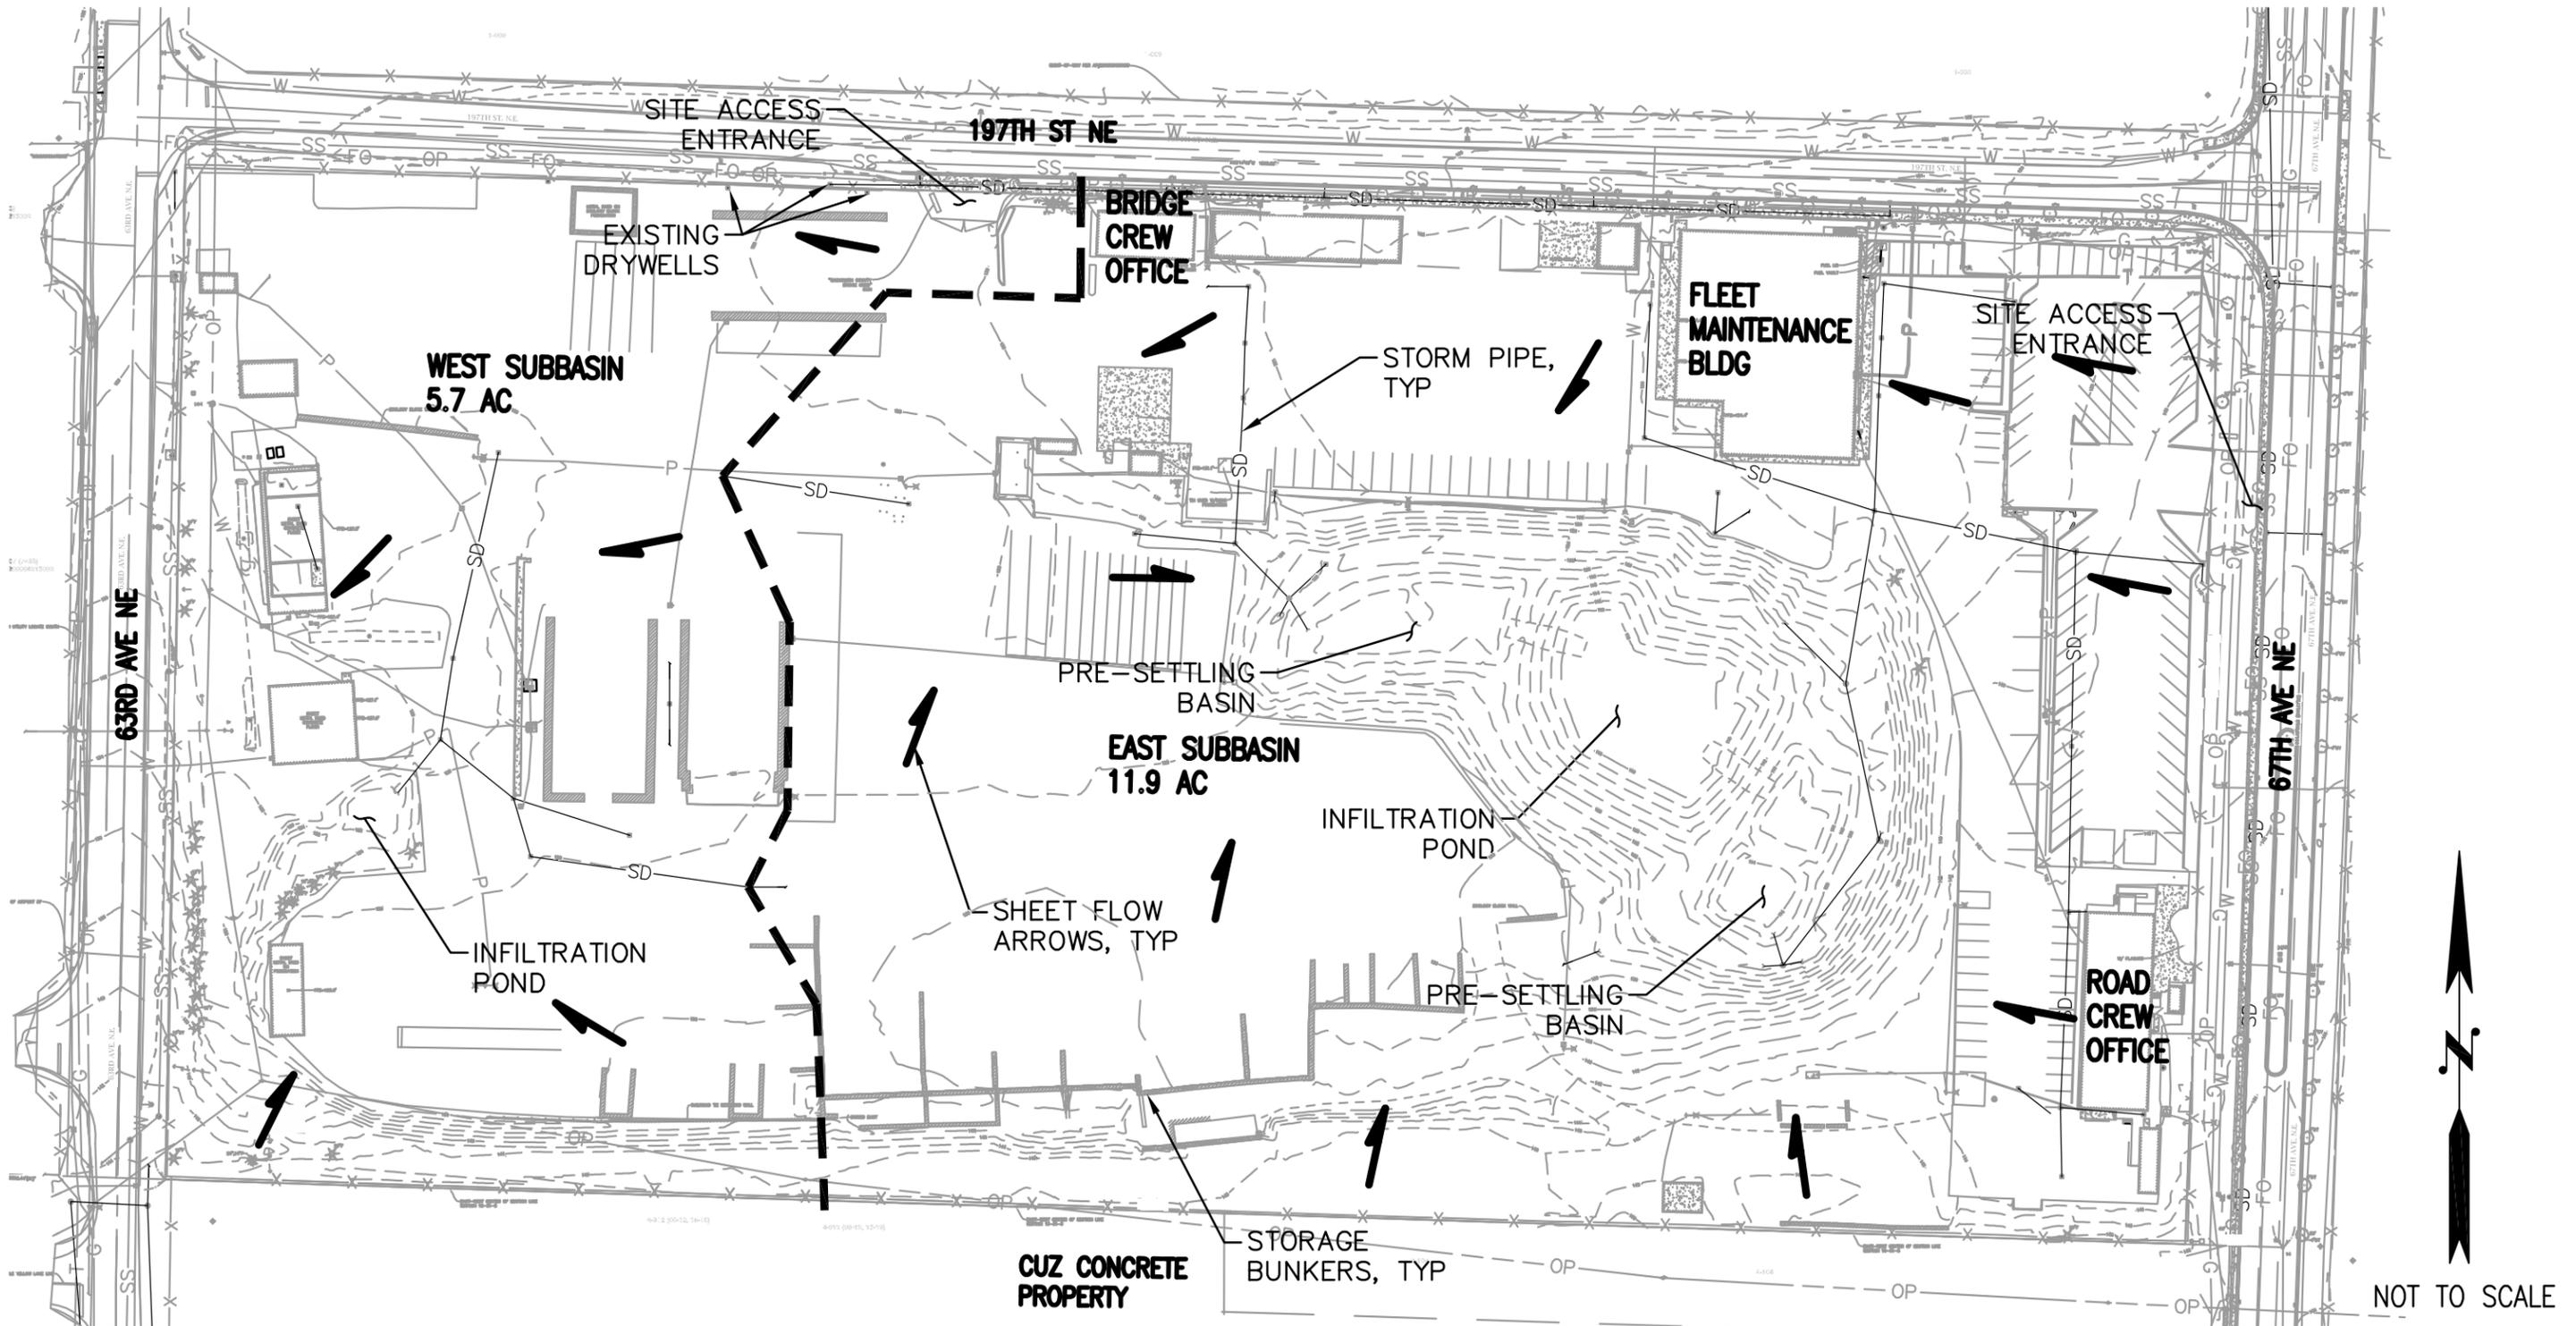
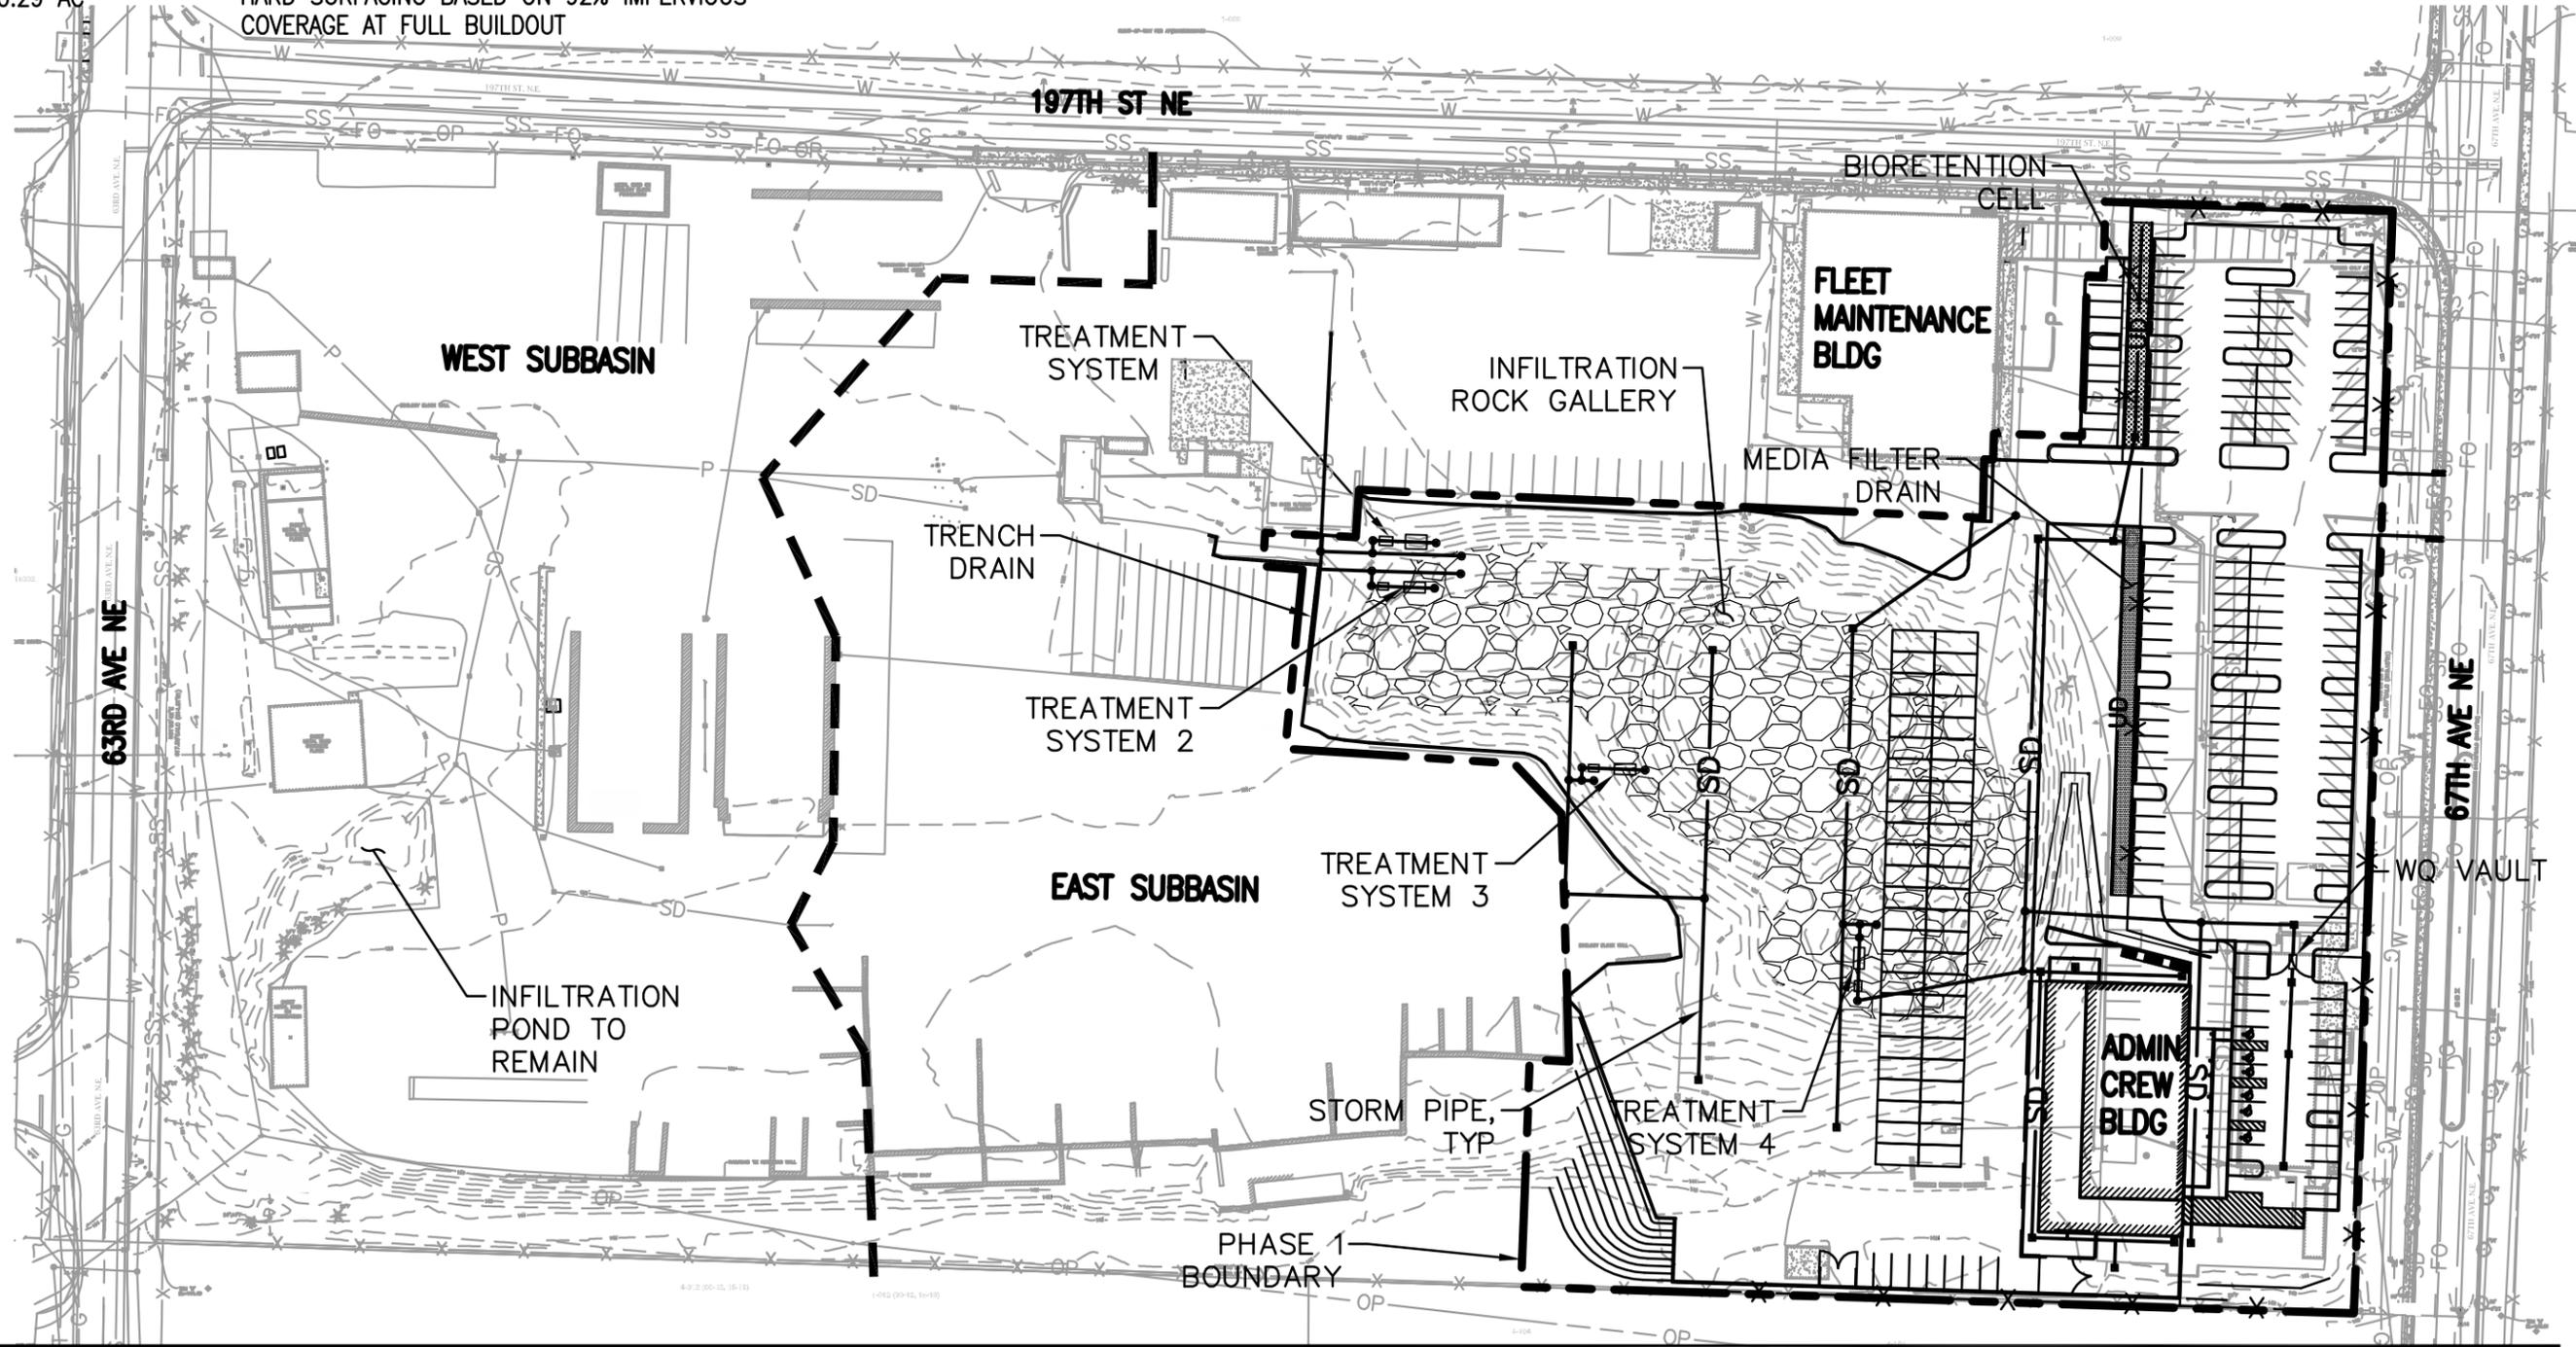
Figure 2. Site Assessment Maps

EAST SUBBASIN - 12 AC TOTAL
 HARD SURFACE = 11.04 AC
 PERVIOUS = 0.96

EAST SUBBASIN
 HARD SURFACING BASED ON 92% IMPERVIOUS
 COVERAGE AT FULL BUILDOUT. PHASE 1
 PERVIOUS = 0.92 AC

WEST SUBBASIN - 5.7 AC
 HARD SURFACE = 5.41 AC
 PERVIOUS = 0.29 AC

WEST SUBBASIN
 HARD SURFACING BASED ON 92% IMPERVIOUS
 COVERAGE AT FULL BUILDOUT

Figures 2 and 3 show site assessment plan drawings. To meet water quality and stream bank erosion goals, the project is constructing an infiltration pond facility that meets current regulations and water quality facilities that meet the enhanced treatment requirement. The project will slope paved areas toward the stormwater management facilities and amend disturbed soils on site. No other mitigation measures are required for this project.

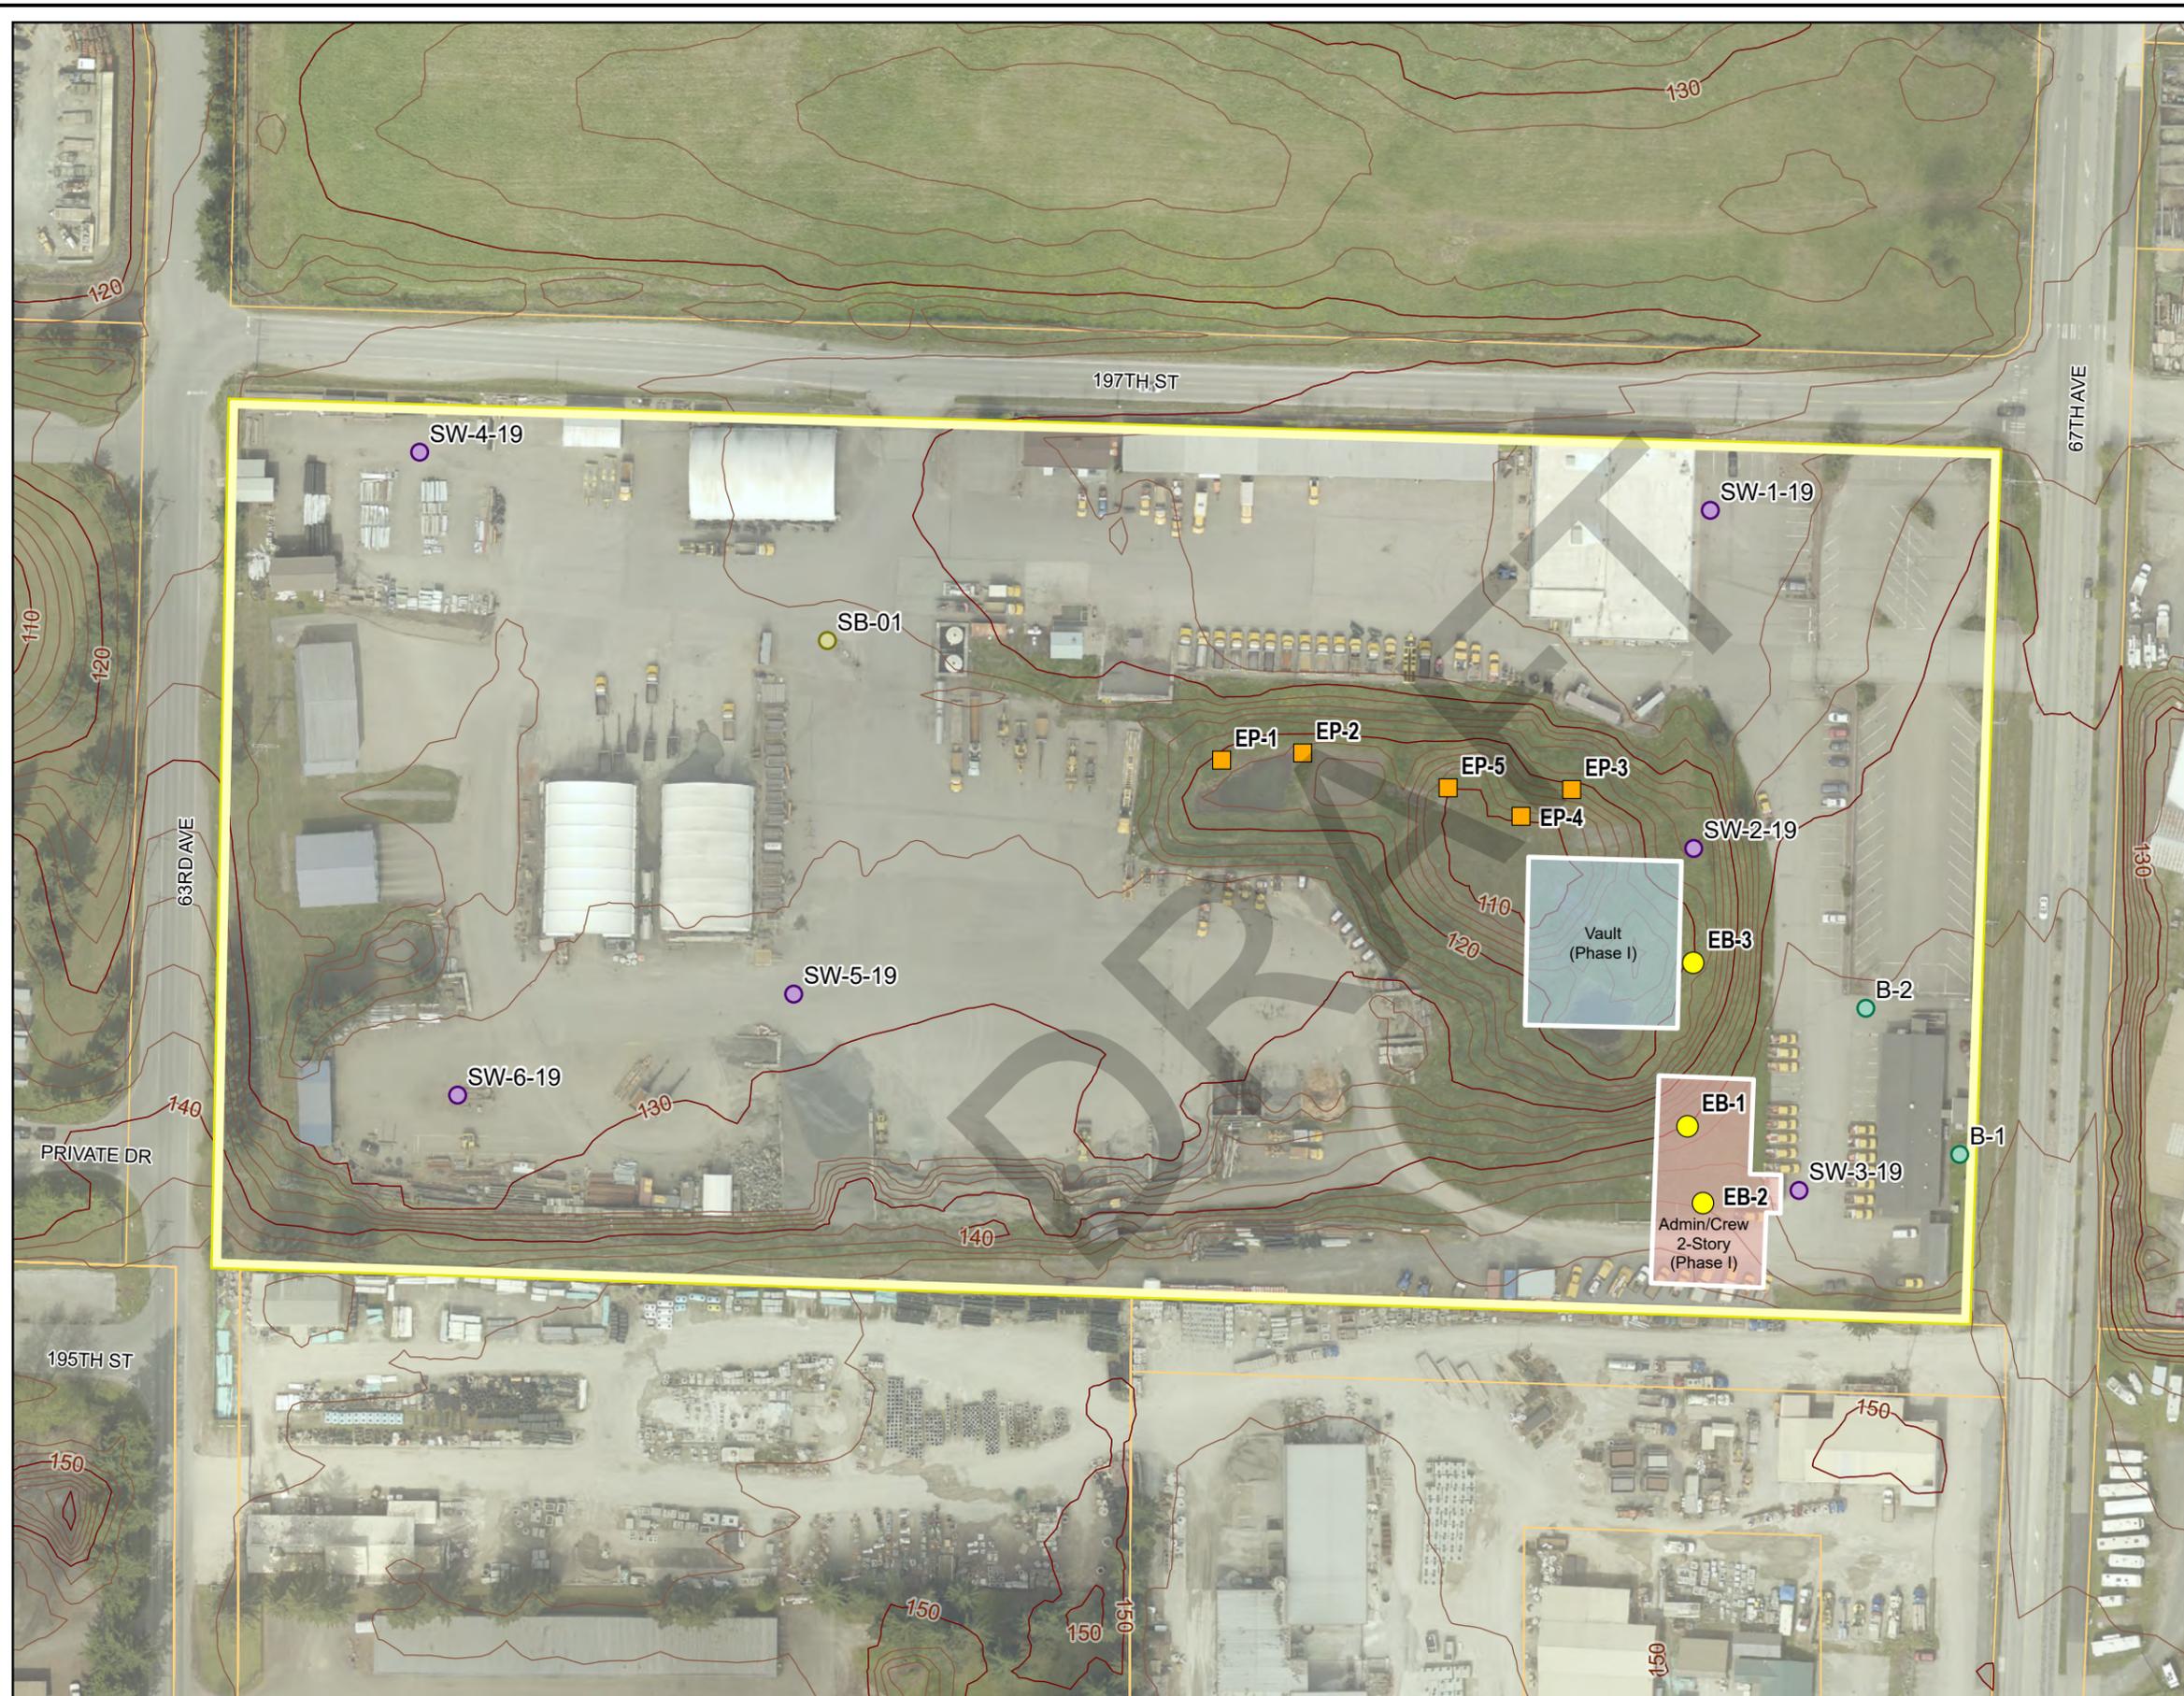
PROJECT NO. 20240001E001	DATE 5/24	FIGURE 2
-----------------------------	--------------	-------------

- SITE
- EXPLORATION BORING (AESI, 2024)
- EXPLORATION PIT (AESI, 1999)
- EXPLORATION BORING (SNOHOMISH COUNTY, 2015)
- EXPLORATION BORING (TERRACON, 2016)
- EXPLORATION BORING (SHANNON & WILSON, 2019)
- ADMIN/CREW 2-STORY
- VAULT
- ~ CONTOUR 10 FT
- ~ CONTOUR 2 FT
- PARCEL

The approximate locations of the borings and exploration pits are shown on Figures 2 and 3, and copies of the exploration logs are included in Appendix B. The subsurface conditions encountered in the previous explorations are summarized in Section 3.2 of this report. The previous subsurface exploration information was used to supplement the subsurface information obtained for this current study and aided in our assessment of the depth to groundwater, fill depths, and the characteristics of the native sediments.

Our field study, completed in April 2024, included advancing three explorations to define the general soil and shallow groundwater conditions in the vicinity of the proposed Phase 1 improvements. The exploration locations are shown on Figure 2 and Figure 3. The various types of sediments, as well as the depths where characteristics of the sediments changed, are indicated on the exploration logs presented in Appendix A. The depths indicated on the logs where conditions changed may represent gradational variations between sediment types in the field. The locations of our field explorations were determined by approximate measurements from known site features.

The exploration borings were completed by Advance Drill Technology Inc., an independent driller working under subcontract to AESI, by advancing a 6-inch outside-diameter, hollow-stem auger with a track-mounted drill rig. The approximate locations of the borings completed for this study are shown on Figure 2. During the drilling process, samples were generally obtained at 2½- to 5-foot-depth intervals. After drilling, each borehole was backfilled with bentonite grout in combination with bentonite chips, and the surface was patched with on-site material.

Our previous study included the excavation of five exploration pits in October of 1999, along the northern side of the infiltration pond. These pits were completed to depths between 12 and 13.5 feet below the ground surface. The exploration pits typically encountered fill, overlying Vashon recessional outwash. Fill was observed extending beyond the total depth explored in EP-1 and EP-2 near the northwestern end of the infiltration pond. EP-3, EP-4, and EP-5 encountered recessional outwash underlying the fill at depths of 2, 6, and 8 feet below the ground surface. No groundwater was encountered at the time of the explorations. The sediments observed within the 2000 exploration pits are generally consistent with the borings completed as part of this study. The approximate boring locations are shown on Figures 2 and 3, and copies of the exploration logs from previous studies are included in Appendix B.

A 2.5-foot-thick layer of peat consisting of soft, brown fibrous organic silt was encountered by Terracon in exploration boring B-1 and B-2; see Figures 2 and 3. The peat was encountered 10.5 feet and 15 feet below the existing ground surface in B-1 and B-2, respectively. Peat is typically deposited in areas that were formerly occupied by streams or swamps. Peat is highly compressible and not suitable for structural support. Peat sediments were not encountered in any of the explorations completed by AESI, Shannon & Wilson, or Snohomish County.

Slopes less than 8 feet in height were observed in the Light Detection and Ranging (LiDAR)-based contours on Figure 2 near the south property line. These slopes appear to have been created during previous grading activities and are generally retained by ecology blocks and/or existing stockpiles of road repair and maintenance materials. We anticipate that the site improvements associated with this phase of the project will not alter the southern slope.

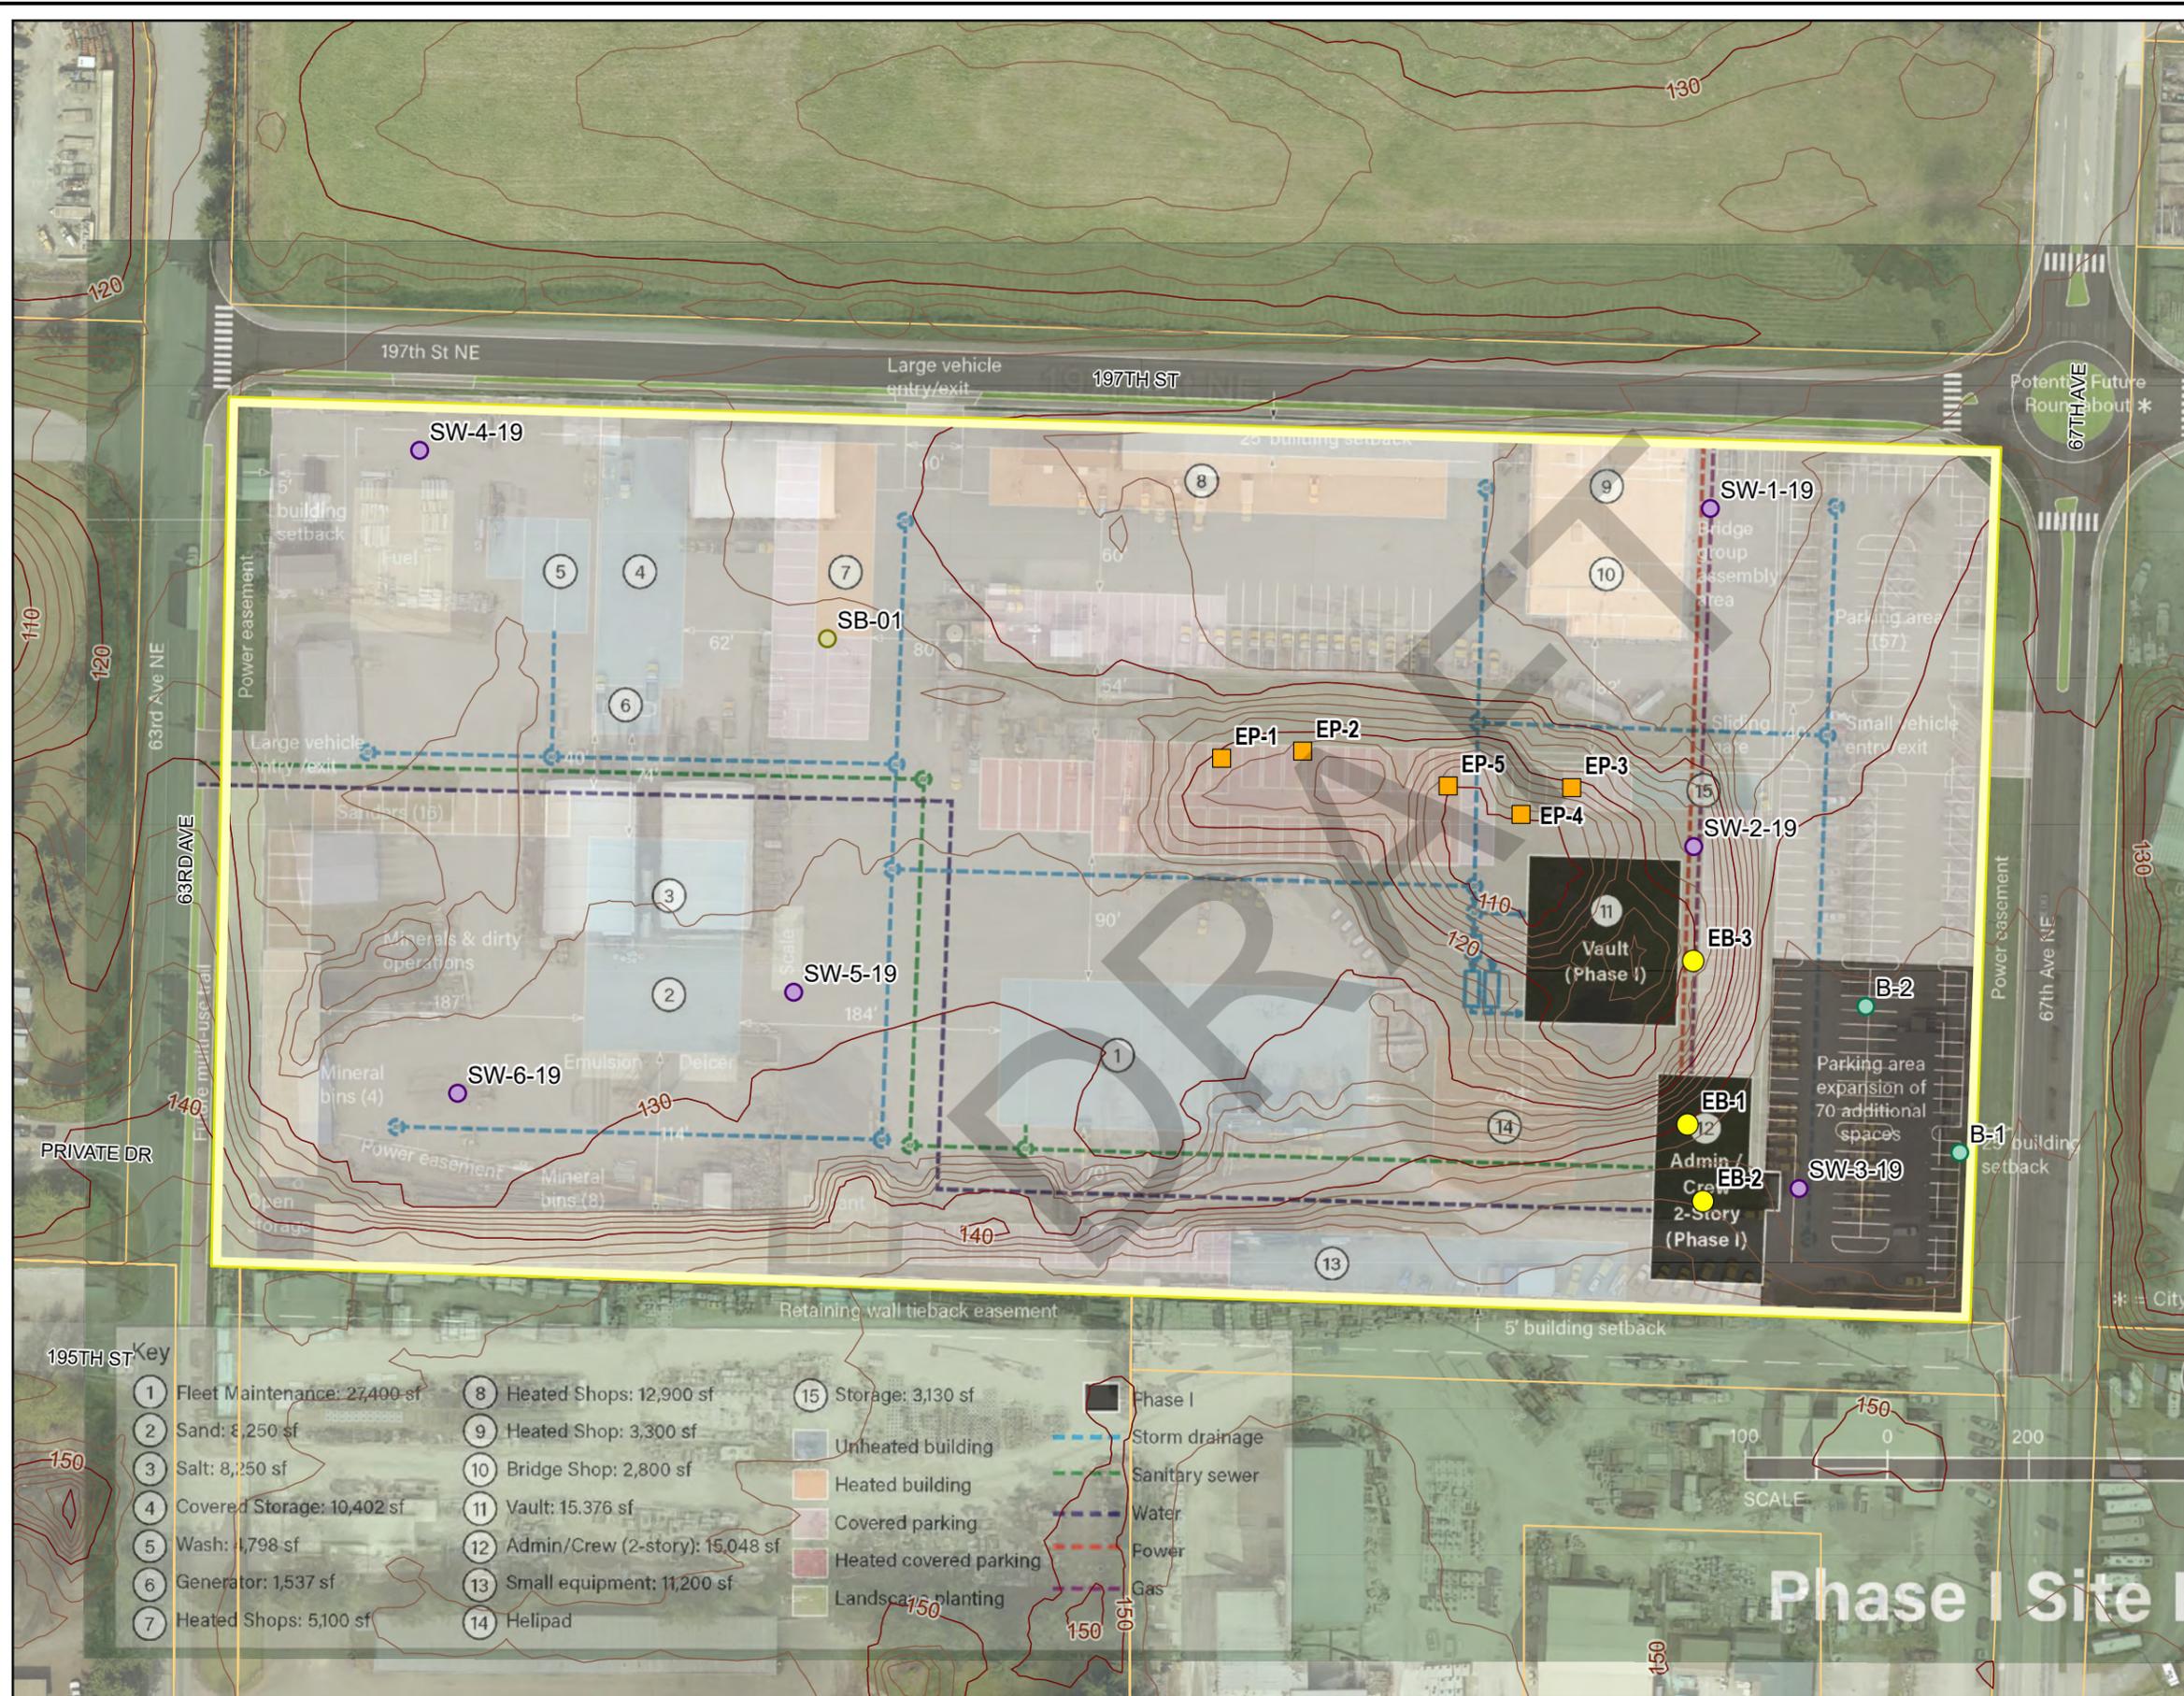
PROJECT NO. 20240001E001	DATE 5/24	FIGURE 3
-----------------------------	--------------	-------------

- SITE
- EXPLORATION BORING (AESI, 2024)
- EXPLORATION PIT (AESI, 1999)
- EXPLORATION BORING (SNOHOMISH COUNTY, 2015)
- EXPLORATION BORING (TERRACON, 2016)
- EXPLORATION BORING (SHANNON & WILSON, 2019)
- CONTOUR 10 FT
- CONTOUR 2 FT
- PARCEL

underground stormwater facilities, utilities, paved parking and driveways, and landscaping as shown on Figure 3, “Proposed Site Improvements.” Future project phases may include covered gathering areas, a fabrication shop, equipment storage, waste material storage, a heated vehicle storage building, and various storage sheds. We understand the project will pursue stormwater infiltration with a new infiltration vault proposed near the bottom of the existing large stormwater infiltration pond.
