Stormwater Drainage Report

**Arlington Operations Center
19620 67th Ave NE
Arlington, WA 98223**

*Subsurface Exploration, Geologic Hazards,
Preliminary Geotechnical Engineering, and Infiltration Feasibility Report*

ARLINGTON OPERATIONS CENTER REDEVELOPMENT

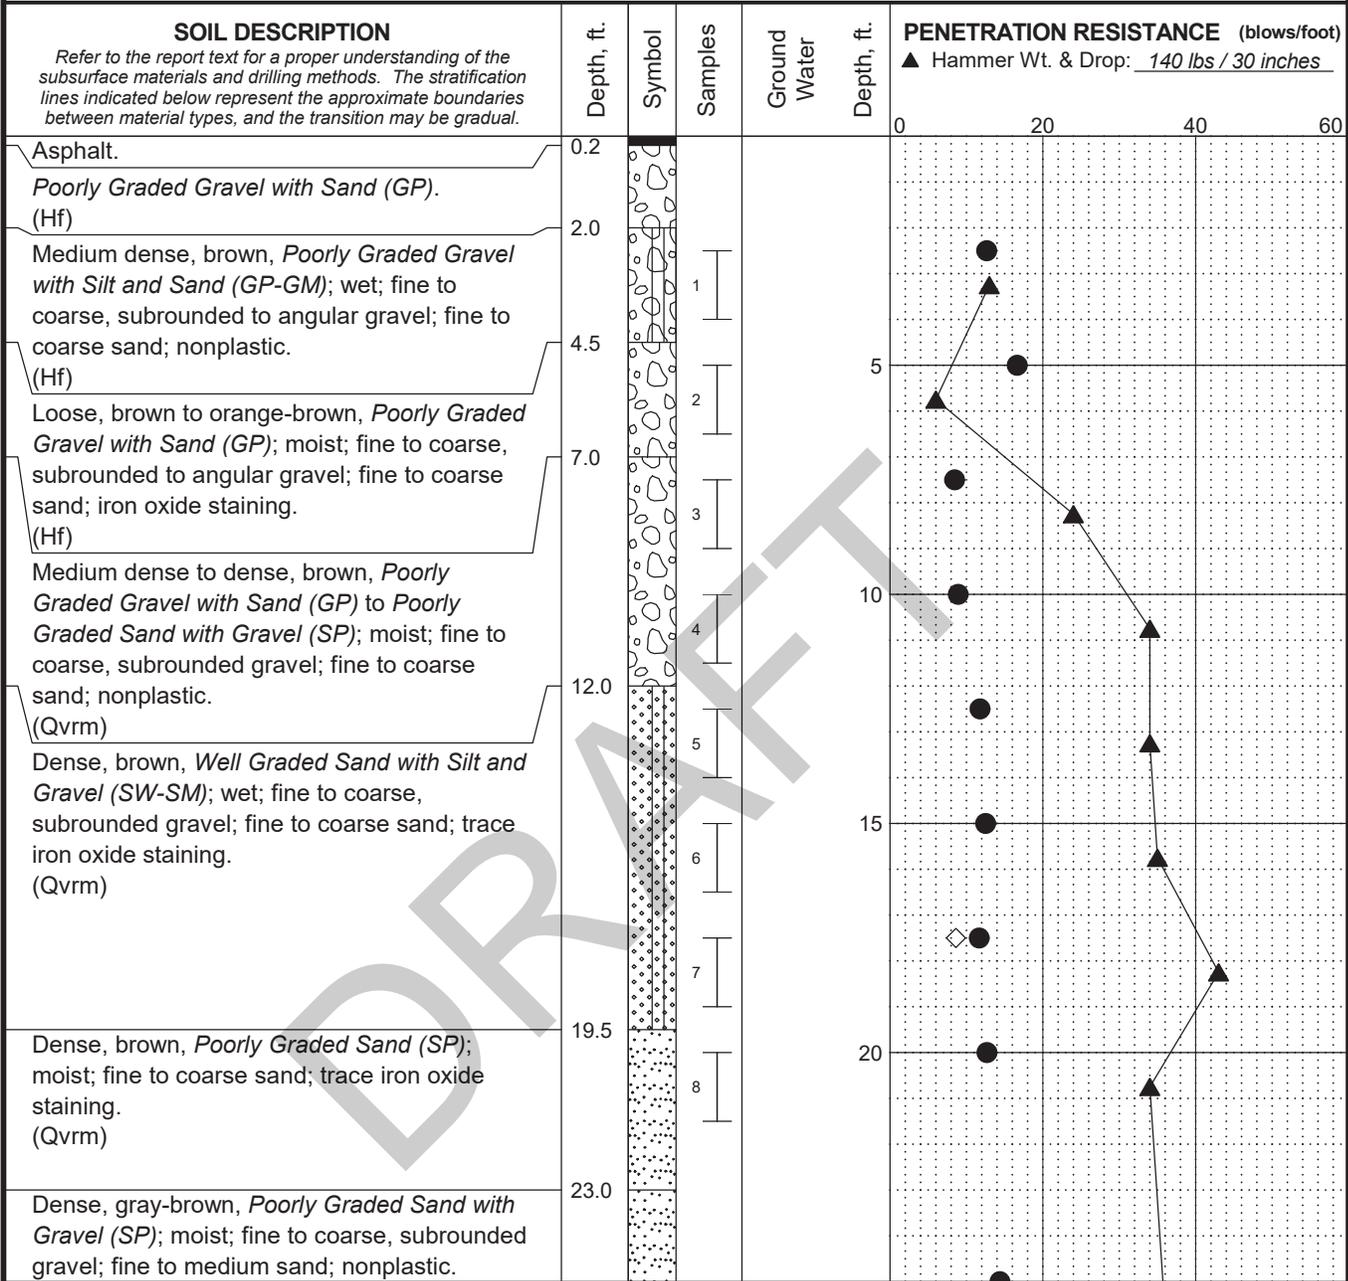
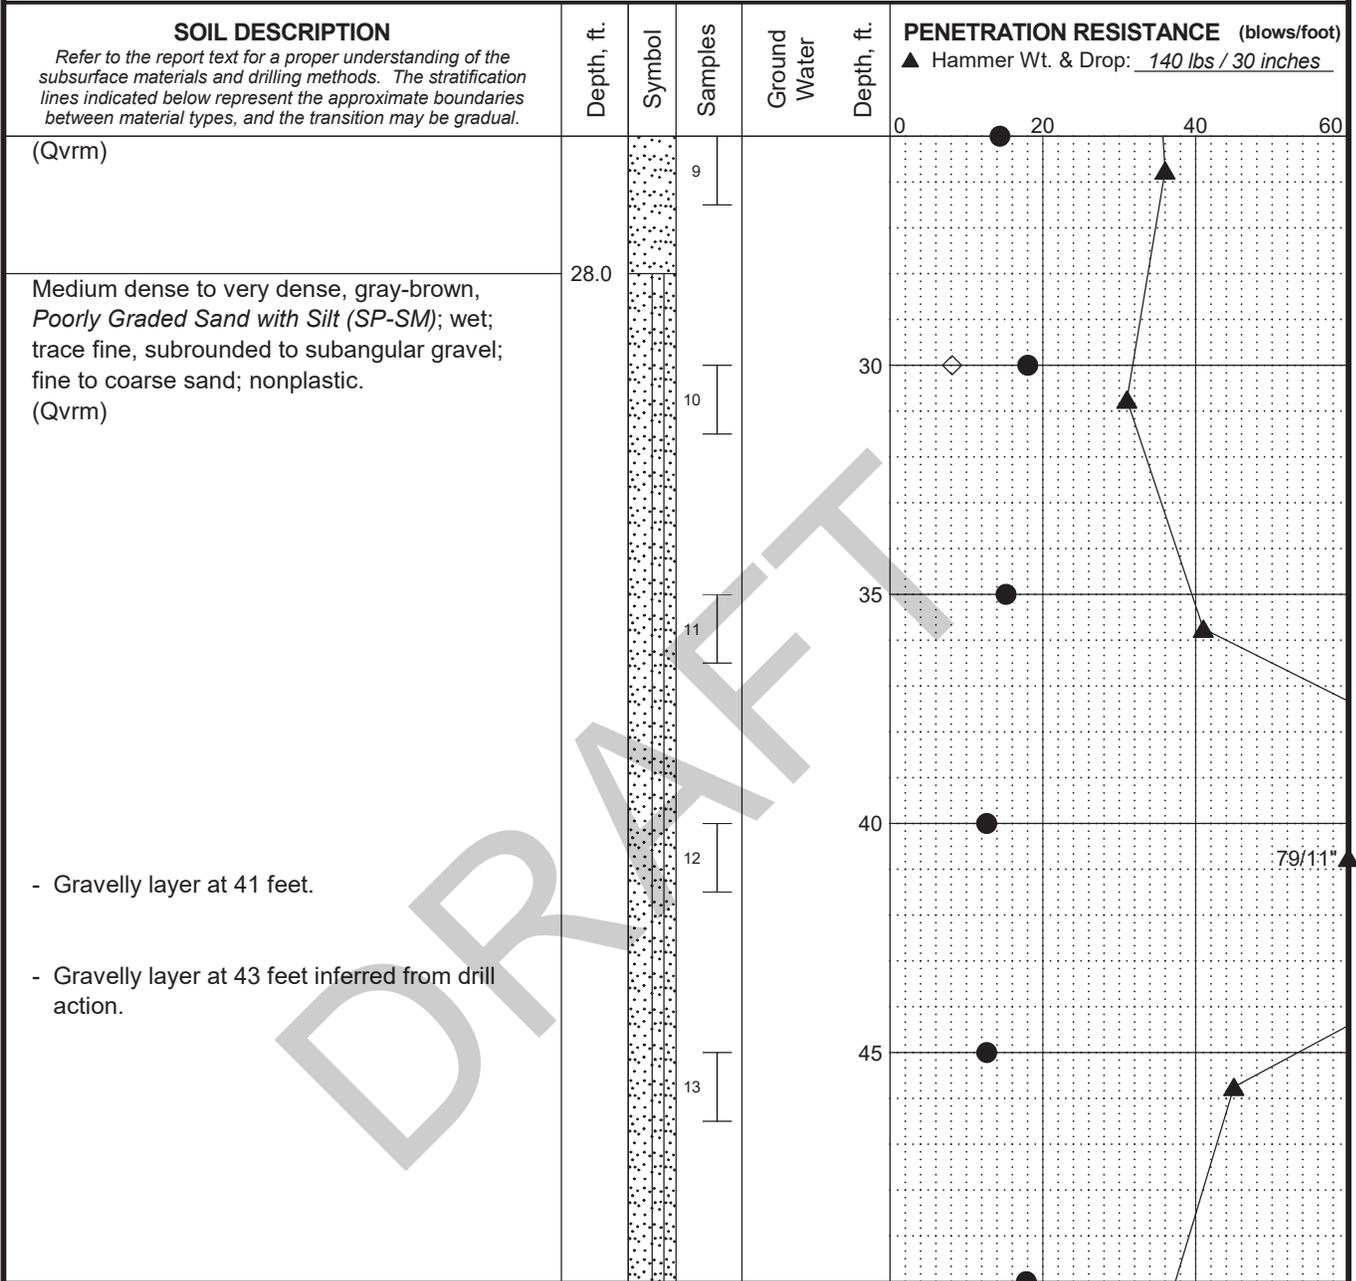
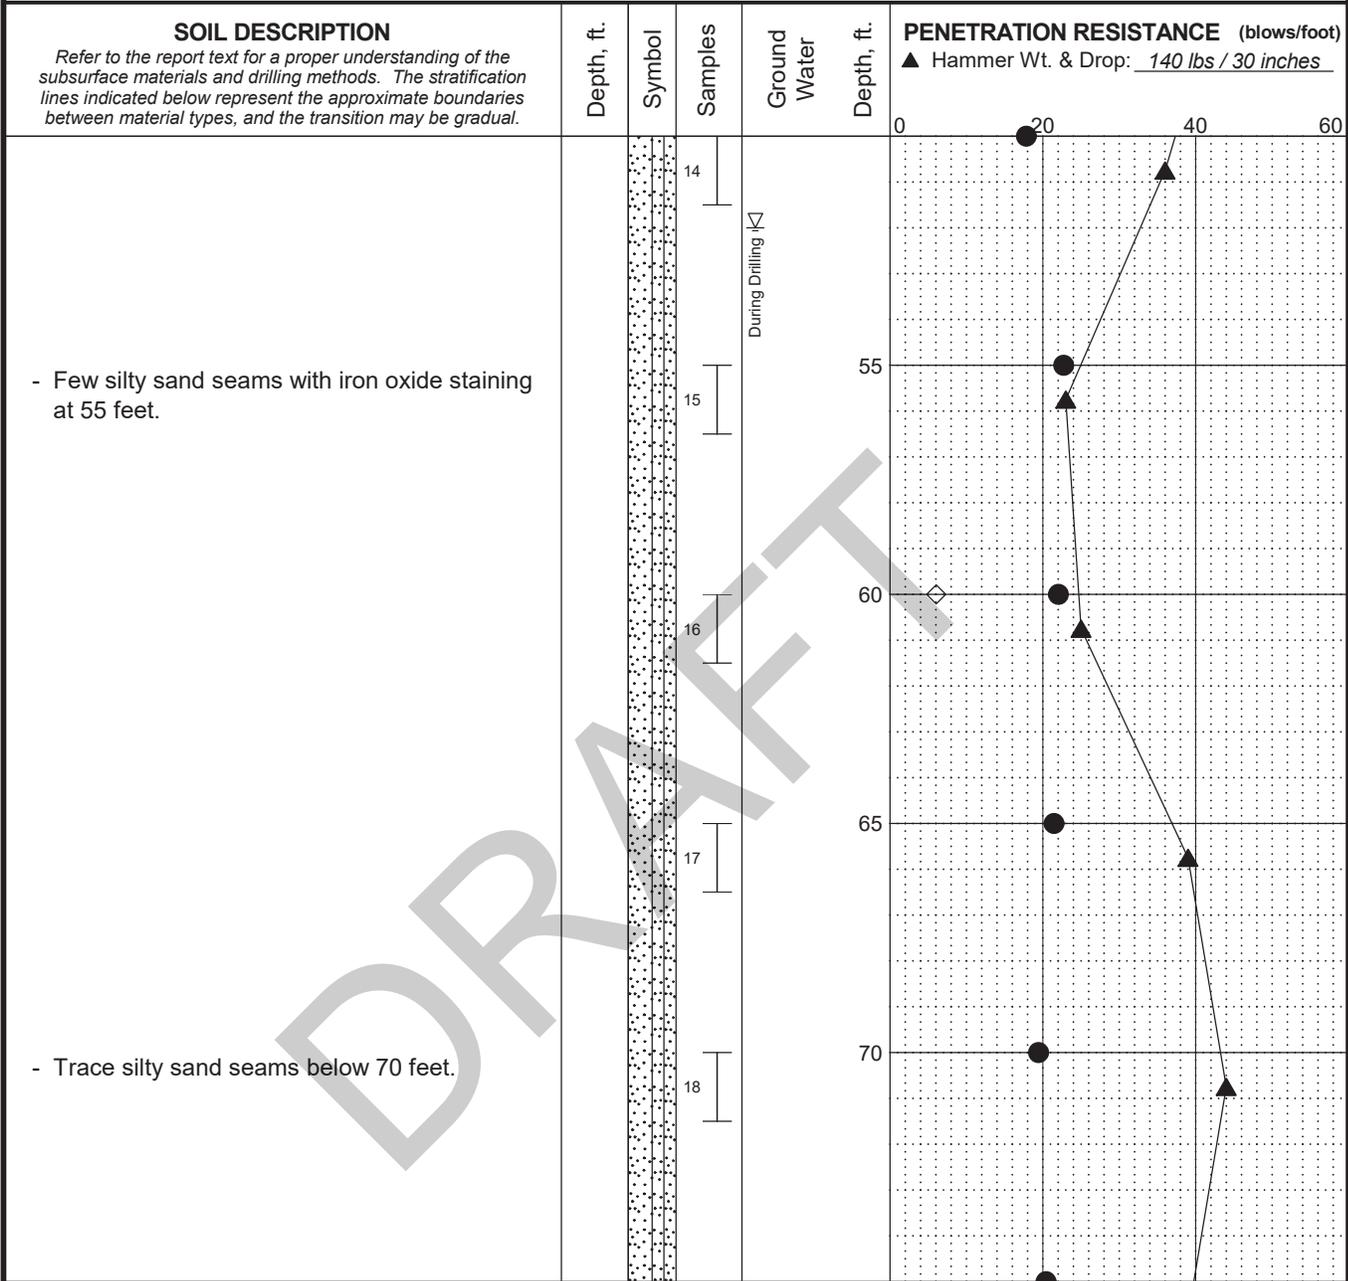
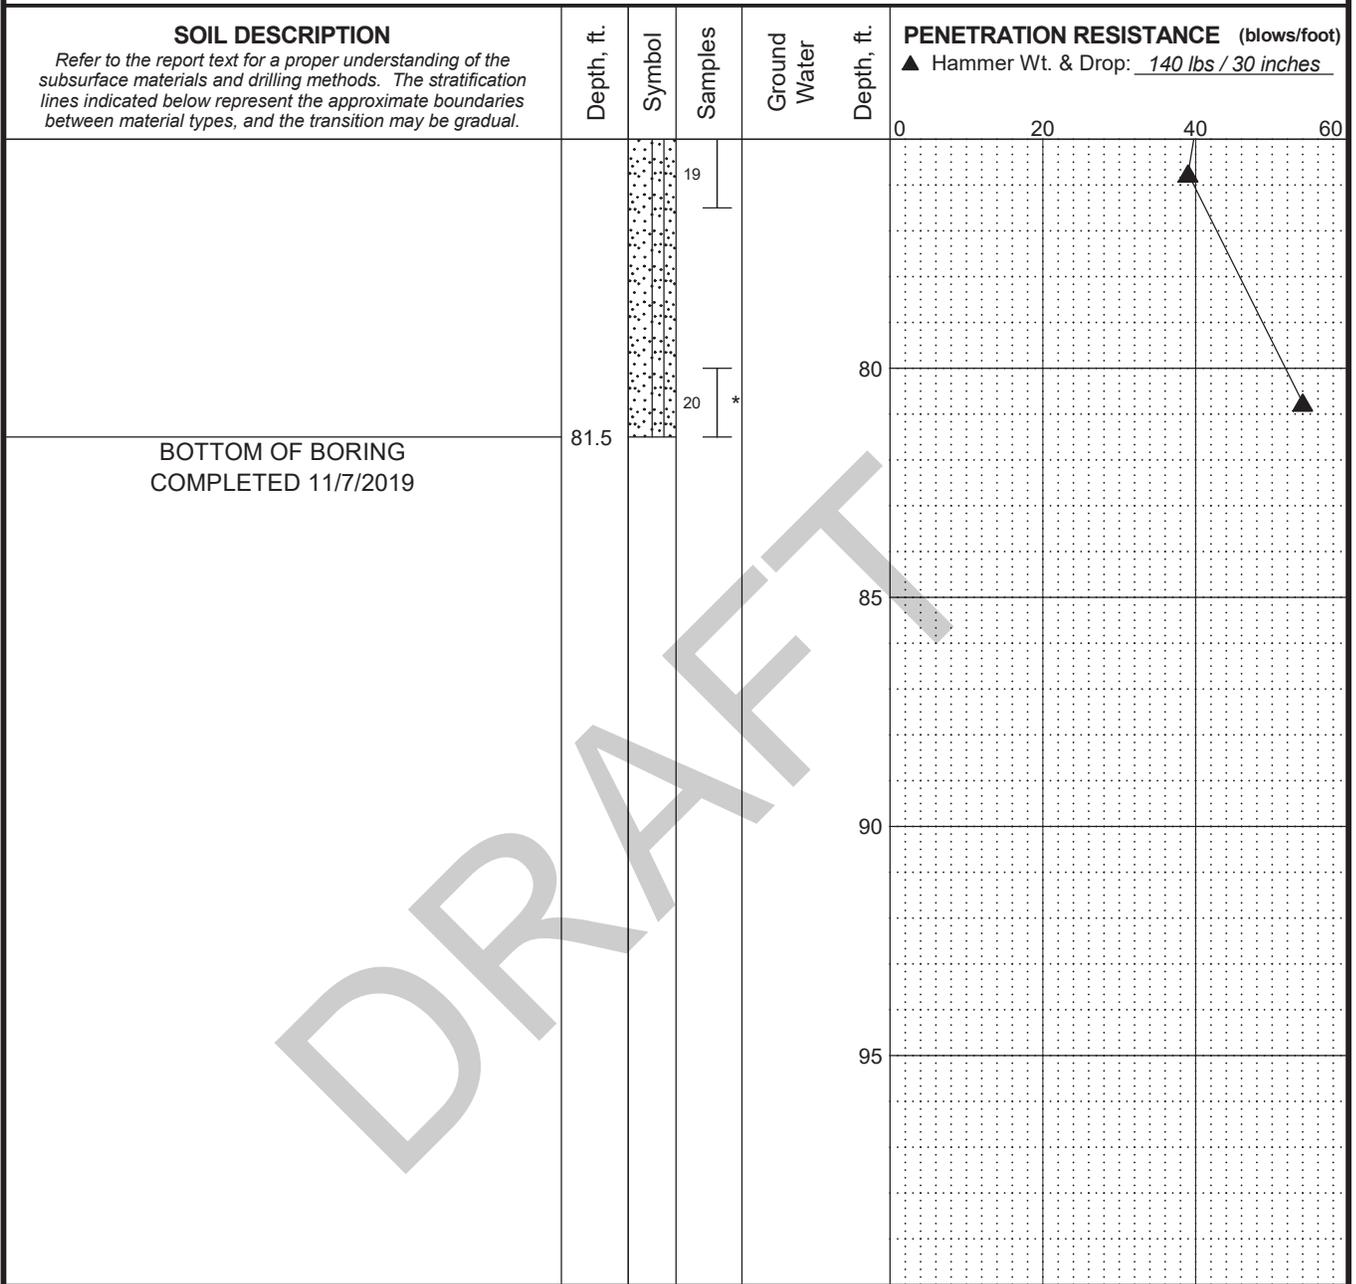
Total Depth: 81.5 ft. Northing: _____ Drilling Method: Mud Rotary Hole Diam.: 6 in.
 Top Elevation: ~ 131 ft. Easting: _____ Drilling Company: Holocene Drilling Rod Diam.: 2-inch ID
 Vert. Datum: _____ Station: _____ Drill Rig Equipment: Diedrich D120 Truck Hammer Type: Automatic
 Horiz. Datum: _____ Offset: _____ Other Comments: _____

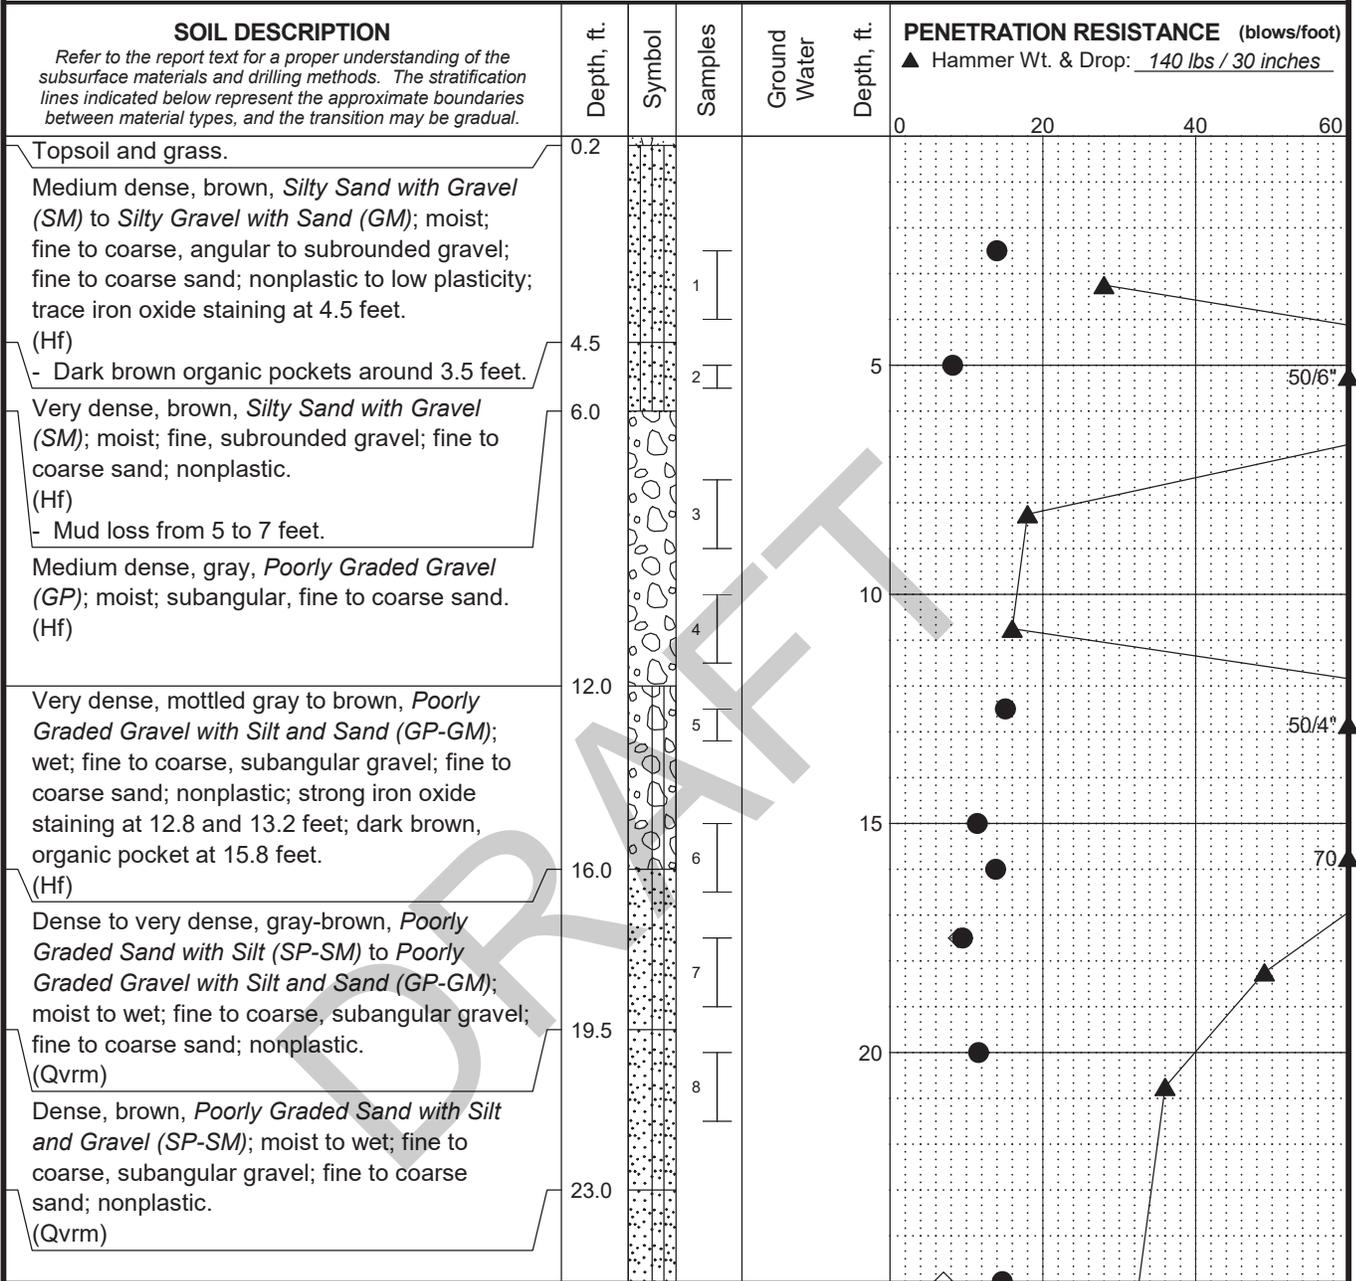
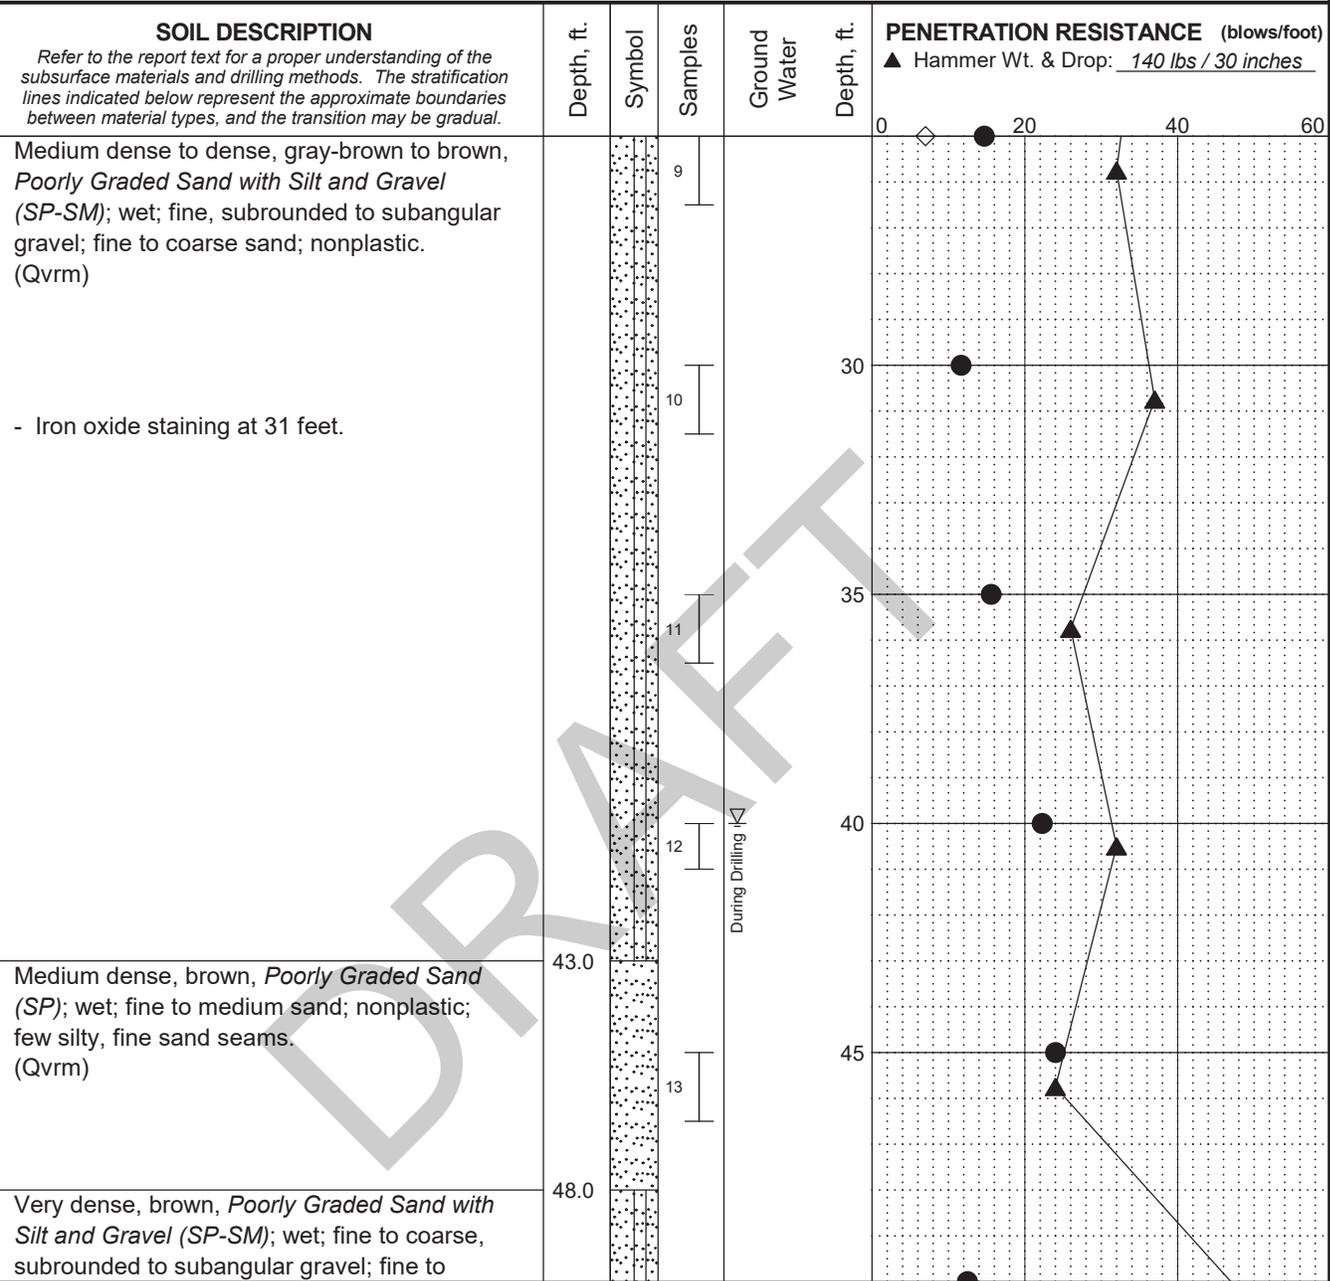
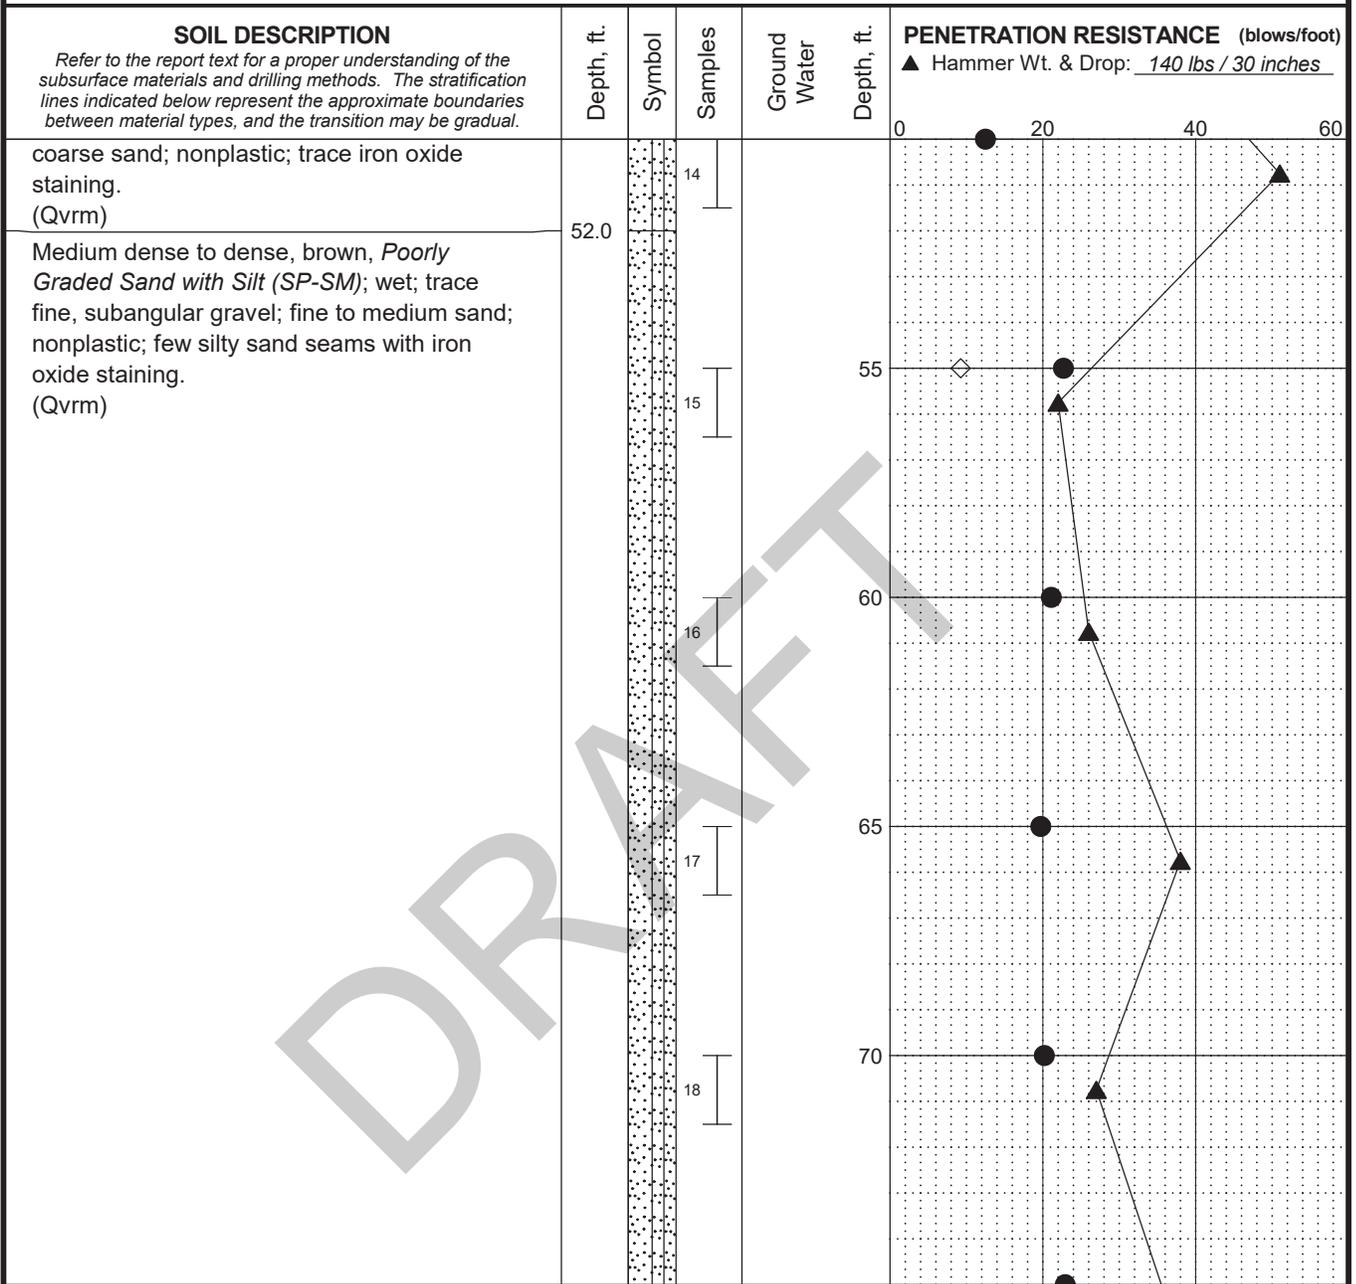
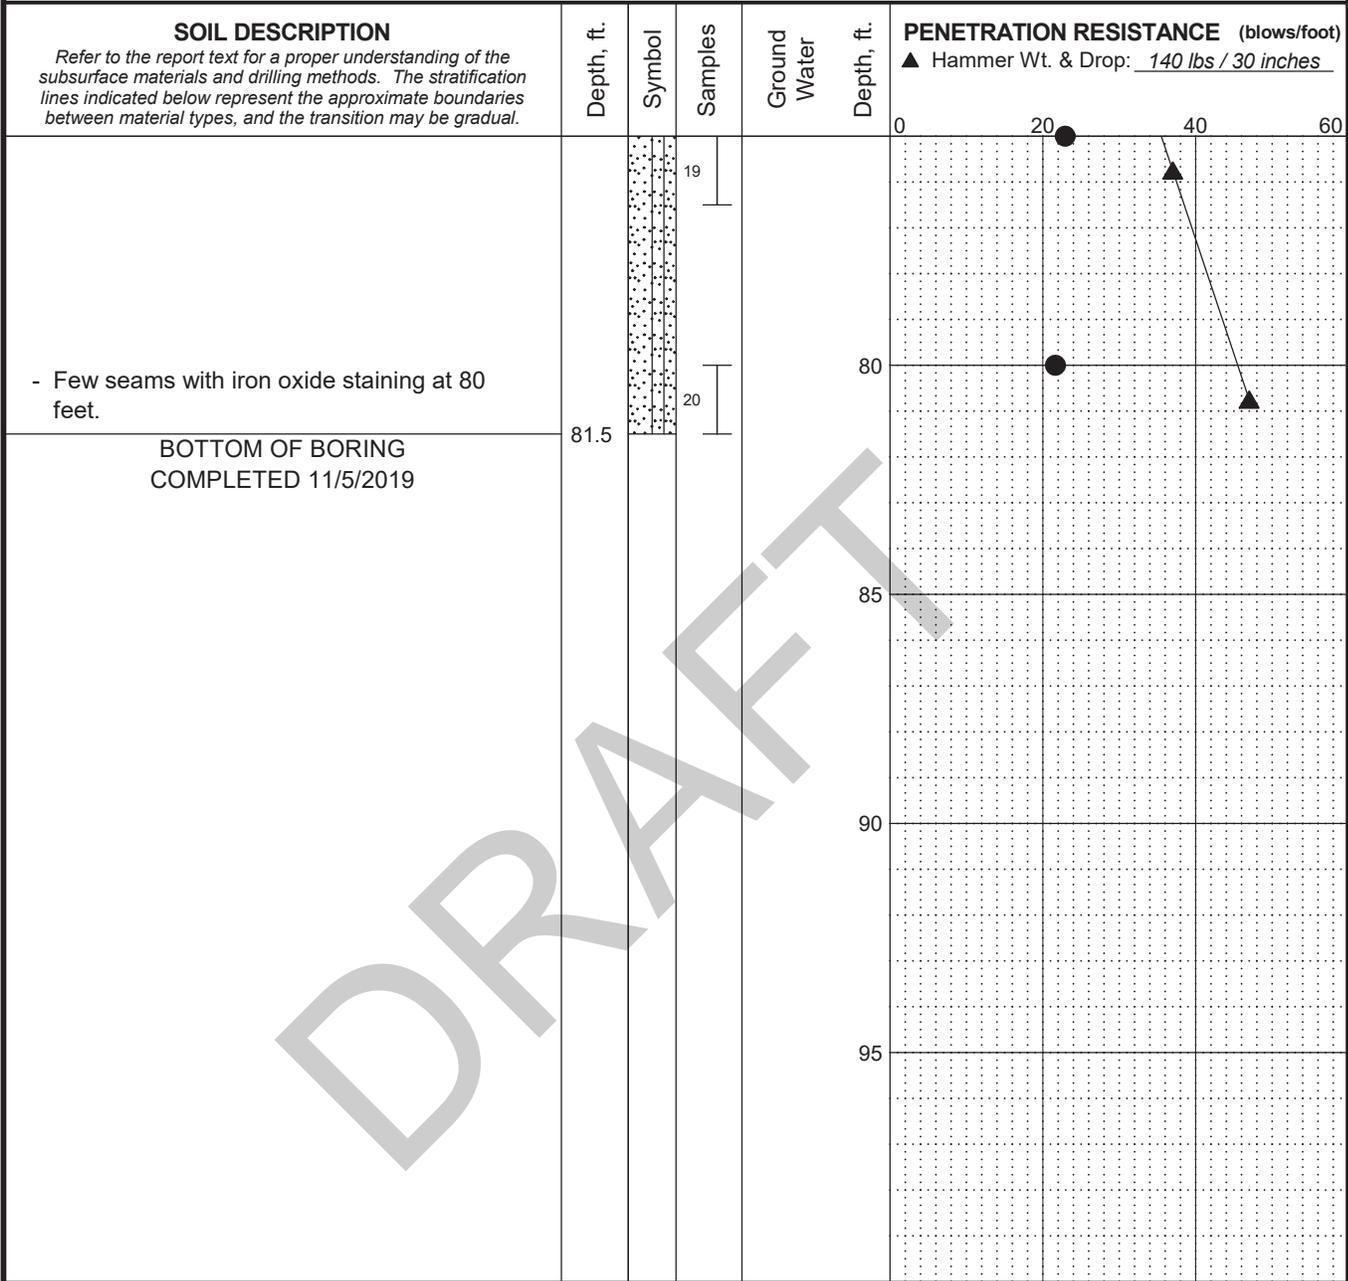
SHANNON & WILSON, INC.
Geotechnical and Environmental Consultants
FIG. A-3
Sheet 1 of 4

Total Depth: 81.5 ft. Northing: _____ Drilling Method: Mud Rotary Hole Diam.: 6 in.
 Top Elevation: ~ 120 ft. Easting: _____ Drilling Company: Holocene Drilling Rod Diam.: 2-inch ID
 Vert. Datum: _____ Station: _____ Drill Rig Equipment: Diedrich D120 Truck Hammer Type: Automatic
 Horiz. Datum: _____ Offset: _____ Other Comments: _____
