Stormwater Drainage Report

**Arlington Operations Center
19620 67th Ave NE
Arlington, WA 98223**

*Subsurface Exploration, Geologic Hazards,
Preliminary Geotechnical Engineering, and Infiltration Feasibility Report*

ARLINGTON OPERATIONS CENTER REDEVELOPMENT

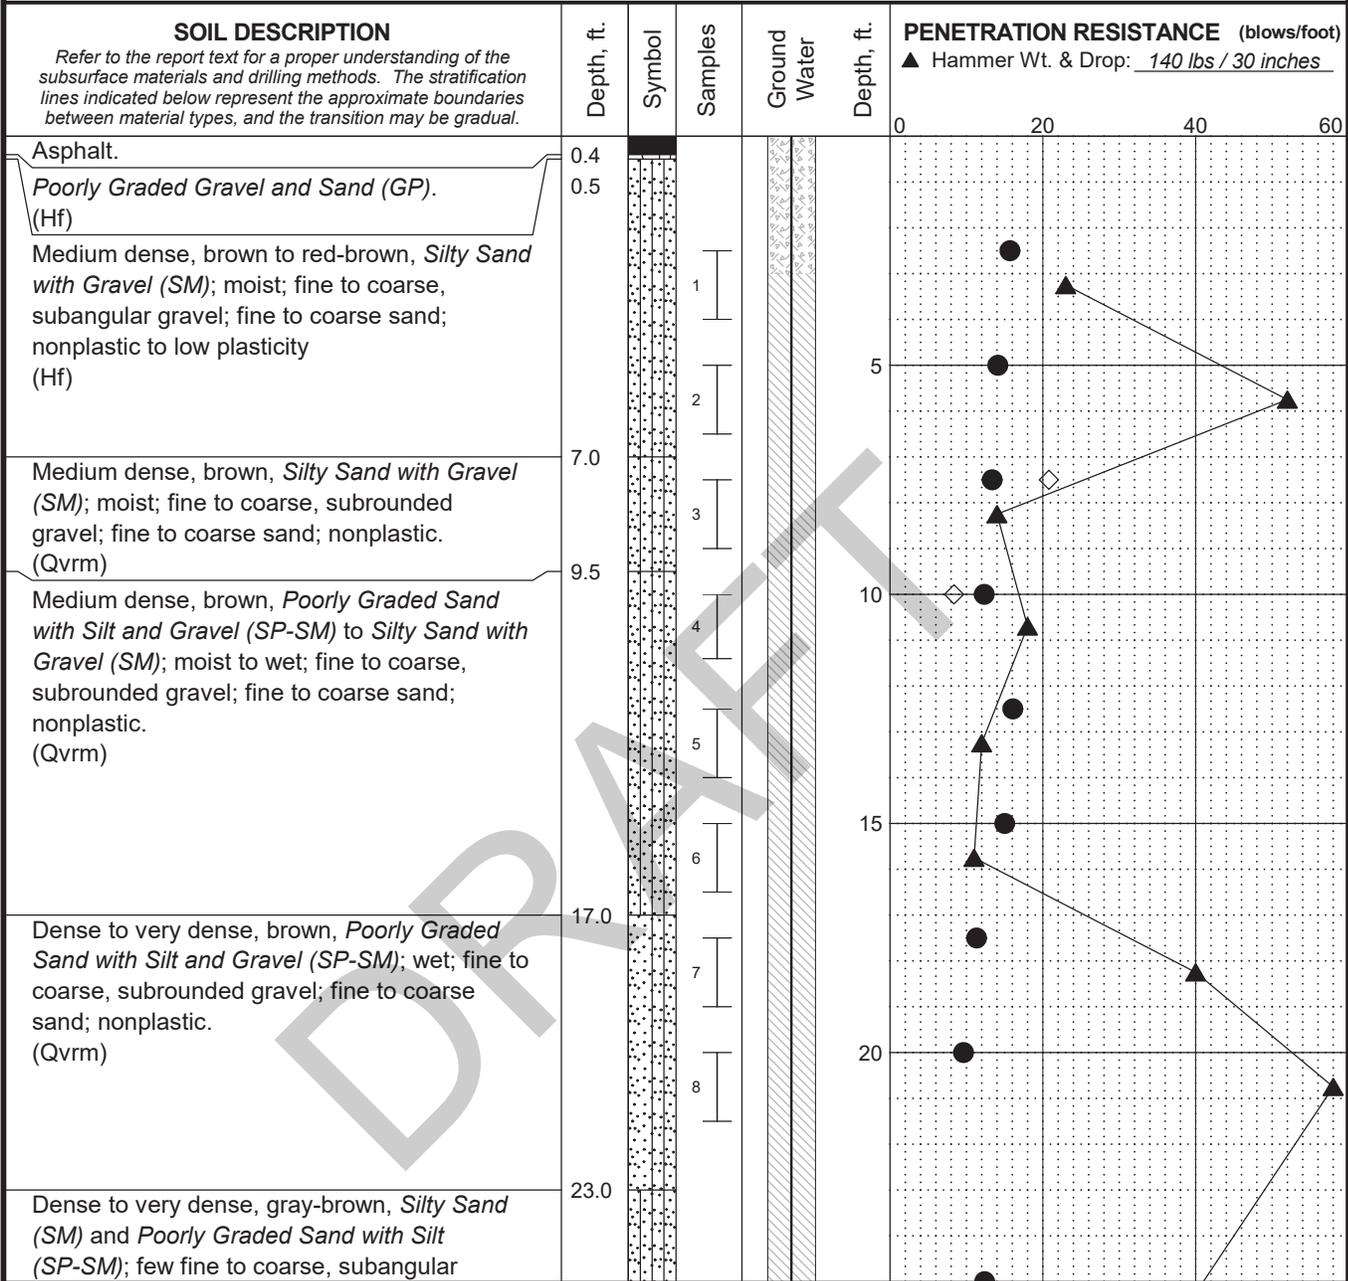
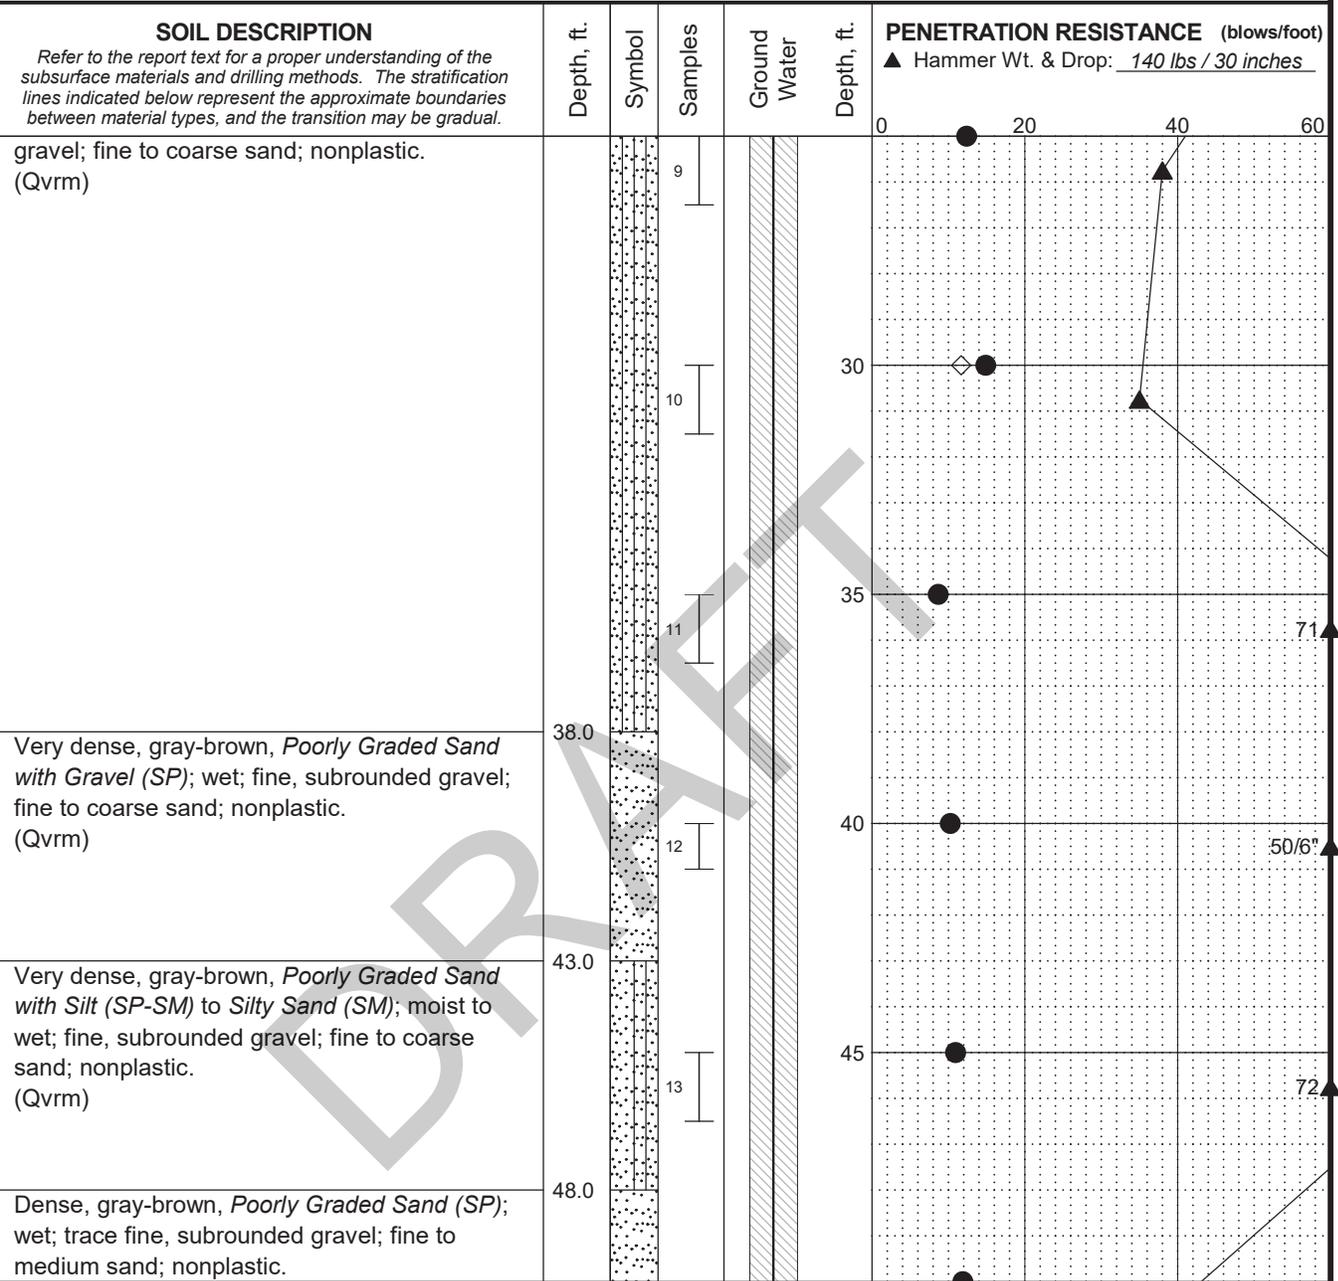
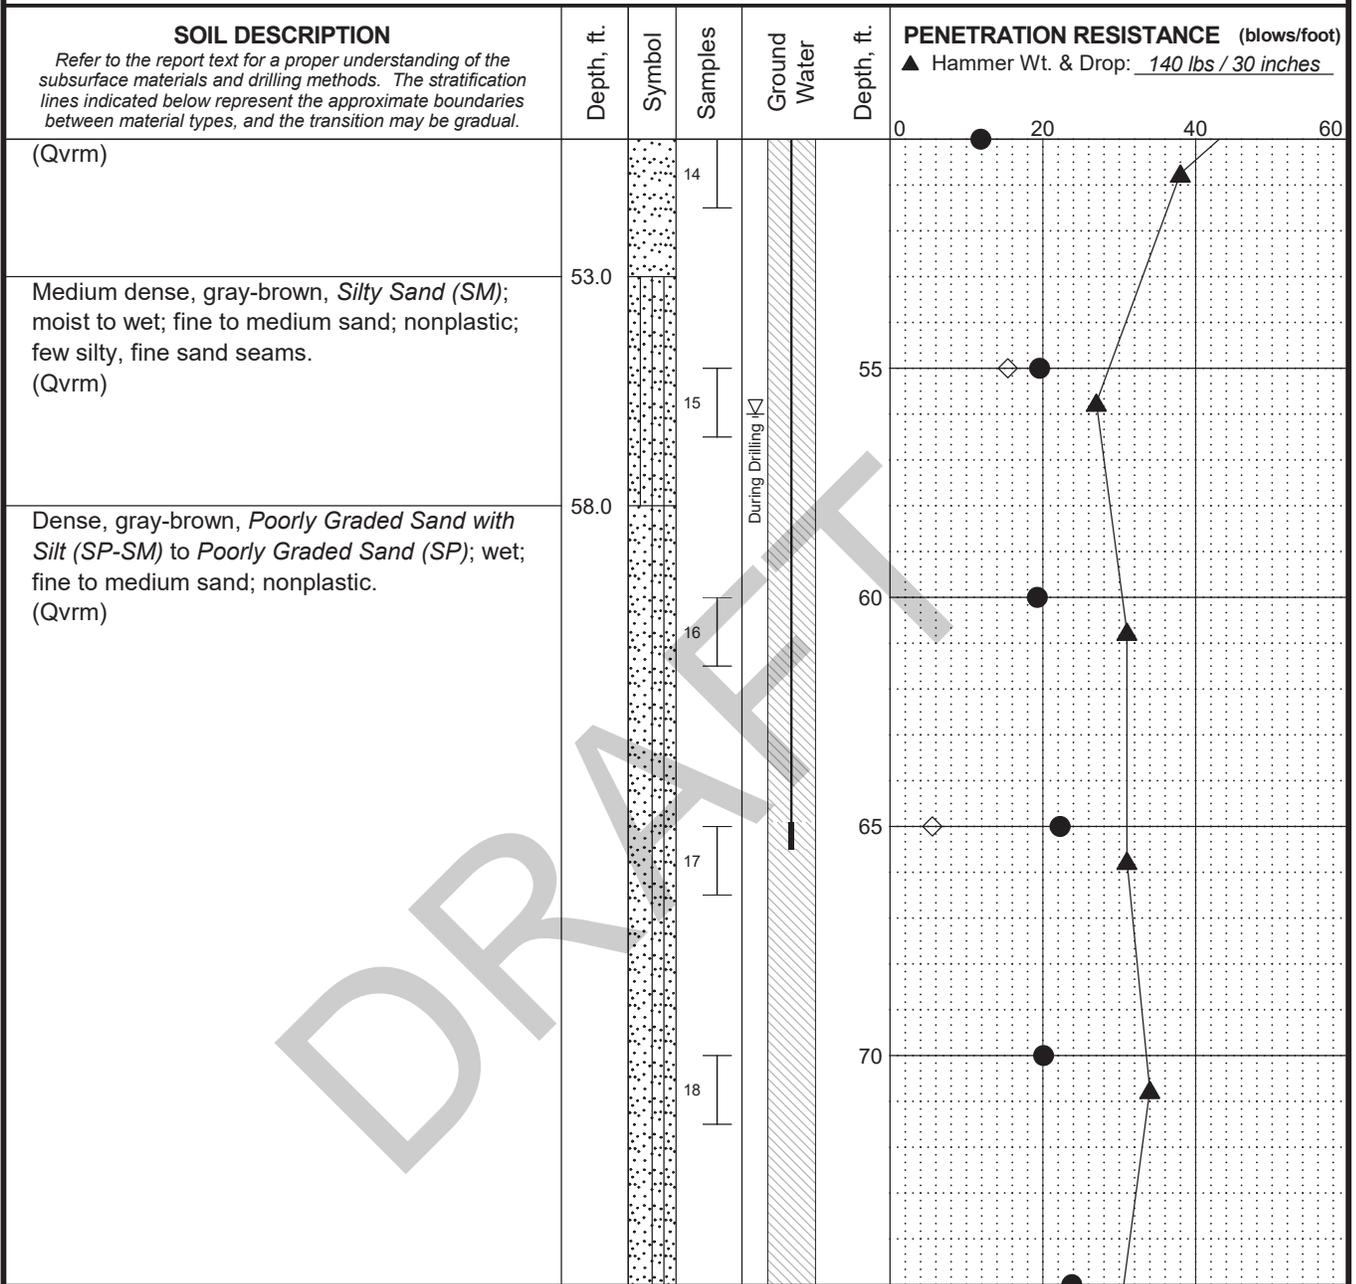
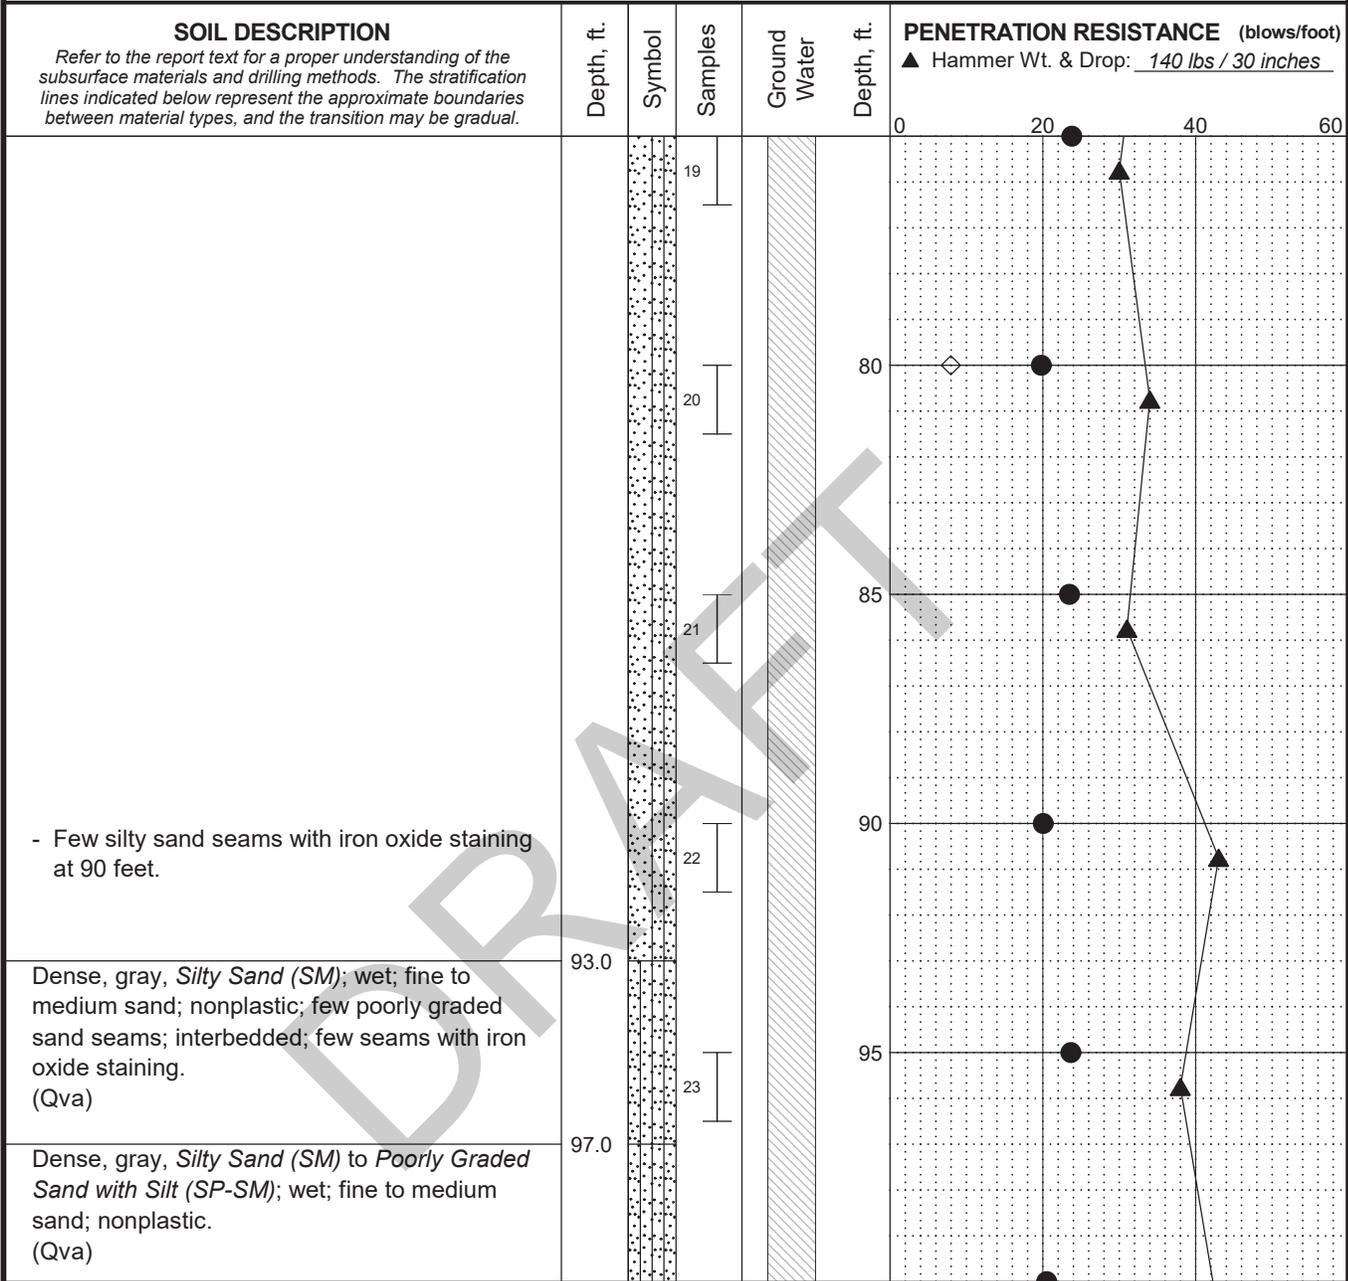
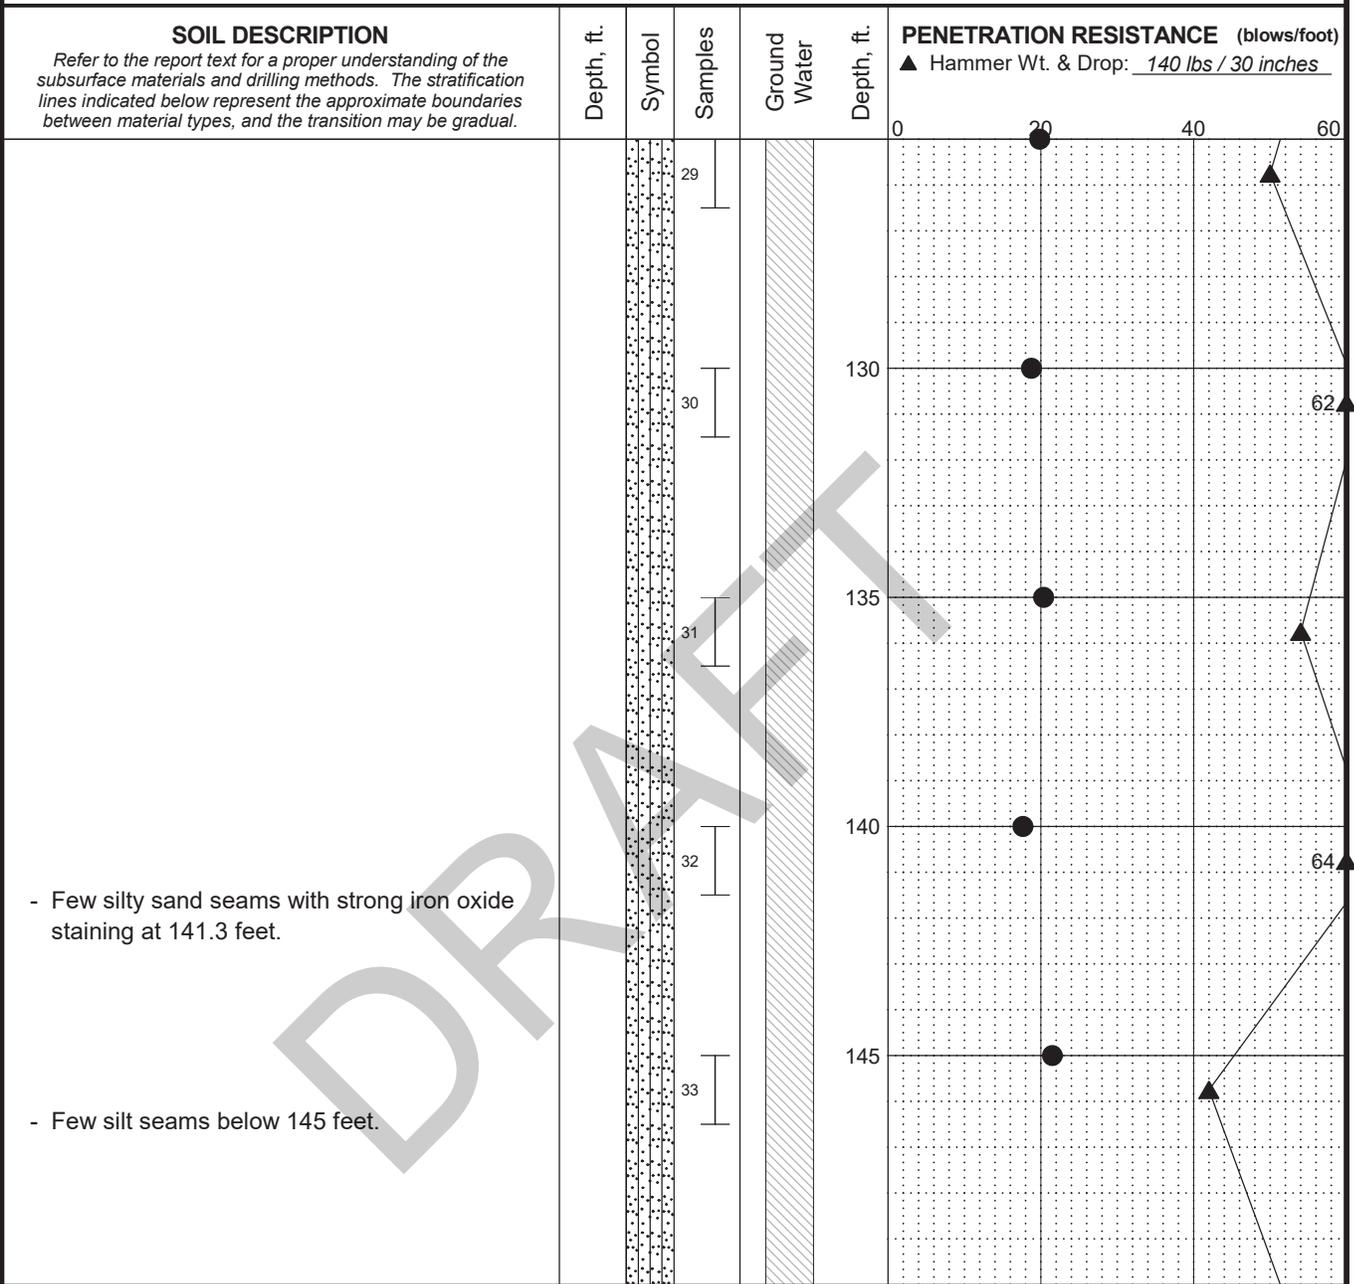
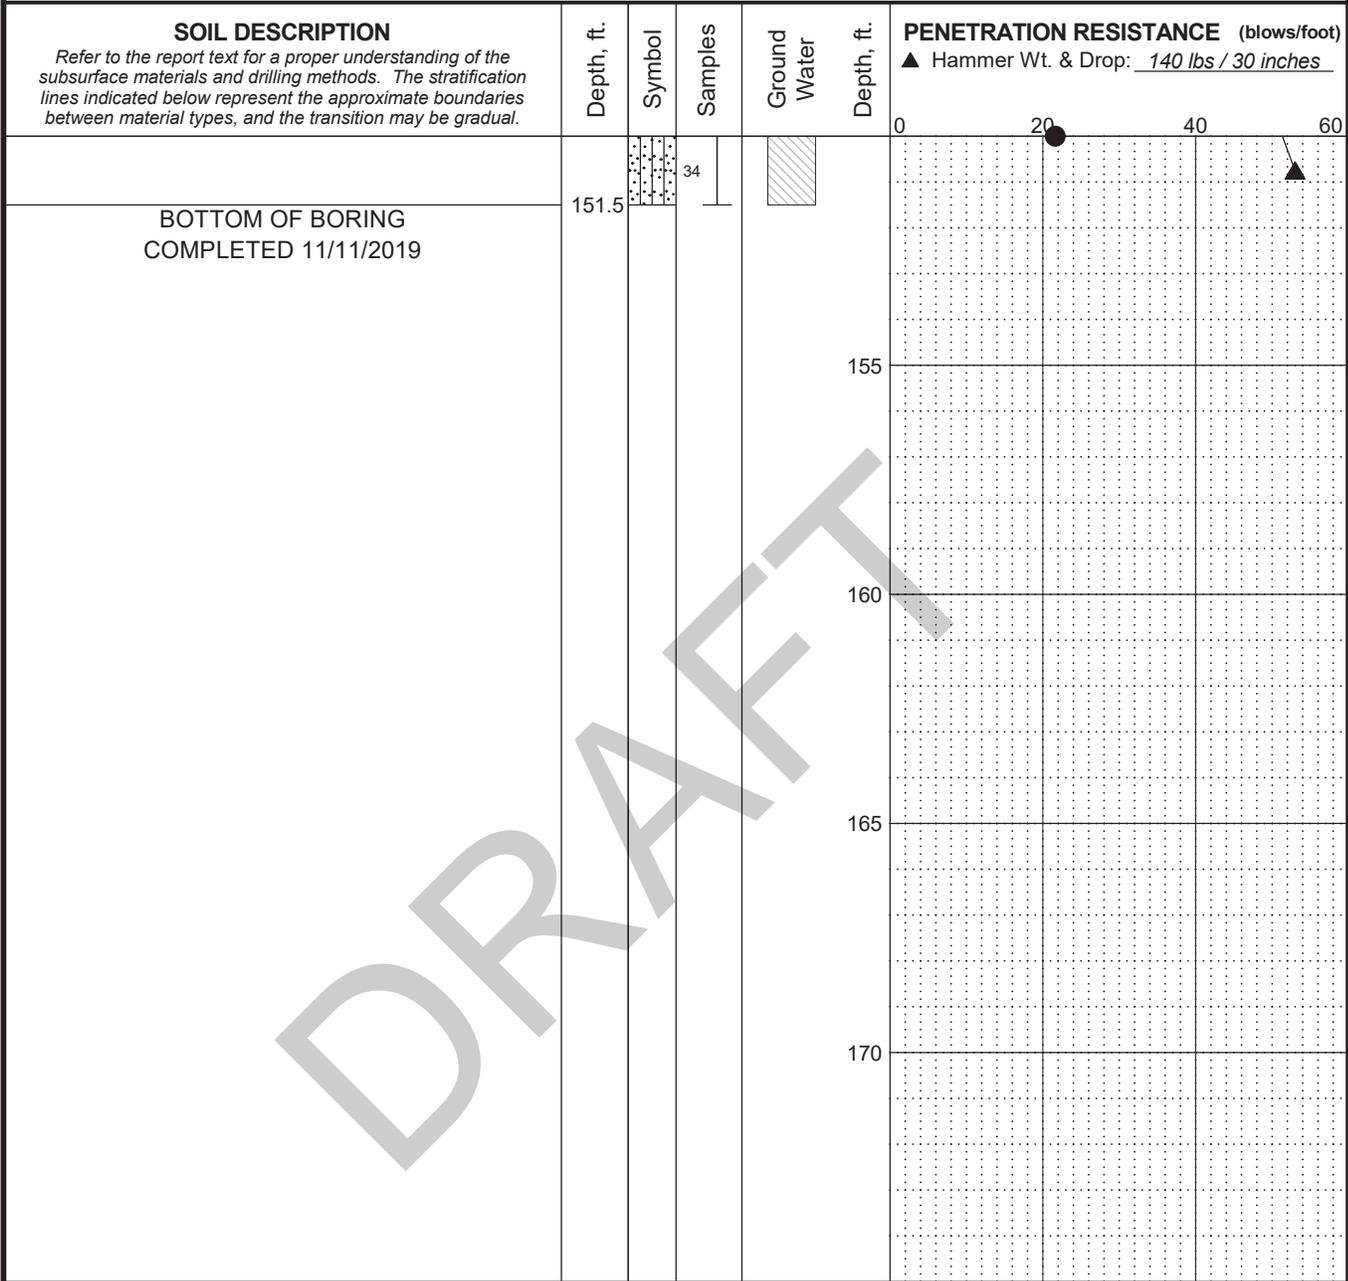
SHANNON & WILSON, INC. **FIG. A-4**
Geotechnical and Environmental Consultants Sheet 2 of 7

Total Depth: 151.5 ft. Northing: _____ Drilling Method: Mud Rotary Hole Diam.: 6 in.
 Top Elevation: ~ 147 ft. Easting: _____ Drilling Company: Holocene Drilling Rod Diam.: 2-inch ID
 Vert. Datum: _____ Station: _____ Drill Rig Equipment: Diedrich D120 Truck Hammer Type: Automatic
 Horiz. Datum: _____ Offset: _____ Other Comments: _____

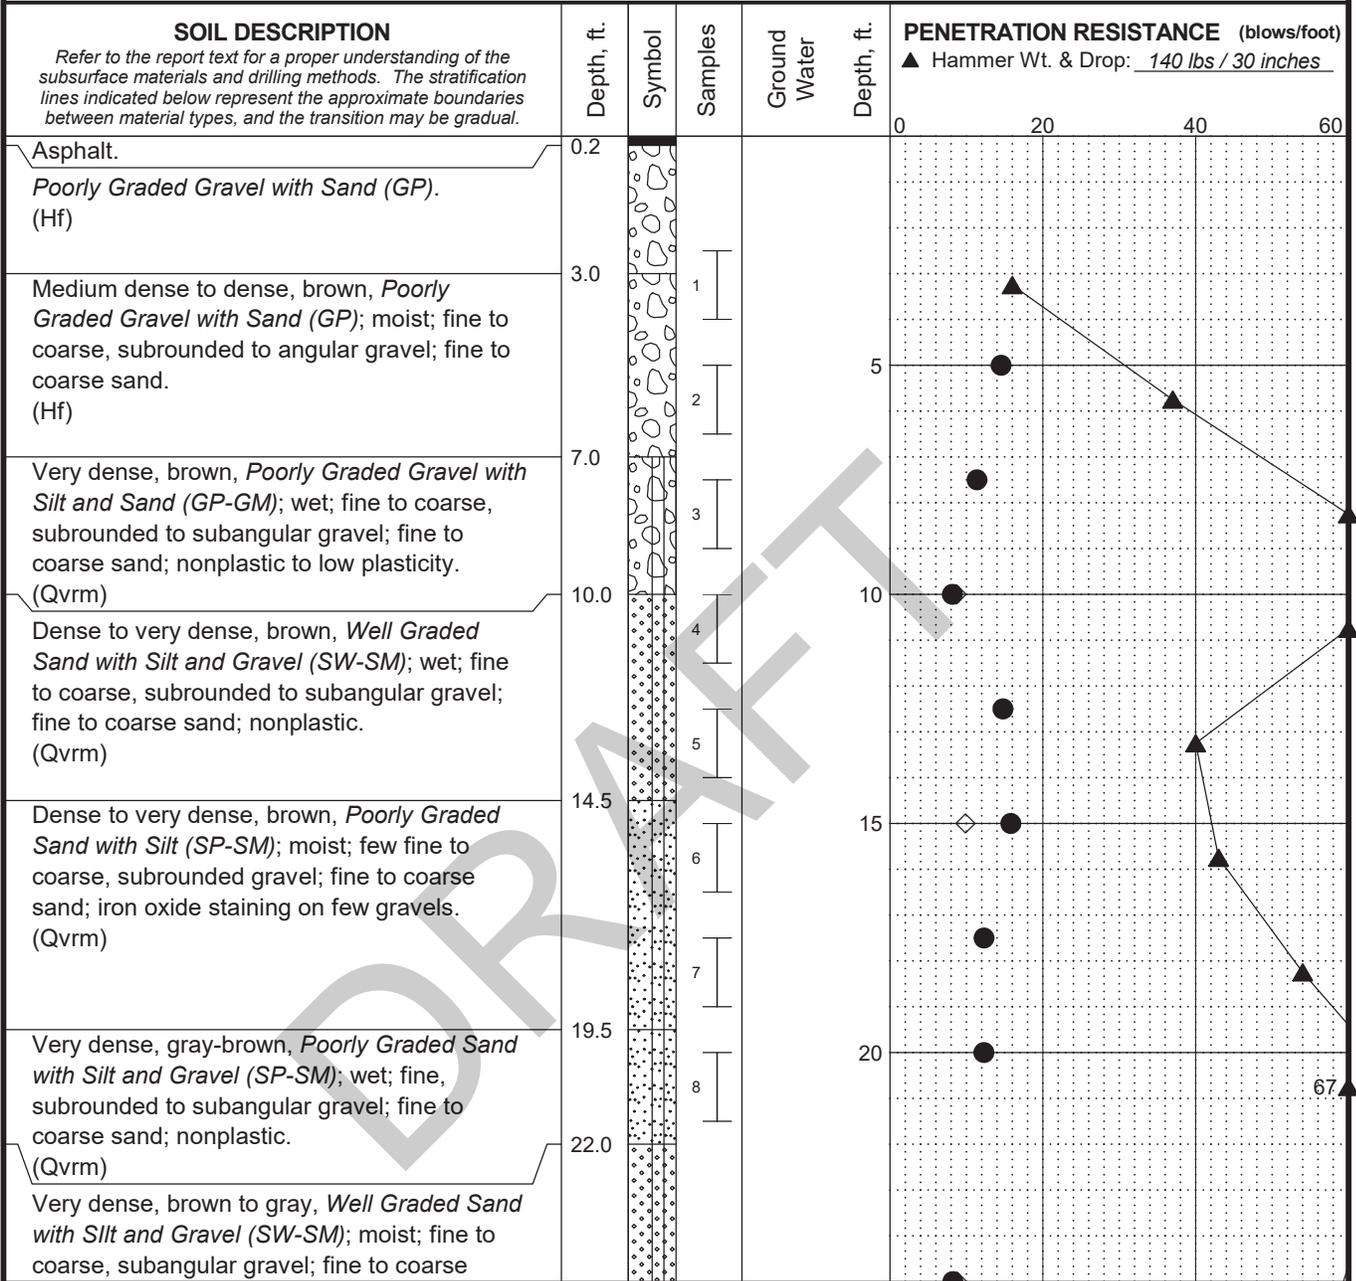
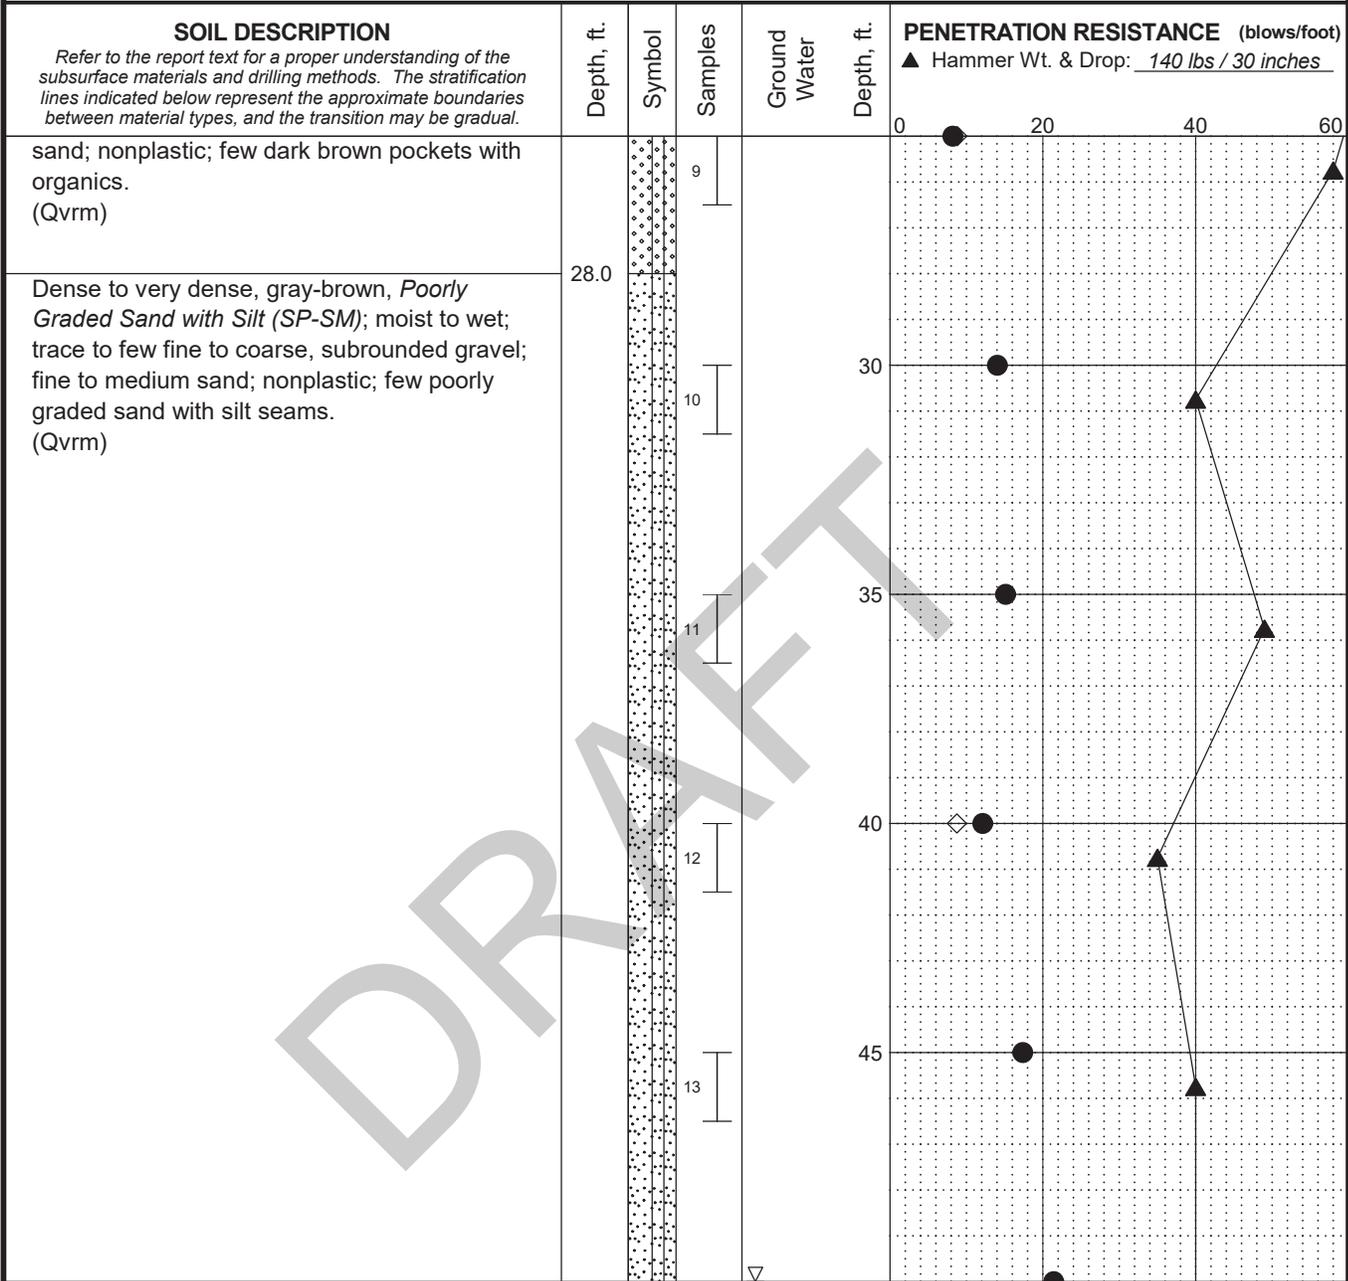
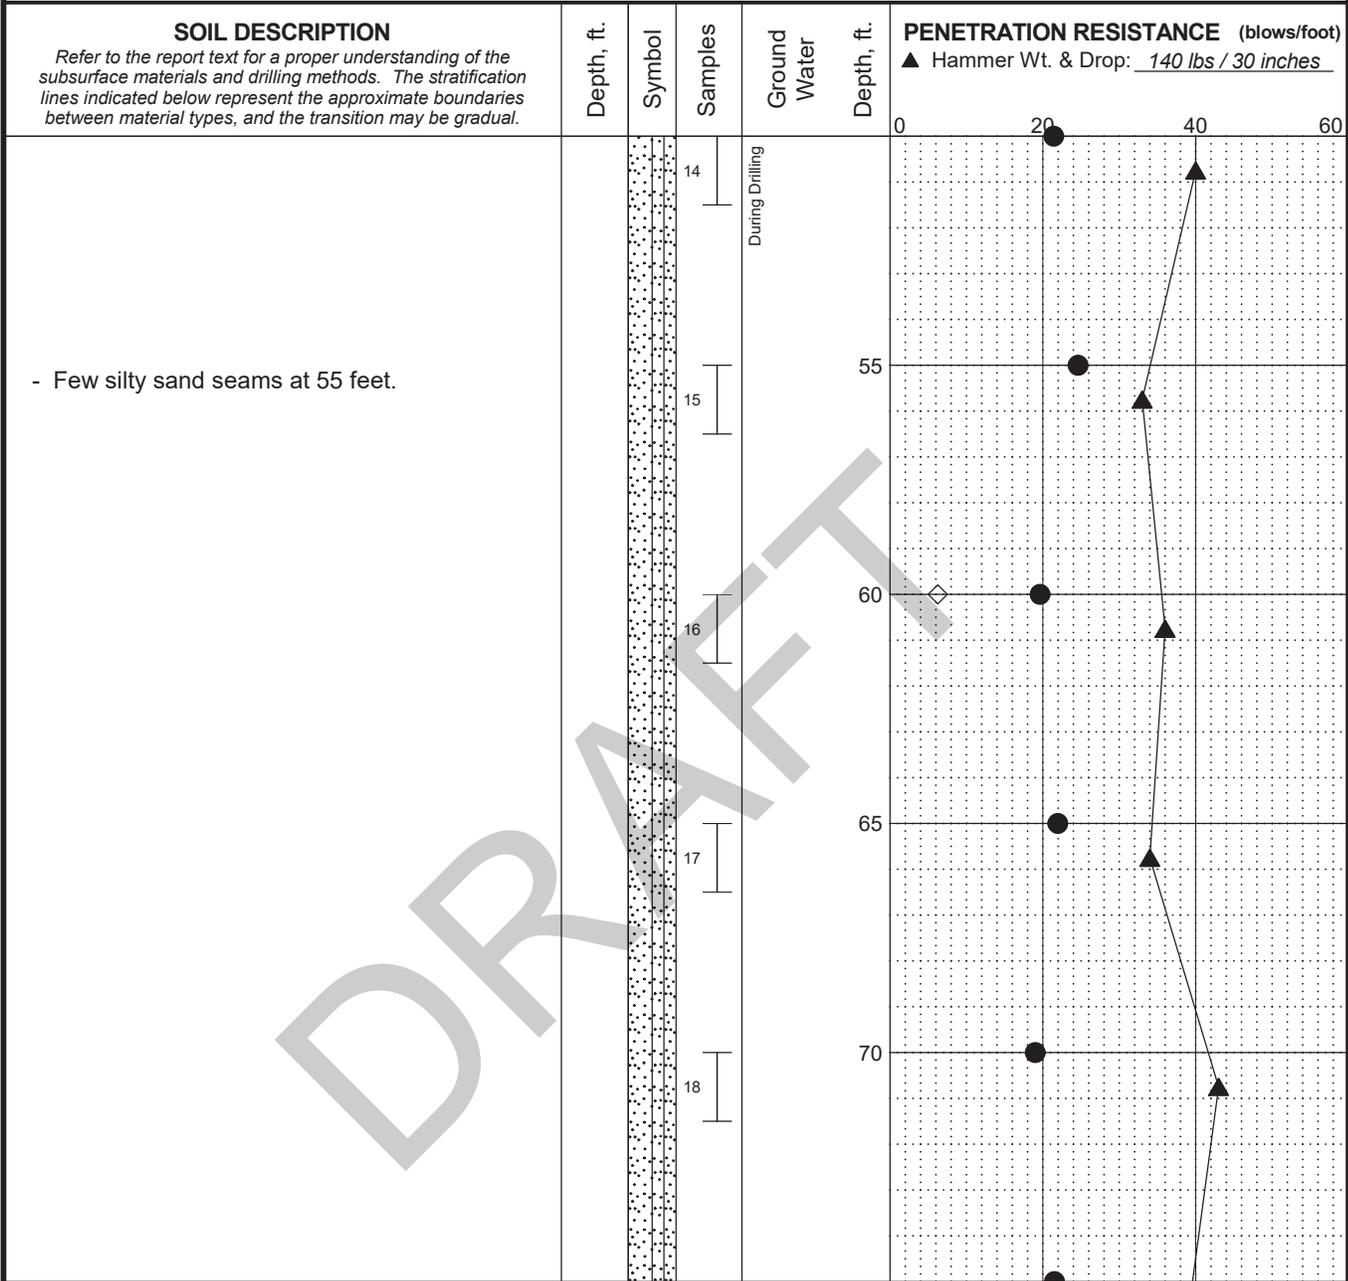
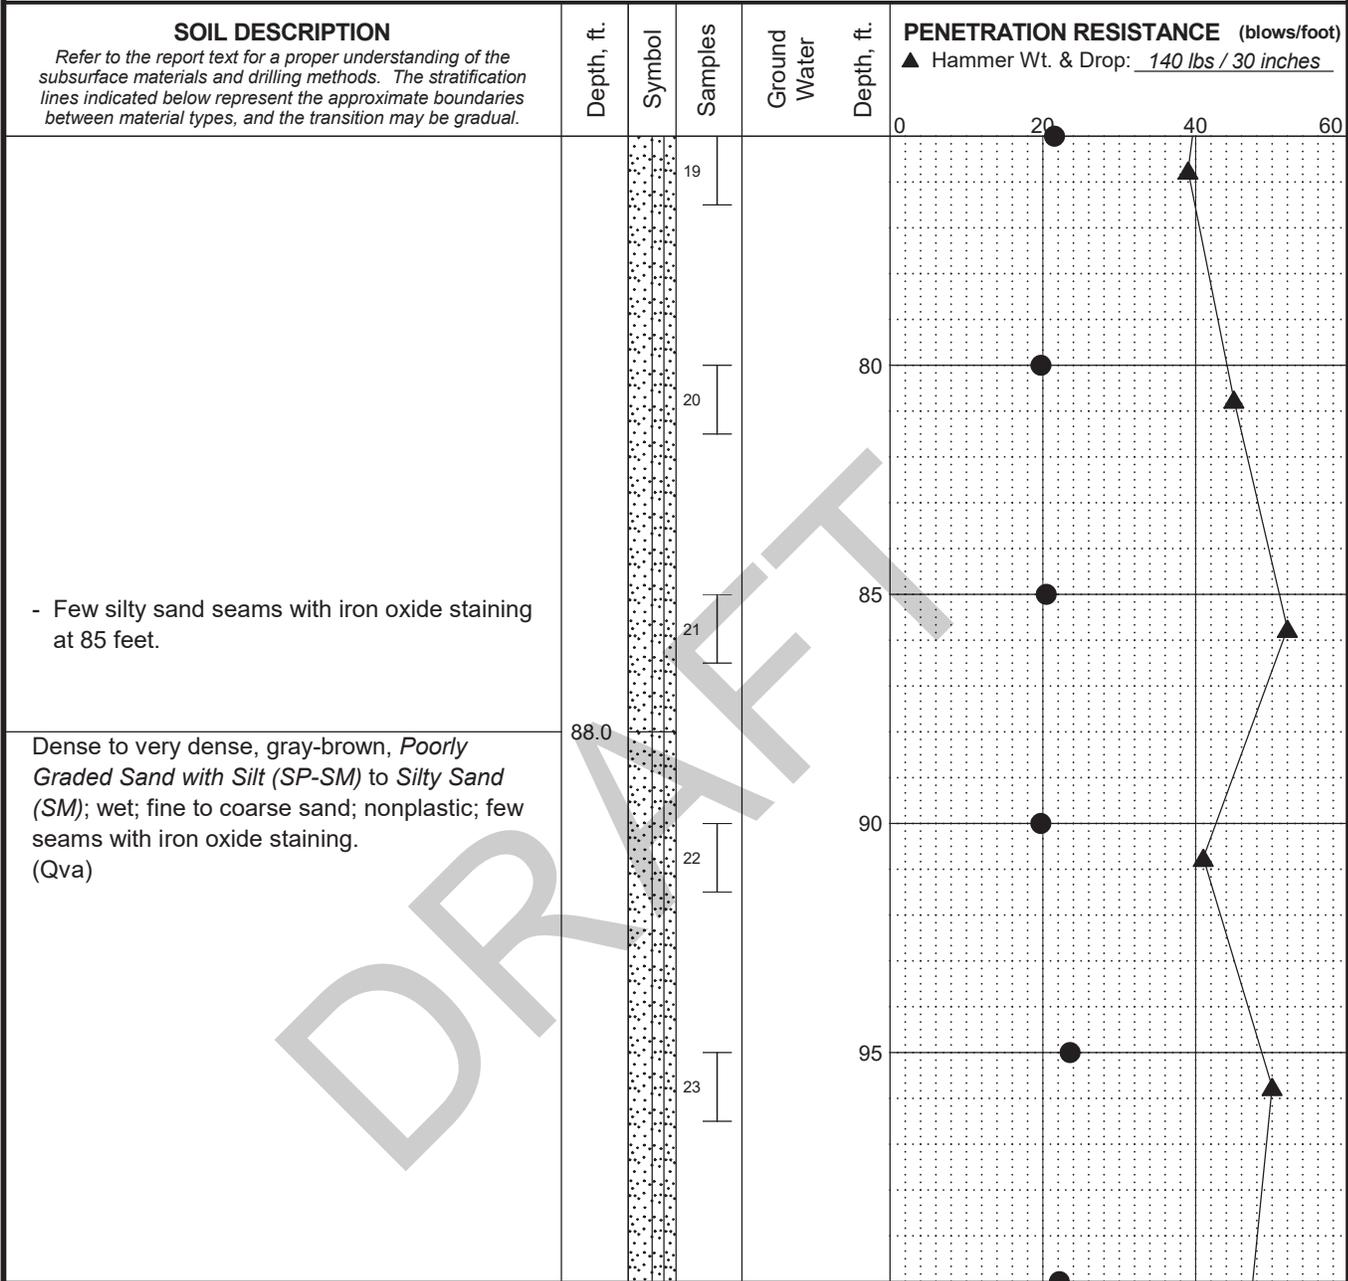
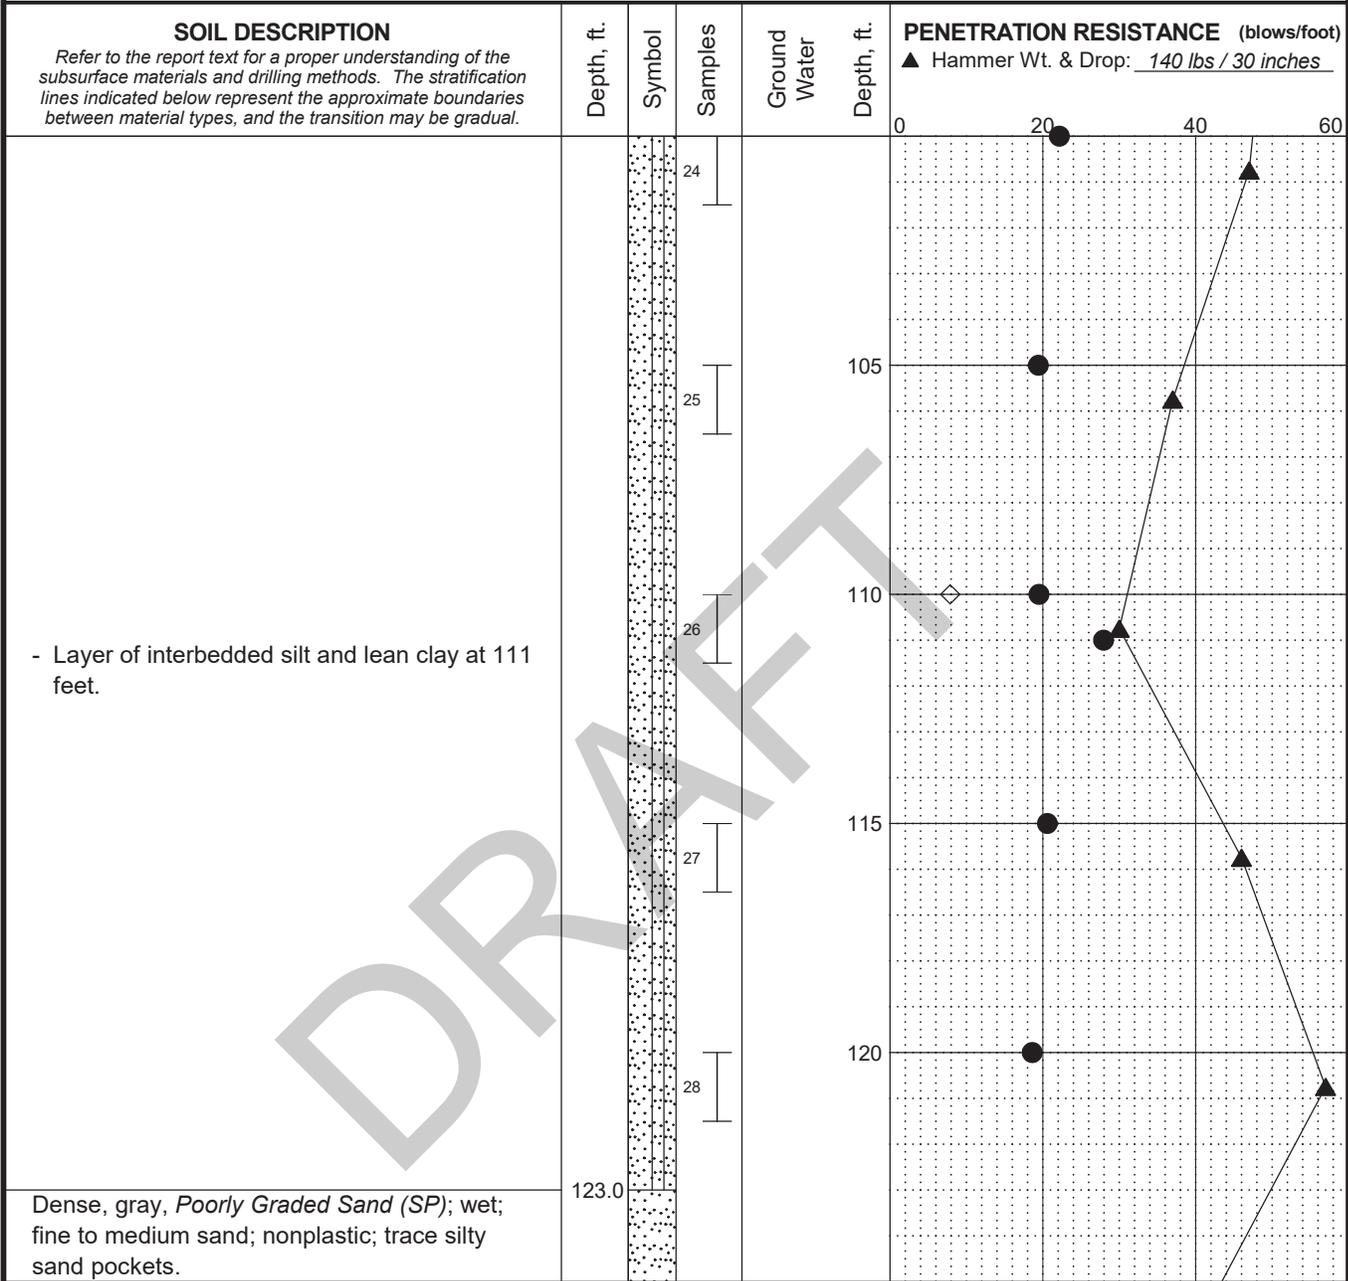
SHANNON & WILSON, INC. **FIG. A-5**
 Geotechnical and Environmental Consultants Sheet 3 of 7

Total Depth: 151.5 ft. Northing: _____ Drilling Method: Mud Rotary Hole Diam.: 6 in.
 Top Elevation: ~ 122 ft. Easting: _____ Drilling Company: Holocene Drilling Rod Diam.: 2-inch ID
 Vert. Datum: _____ Station: _____ Drill Rig Equipment: Diedrich D120 Truck Hammer Type: Automatic
 Horiz. Datum: _____ Offset: _____ Other Comments: _____

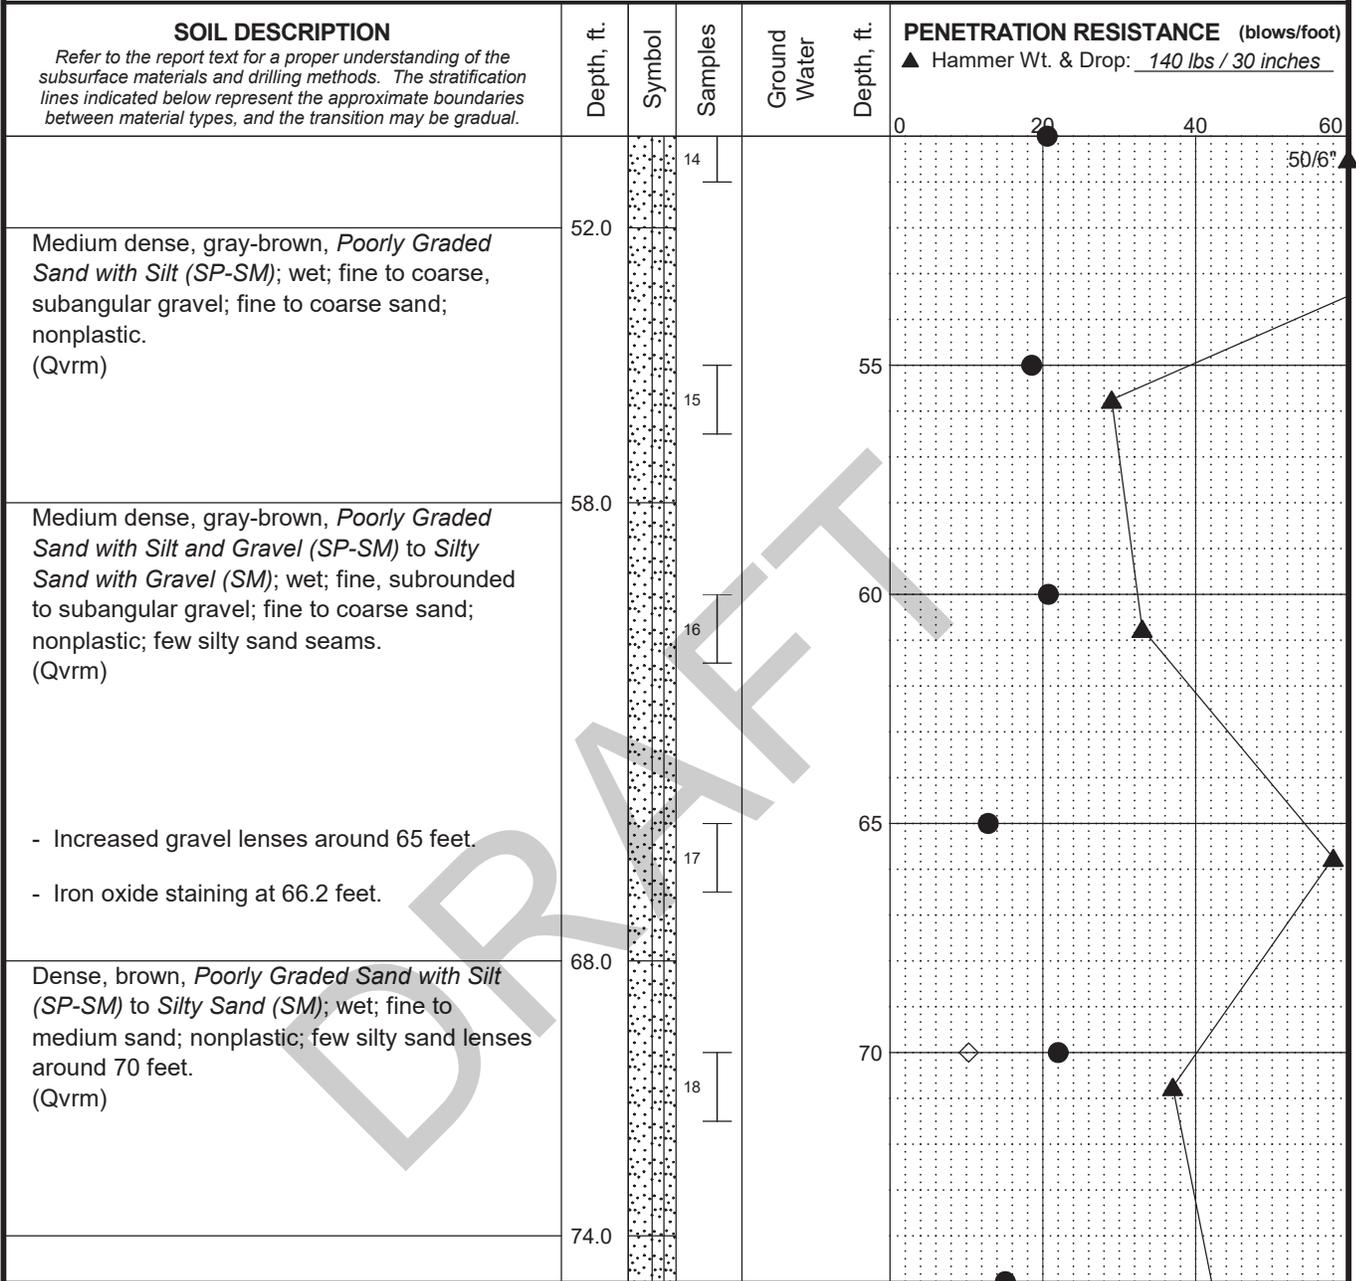
SHANNON & WILSON, INC.
Geotechnical and Environmental Consultants
FIG. A-6
Sheet 1 of 4

Total Depth: 81.5 ft. Northing: _____ Drilling Method: Mud Rotary Hole Diam.: 6 in.
 Top Elevation: ~ 125 ft. Easting: _____ Drilling Company: Holocene Drilling Rod Diam.: 2-inch ID
 Vert. Datum: _____ Station: _____ Drill Rig Equipment: Diedrich D120 Truck Hammer Type: Automatic
 Horiz. Datum: _____ Offset: _____ Other Comments: _____

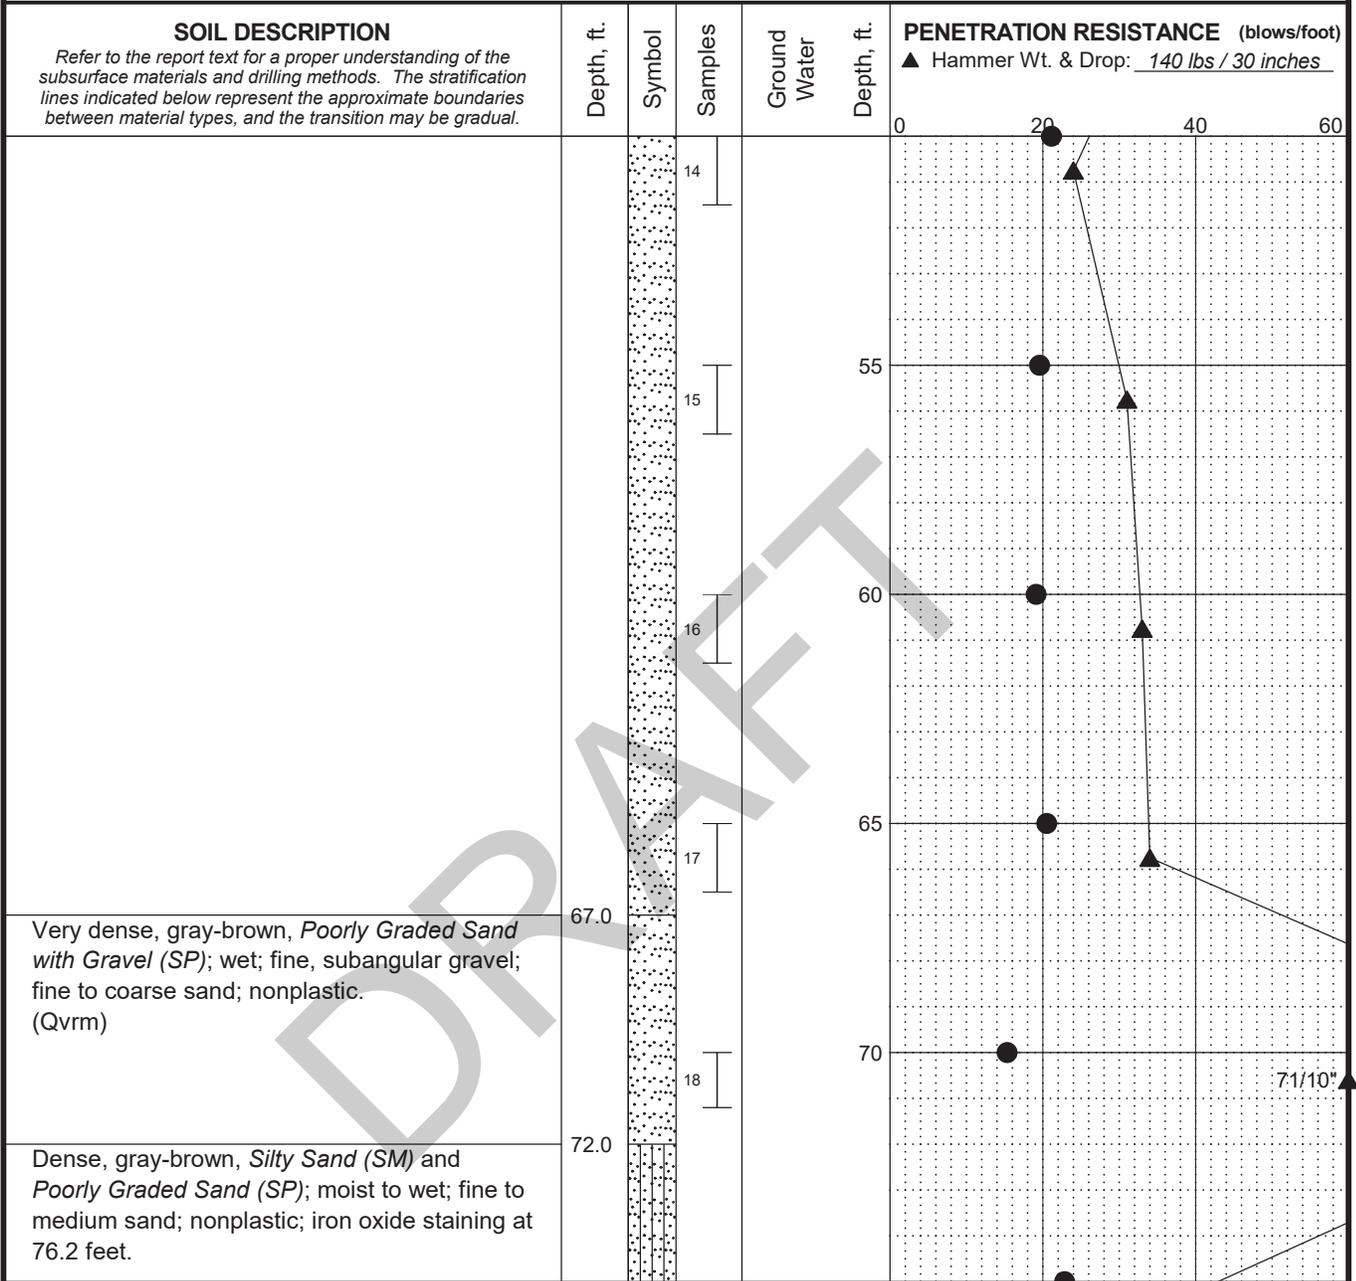
SHANNON & WILSON, INC. **FIG. A-7**
 Geotechnical and Environmental Consultants Sheet 3 of 4

Total Depth: 81.5 ft. Northing: _____ Drilling Method: Mud Rotary Hole Diam.: 6 in.
 Top Elevation: ~ 125 ft. Easting: _____ Drilling Company: Holocene Drilling Rod Diam.: 2-inch ID
 Vert. Datum: _____ Station: _____ Drill Rig Equipment: Diedrich D120 Truck Hammer Type: Automatic
 Horiz. Datum: _____ Offset: _____ Other Comments: _____
