Stormwater Drainage Report

**Arlington Operations Center
19620 67th Ave NE
Arlington, WA 98223**

*Subsurface Exploration, Geologic Hazards,
Preliminary Geotechnical Engineering, and Infiltration Feasibility Report*

ARLINGTON OPERATIONS CENTER REDEVELOPMENT

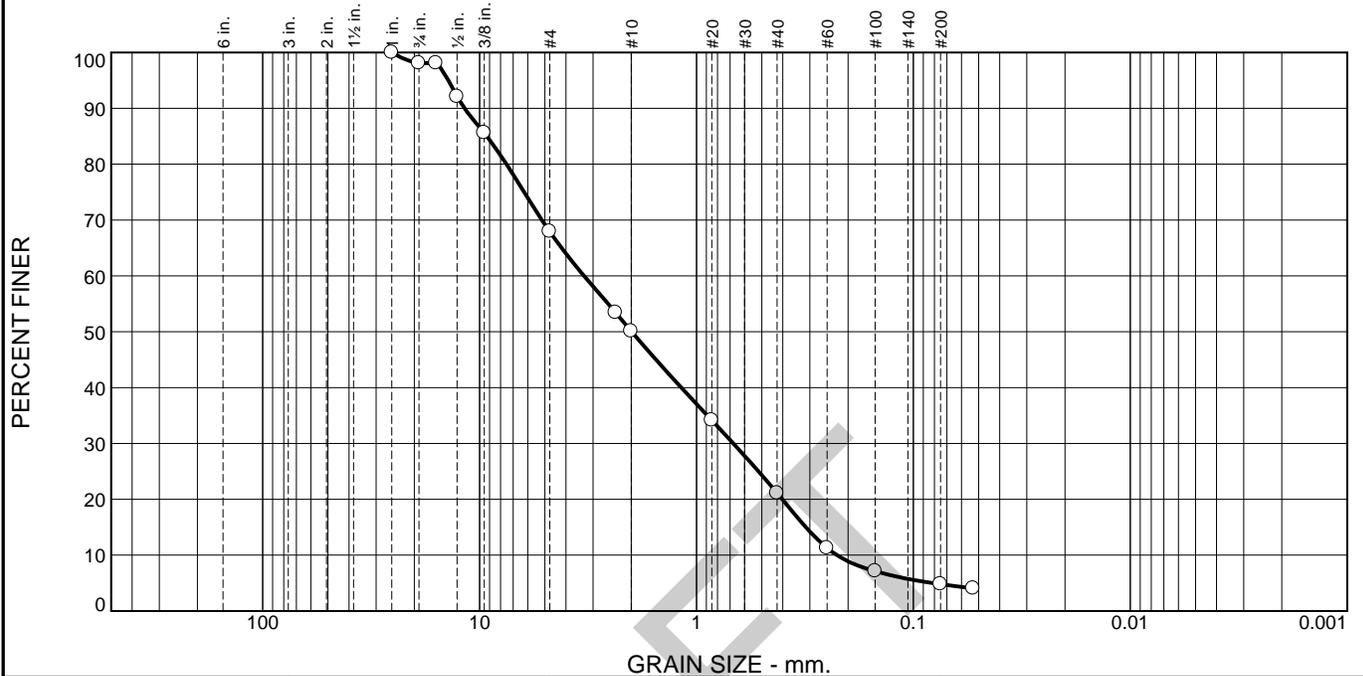
Particle Size Distribution Report

% +3"	% Gravel		% Sand			% Fines	
	Coarse	Fine	Coarse	Medium	Fine	Silt	Clay
0.0	1.9	30.2	17.8	29.0	16.3	4.8

TEST RESULTS			
Opening Size	Percent Finer	Spec.* (Percent)	Pass? (X=Fail)
1"	100.0		
3/4"	98.1		
5/8"	98.1		
1/2"	92.1		
3/8"	85.6		
#4	67.9		
#8	53.4		
#10	50.1		
#20	34.1		
#40	21.1		
#60	11.3		
#100	7.1		
#200	4.8		
#270	4.1

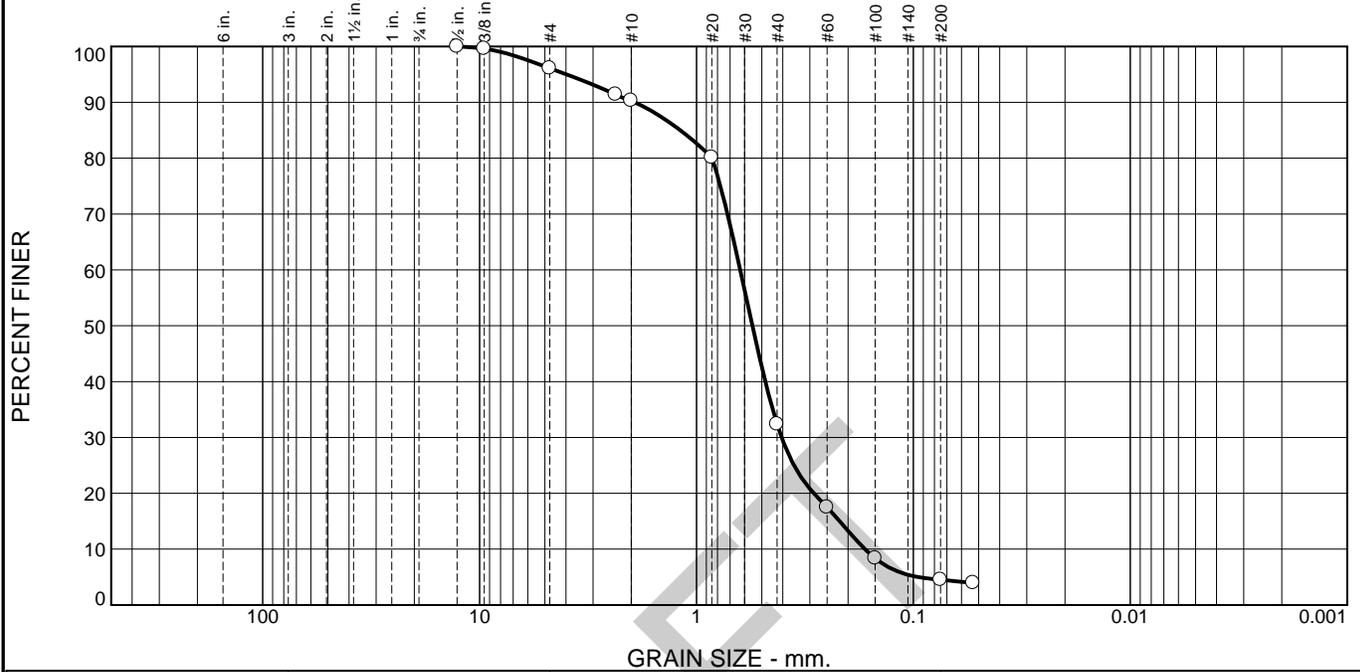
Particle Size Distribution Report

% +3"	% Gravel		% Sand			% Fines	
	Coarse	Fine	Coarse	Medium	Fine	Silt	Clay
0.0	0.0	3.9	5.8	57.9	27.9	4.5

TEST RESULTS			
Opening Size	Percent Finer	Spec.* (Percent)	Pass? (X=Fail)
1/2"	100.0		
3/8"	99.6		
#4	96.1		
#8	91.4		
#10	90.3		
#20	80.1		
#40	32.4		
#60	17.5		
#100	8.4		
#200	4.5		
#270	3.9

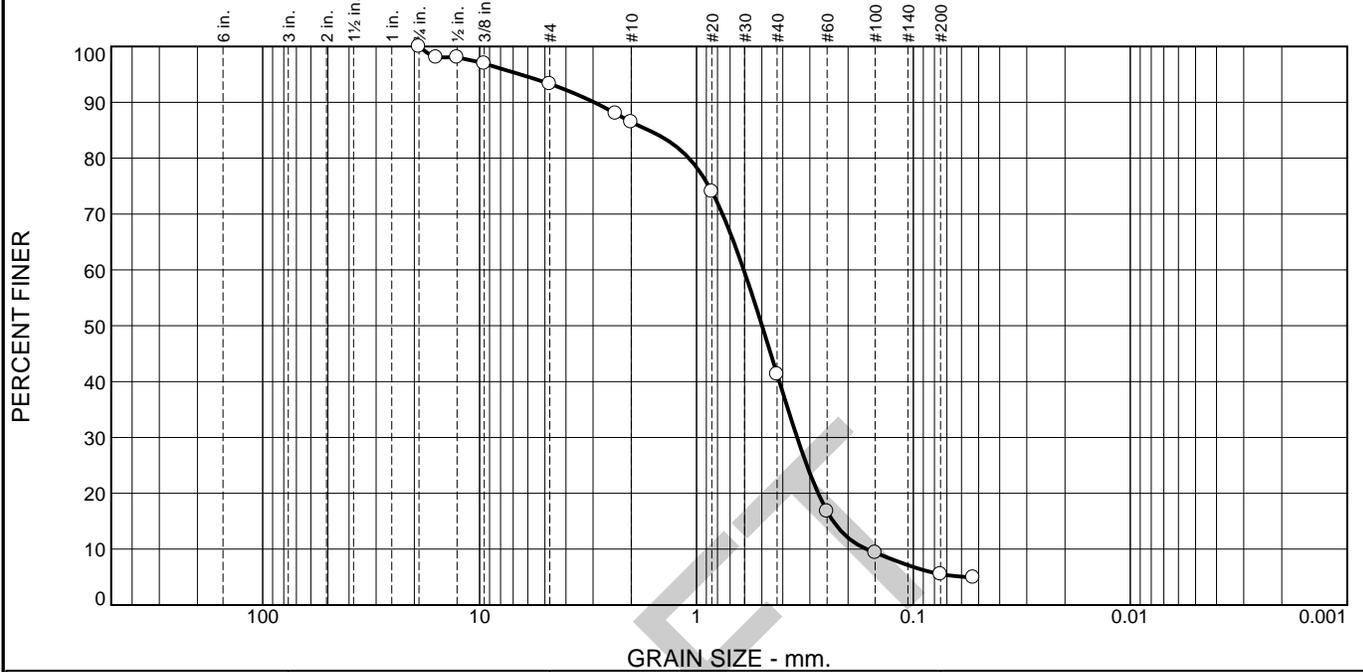
Particle Size Distribution Report

% +3"	% Gravel		% Sand			% Fines	
	Coarse	Fine	Coarse	Medium	Fine	Silt	Clay
0.0	0.0	6.7	6.8	45.2	35.8	5.5

TEST RESULTS			
Opening Size	Percent Finer	Spec.* (Percent)	Pass? (X=Fail)
3/4"	100.0		
5/8"	98.0		
1/2"	98.0		
3/8"	97.0		
#4	93.3		
#8	88.0		
#10	86.5		
#20	74.0		
#40	41.3		
#60	16.8		
#100	9.4		
#200	5.5		
#270	4.9

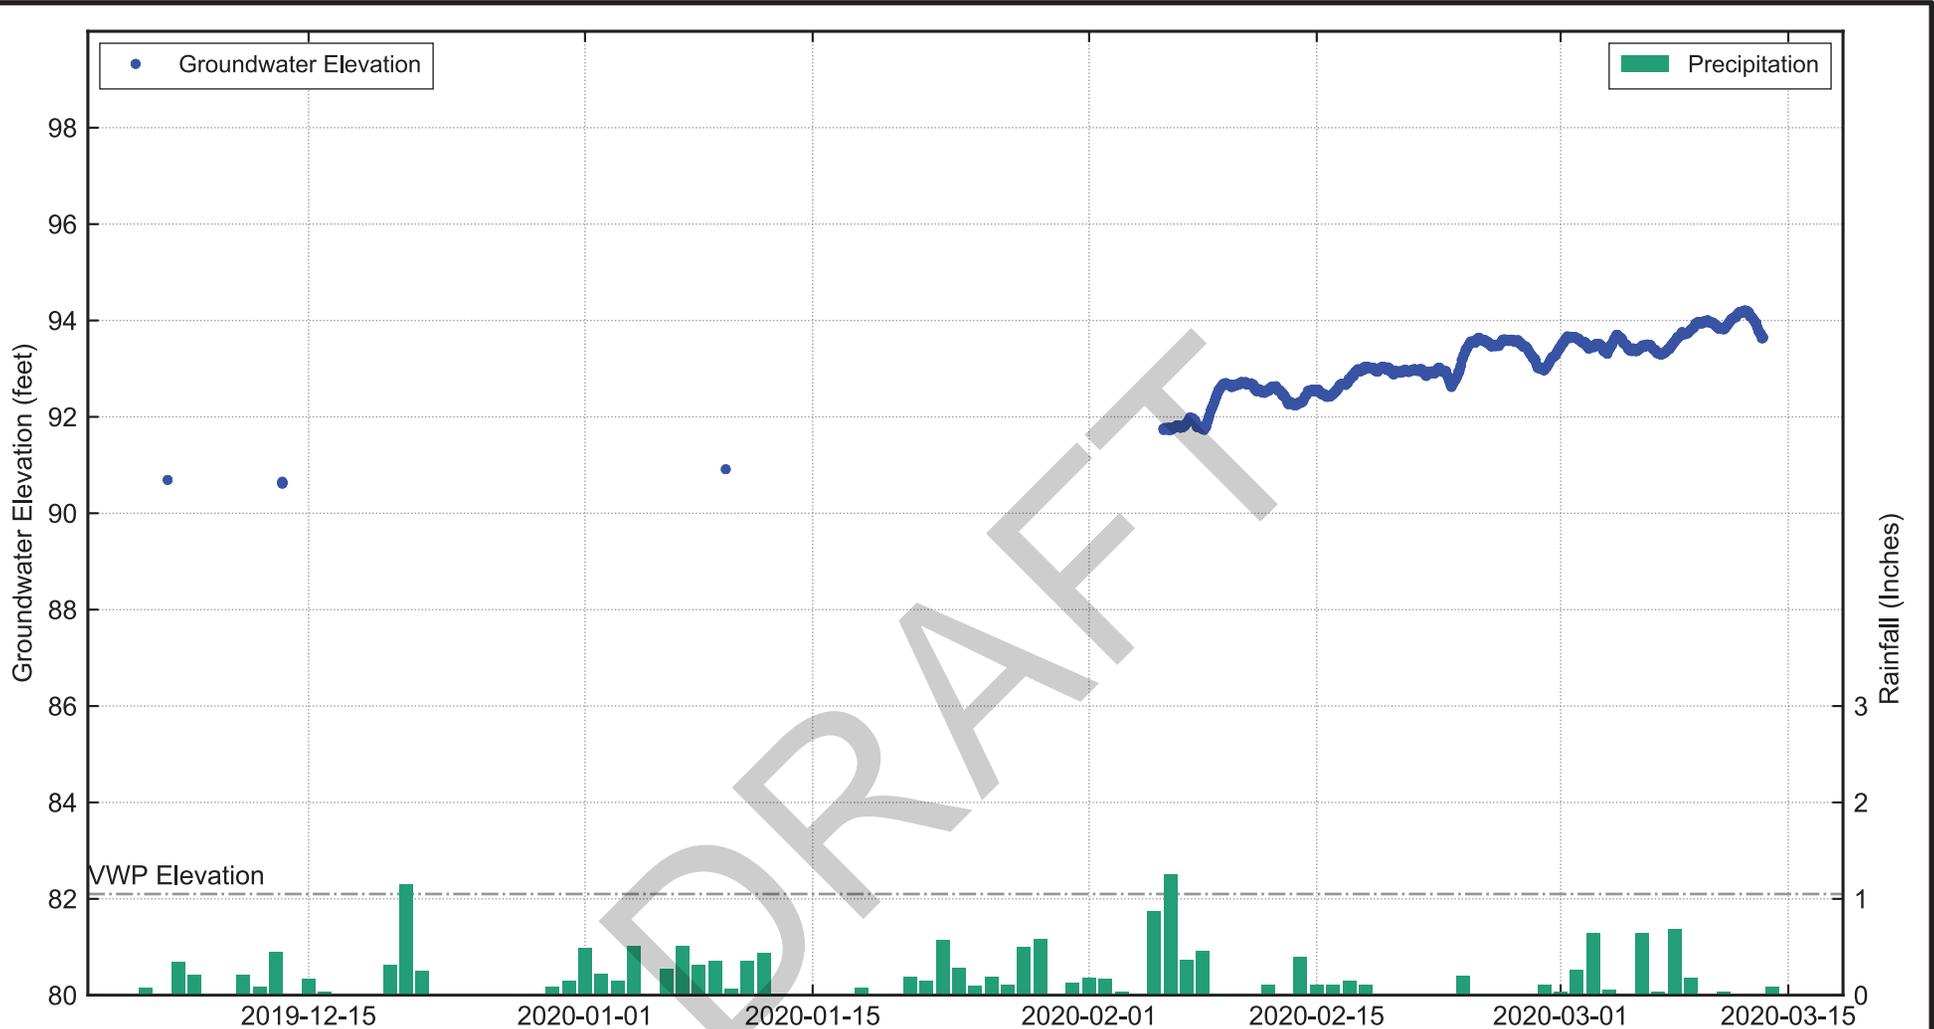
Hydrographs

Notes:

1. Ground surface elevation at SW-3-19 is approximately 147 feet. The VWP is installed at a depth of 65 feet, corresponding to approximate elevation +82 feet.
2. Rainfall data sourced from NOAA station US1WASN0043 located in North Marysville about 5 miles south of Arlington
