Geotechnical Engineering Report  
The Point  
19402 Smokey Point Boulevard  
Arlington, WA

September 16, 2022  
Project No. 22-0727

**Regarding: Geotechnical Engineering Report  
The Point  
19402 Smokey Point Boulevard  
Arlington, WA  
(Parcel No. 31051700400600)**

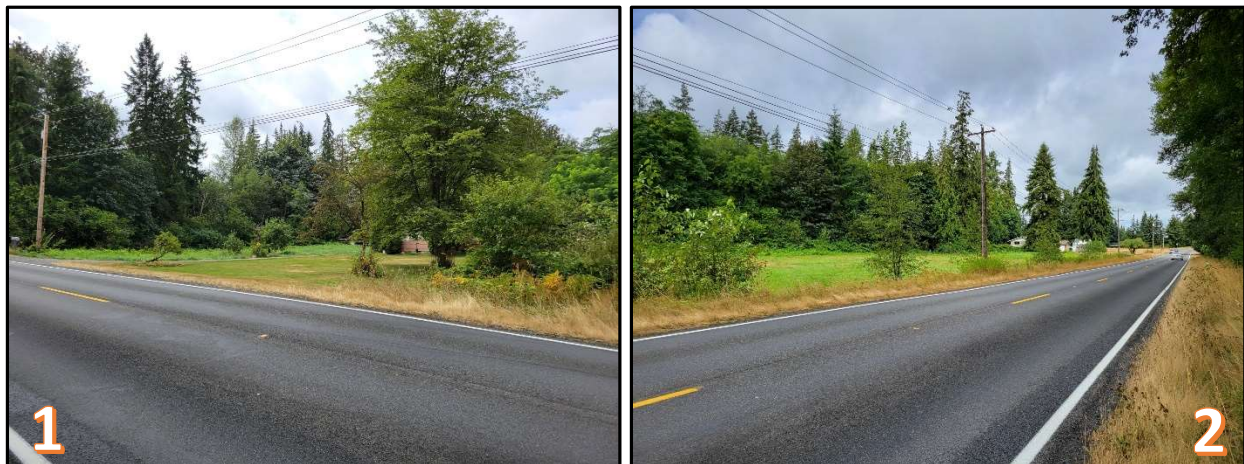
**Images 1 and 2.** A southwestern view of the upper portion of the property and the single-family residence on site (Image 1), as well as a northwestern view of the lower portion of the subject parcel (Image 2).

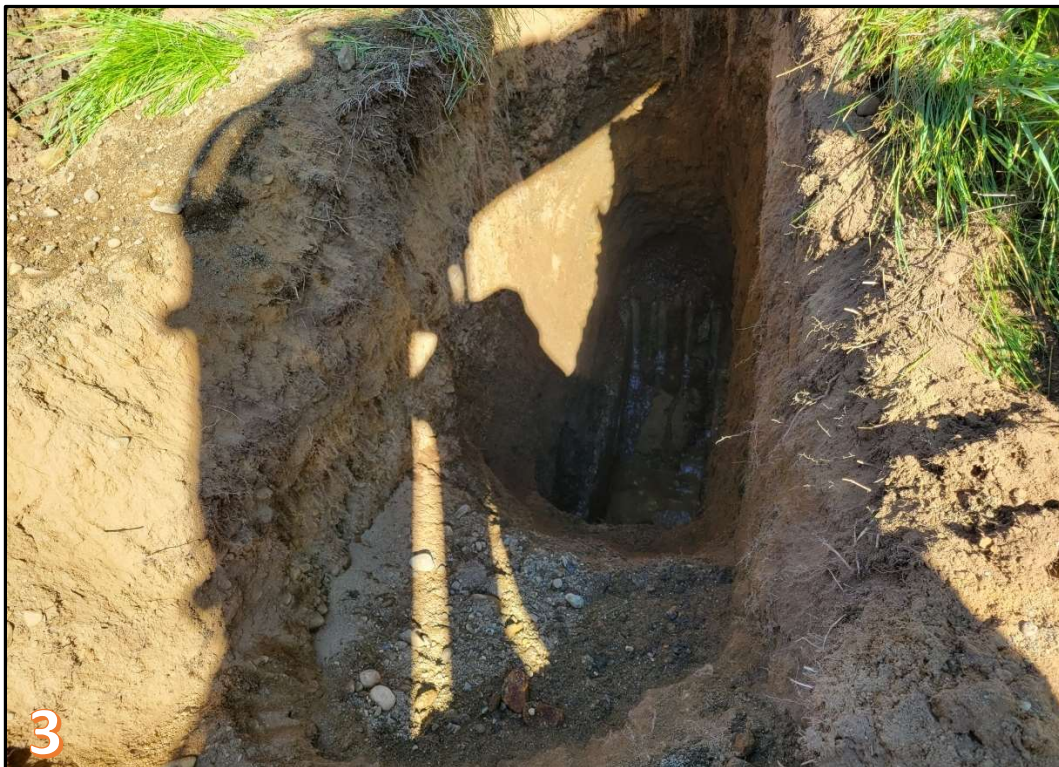
**Image 3.** Subsurface soil conditions within test pit TP-3, exhibiting granular outwash overlying slightly clayey, very sandy silt at depth, with perched groundwater atop these finer soils.

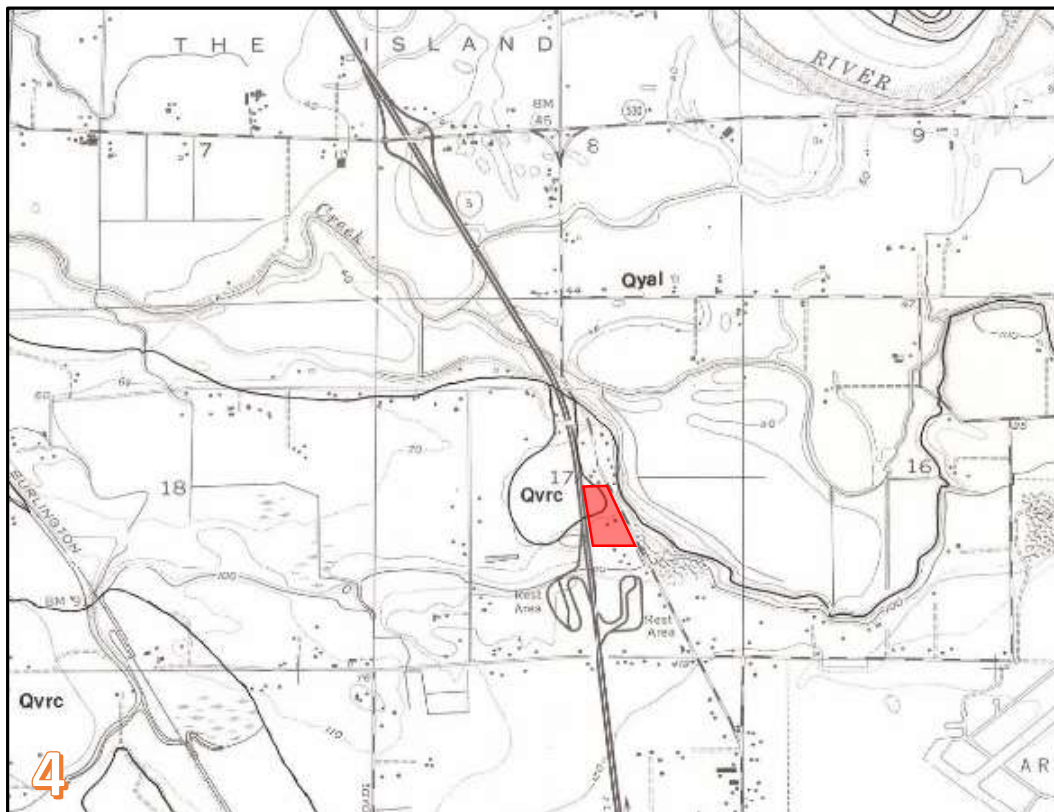
**Image 4.** Mapped geologic units within the vicinity of the project site (shown in red), as mapped by Minard, illustrating the presence of alluvium (map unit Qyal), Marysville Sand (map unit Qvrm), and the Clay Member (map unit Qvrc) in the area.

The Marysville Sand Member of the Recessional Outwash consists of mostly well-drained, outwash sand with minor amounts of gravel. The Clay Member is comprised of gray, olive gray, mottled, massive clay to silt and is associated with the Marysville Sand Member, such that it grades into and interfingers laterally with the Marysville Sand member. Recessional outwash deposits such as these were deposited as valley fill by meltwater flowing south from the stagnating and receding Vashon Glacier during the Pleistocene Epoch. Glaciofluvial environments

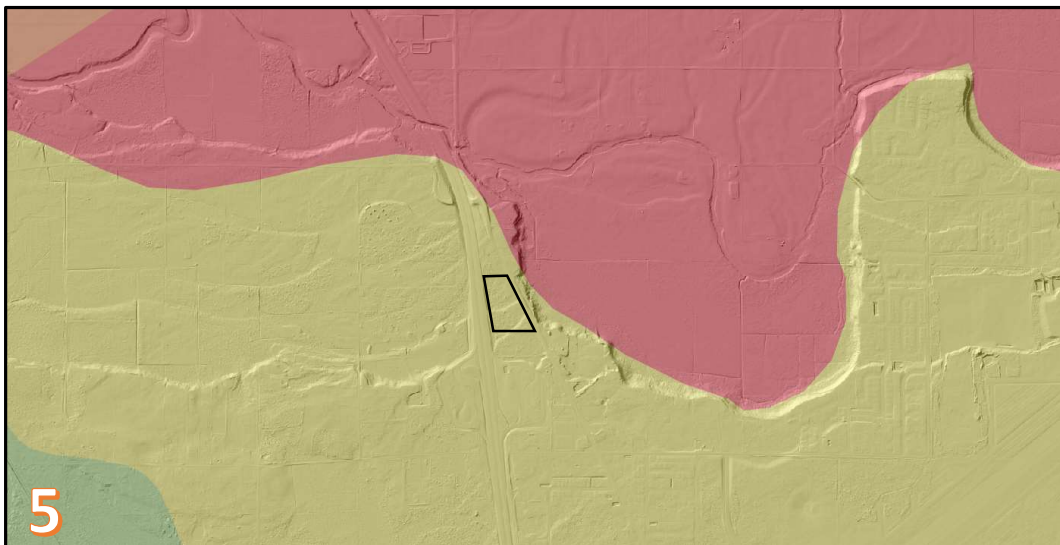
**Image 5.** Map showing liquefaction hazard susceptibility within the proposed development area shown in black. Yellow depicts “low to moderate” susceptibility in the vicinity of subject property (Data source: Washington Geologic Information Portal).

Based on our subsurface explorations, the site is underlain by native, medium dense, sandy soils with varying amounts of gravel. Groundwater seepage was encountered within medium dense, native soils. Due to these factors, it is GeoTest’s opinion that the potential for liquefaction

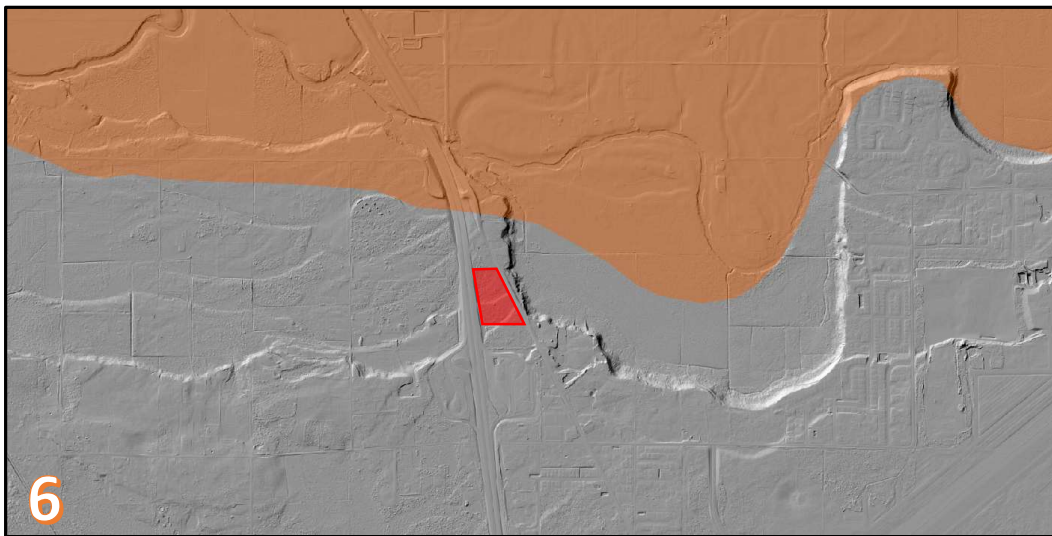
**Image 6.** Map showing the proposed development in red and its vicinity to a potential lahar flow path from a Glacier Peak volcanic event in orange (Data source: Washington Geologic Information Portal).

Based on a review of information obtained from the *Geologic Information Portal*, the project area is located approximately 750 feet from a mapped Volcanic Hazard Area (Lahar Hazard). The AMC does not define volcanic hazards; thus, no volcanic hazards exist on this property per AMC. However, the project's vicinity to a lateral perimeter of a mapped "volcanic hazard," as mapped by the Department of Nature Resources, should be noted.

It is GeoTest's opinion that the level of risk is not sufficient to prevent development of the subject property as proposed due to the elevation above the Stillaguamish River floodplain. No lahar mitigations are expected as part of site development.

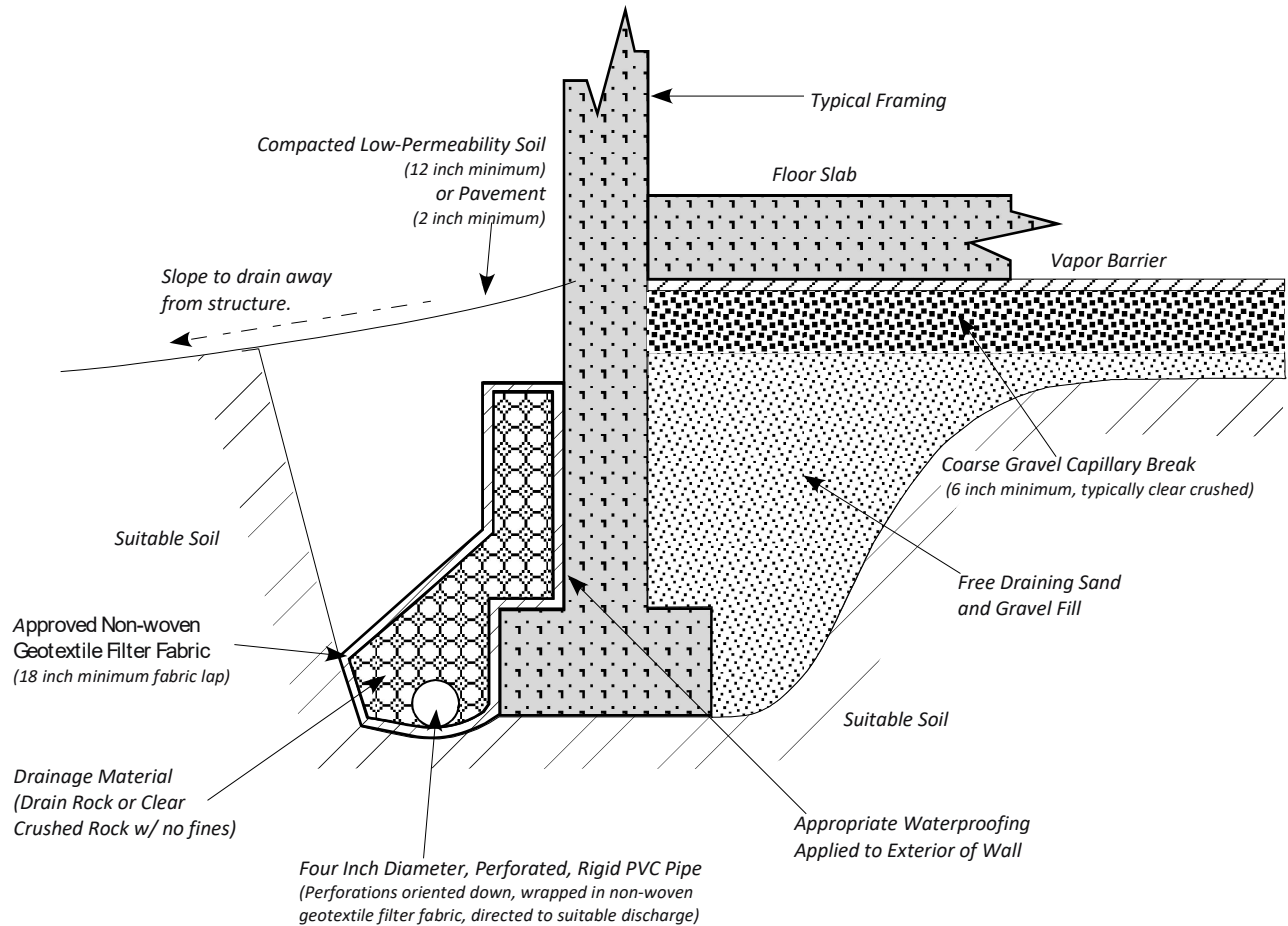
## CONCEPTUAL FOOTINGS WITH INTERIOR SLAB-ON-GRADE

Footings should be properly buried for frost protection in accordance with International Building Code or local building codes (Typically 18 inches below exterior finished grades).

To reduce the potential for groundwater and surface water to seep into interior spaces, GeoTest recommends that an exterior footing drain system be constructed around the perimeter of new foundations as shown in the *Conceptual Footing and Wall Drain Section* (Figure 6) of this report. The drain should consist of a perforated pipe measuring 4 inches in diameter at minimum, surrounded by at least 12 inches of filtering media. The pipe should be sloped to carry water to an approved collection system.
